## Salinity Measurements and General Condition of Violet Marsh, Post Hurricane Katrina

*by Jeff P. Lin and Barbara A. Kleiss*

**PURPOSE:** This technical note reports surface salinity measurements taken in Violet Marsh approximately 3-1/2 months after Hurricane Katrina, and compares them to measurements made in 1993-1994 as part of the Violet Siphon Project. This note also includes photo documentation and general visual observations of the physical condition of the marsh post-Katrina.

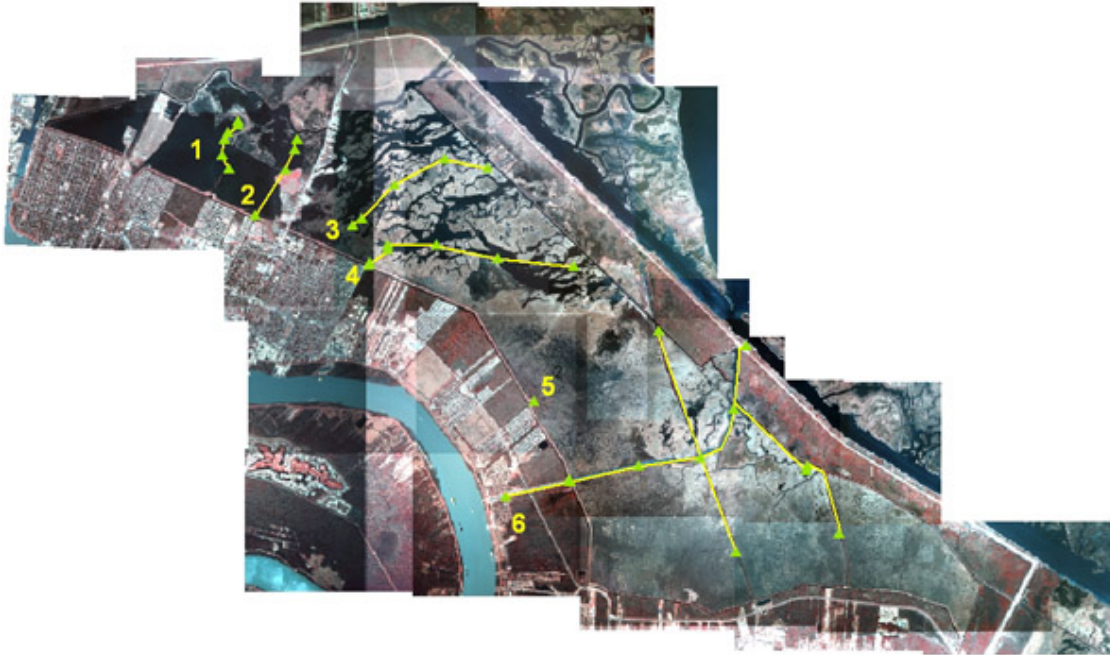
Figure 2. Transects/areas where sampling stations (indicated by the green triangles) were located

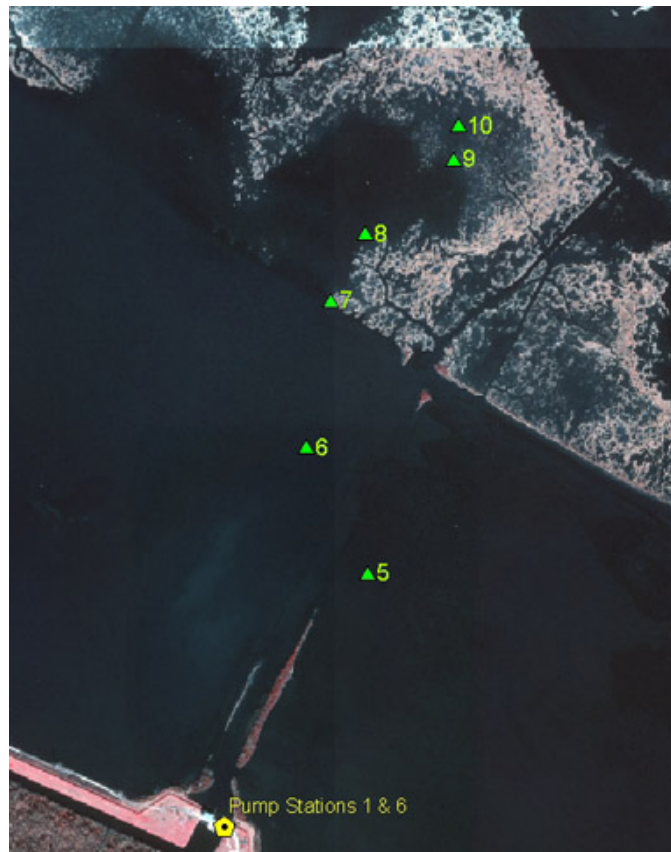
**Transect 1:** Transect 1 (Figure 3) is located at the northern end of the marsh and runs north/northeast from the location of Pump Stations 1 and 6 (Fortification and Jean Lafitte). Stations were sampled on December 13, 2005. Table 1 contains the results from this transect.

Figure 3. Transect 1 sampling locations (green triangles)

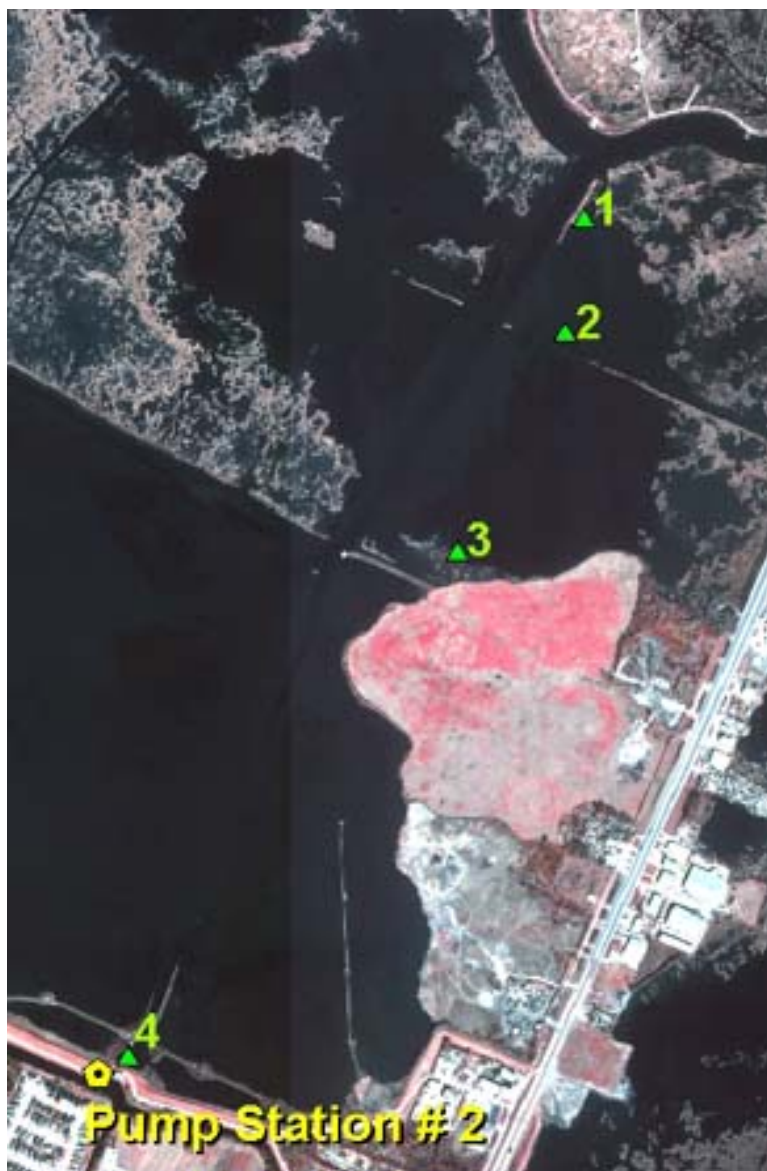
**Transect 2:** Transect 2 (Figure 5) is located at the northern end of the marsh and runs north/northeast from the location of pump station 2 (Guichard). Stations were sampled on December 13, 2005. Table 2 contains the results from this transect, which passes primarily through an open water area. There are large broken patches of *Spartina* in the area of station 3 (Figure 6). A soil core taken at station 1 consisted of a mixture of clay and undecomposed organic material (Figure 7).

Figure 5. Transect 2 sampling locations

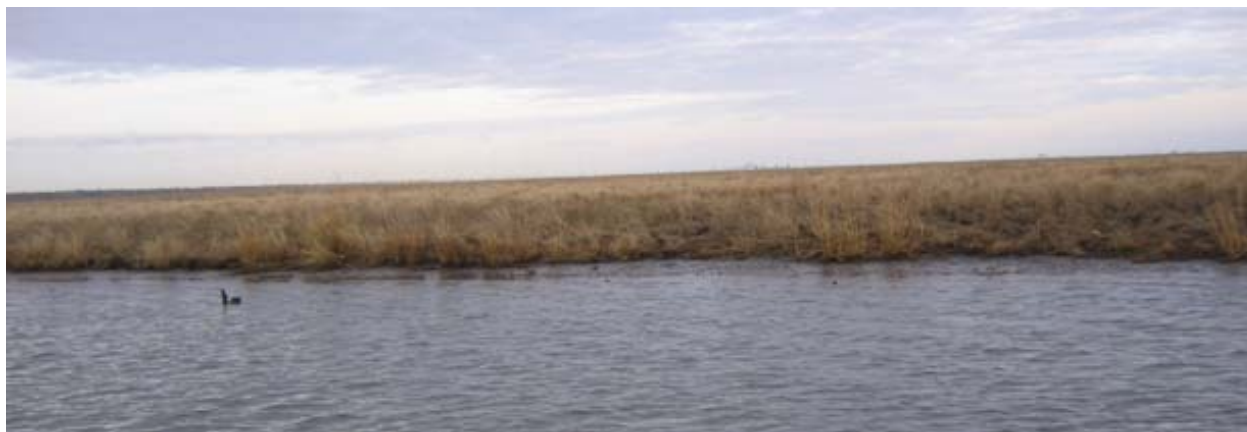
Figure 15. Station 18, facing north

The marsh throughout this transect area appeared to be fairly intact (Figure 15). A soil core taken at station 24 consisted of highly reduced clay with very little noticeable organic matter.

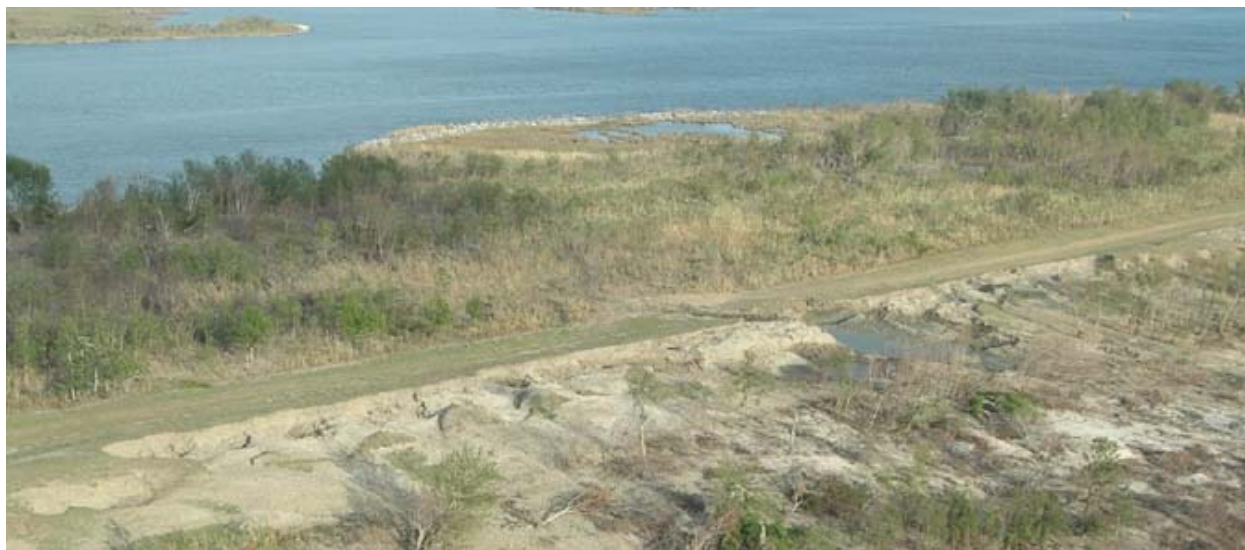
Figure 17. Photo of one of the breaches along the MRGO levee
