Ecosystem Management and Restoration Research Program

A Multi-Scale Approach to Assess and Restore Ecosystems in a Watershed Context

Ronald D. Smith and Charles V. Klimas

September 2013

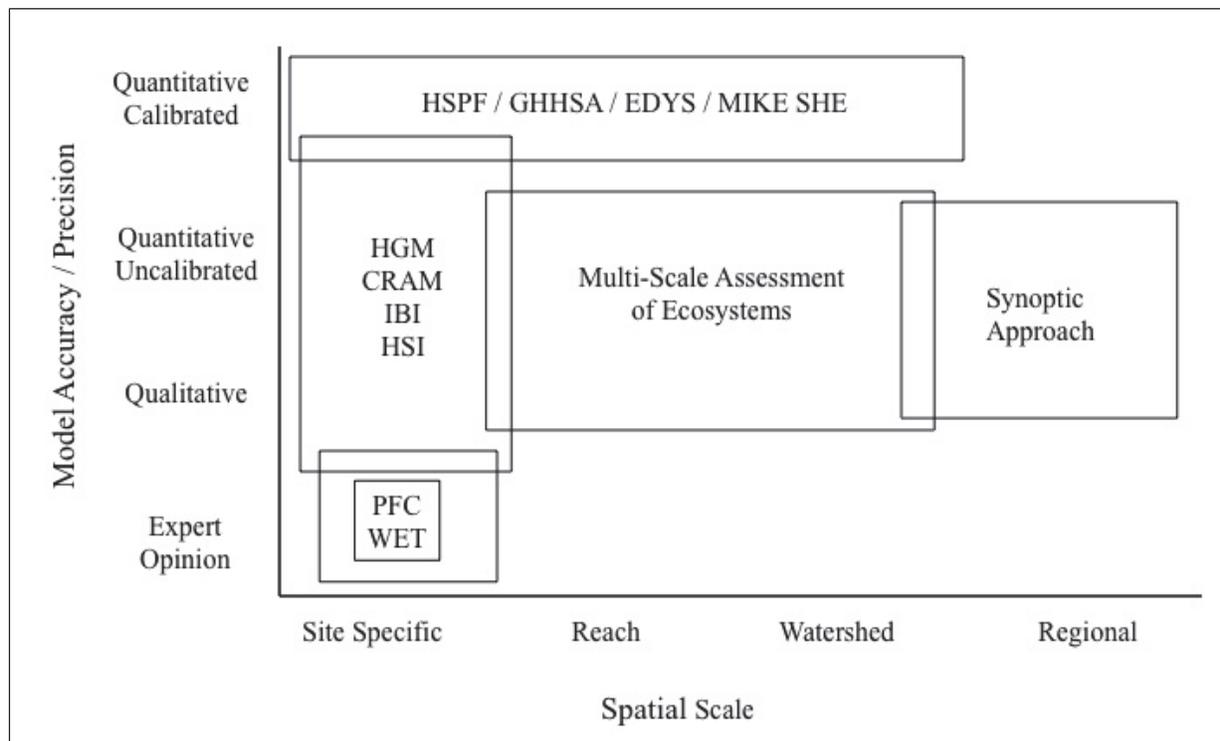
Figure 1. Ordination of assessment methods based on spatial scale and model accuracy/precision.

ERDC researchers have devised a multiple spatial scale approach that explicitly incorporates the watershed and/or landscape context into the assessment of baseline conditions, and allows consideration of various impact and restoration scenarios using the same assessment criteria (Figure 1). The "watershed context" of this approach naturally implies that the entire drainage basin is considered and assessed. However, it also reflects the fact that, by assessing ecosystem characteristics across multiple spatial scales, the interconnectedness of the entire system is accounted for. Degraded conditions or proposed impacts or restoration actions in one part of the watershed can be evaluated in terms of both their direct on-site effects, and at the same time, their effects on other parts of the system. This allows recognition of landscape-scale responses to site-specific actions, and accounts for the cascading effects of actions that interrupt key ecosystem processes.

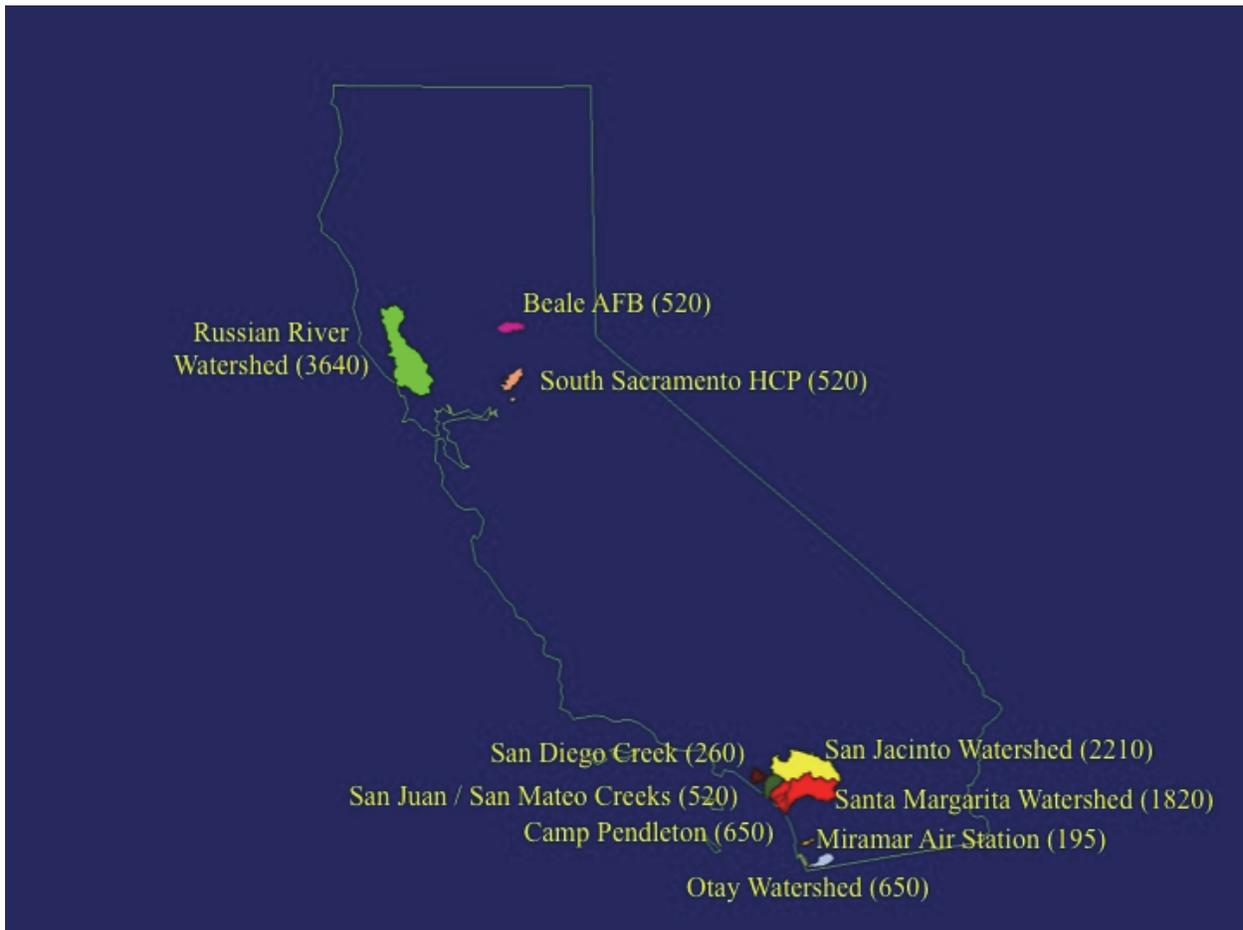
Figure 2. Name, location, and size (square kilometers) of project watersheds in California.

This approach was developed and refined over the course of the past decade in a variety of California watersheds ranging in size from 200 to 3600 km² (Figure 2). The initial baseline assessment involves three steps. First, the watershed is divided into relatively homogenous assessment units. Second, geospatial information and field data are collected to characterize each of the assessment units in terms of selected biotic and abiotic indicators. Third, models are developed specifically for the project or are adapted from existing methods (e.g., HEP, IBI, HGM, etc.), to aggregate information and compare the condition of ecosystems in the assessment units of the watershed relative to a specified reference condition. Results from the baseline assessment are linked to a Geographic Information System (GIS) for display, interpretation, analysis of model sensitivity and the influence of missing data, comparison across assessment units, and, finally, deployment in a variety of subsequent uses. These uses include: 1) identification of priority areas based on project-specific criteria, 2) simulation of historical conditions, 3) determination of cumulative impacts, 4) analysis of the impacts or benefits of project alternatives, 5) development of watershed-scale restoration plans, 6) development of regional regulatory permit strategies, and 7) comparison of the costs and benefits of alternative restoration scenarios, and other applications.

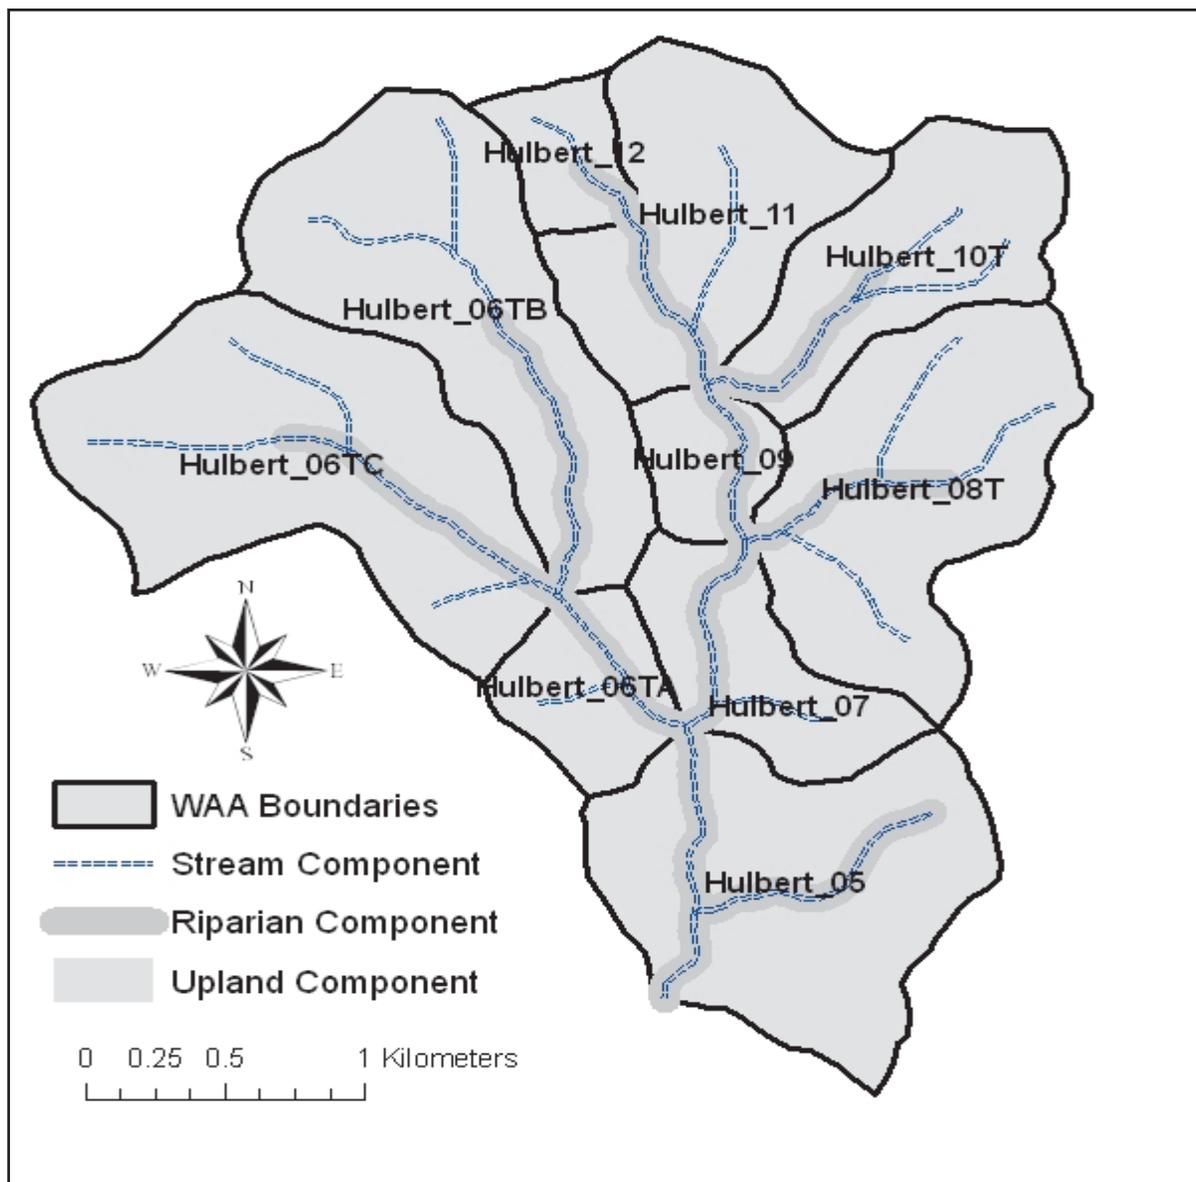
Figure 3. Watershed Assessment Areas, local drainages, drainage basins, and stream, riparian, and upland components of the WAA.

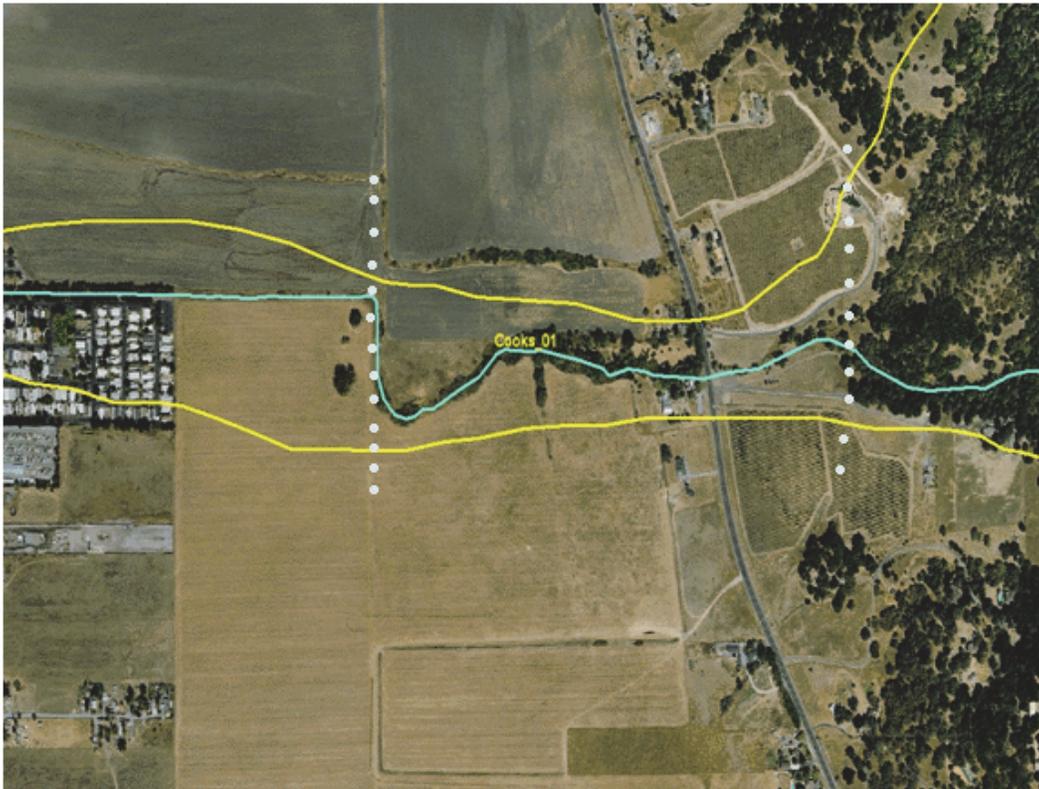
Figure 4. WAA upstream and downstream boundaries (dotted lines) drawn at changes in land use.

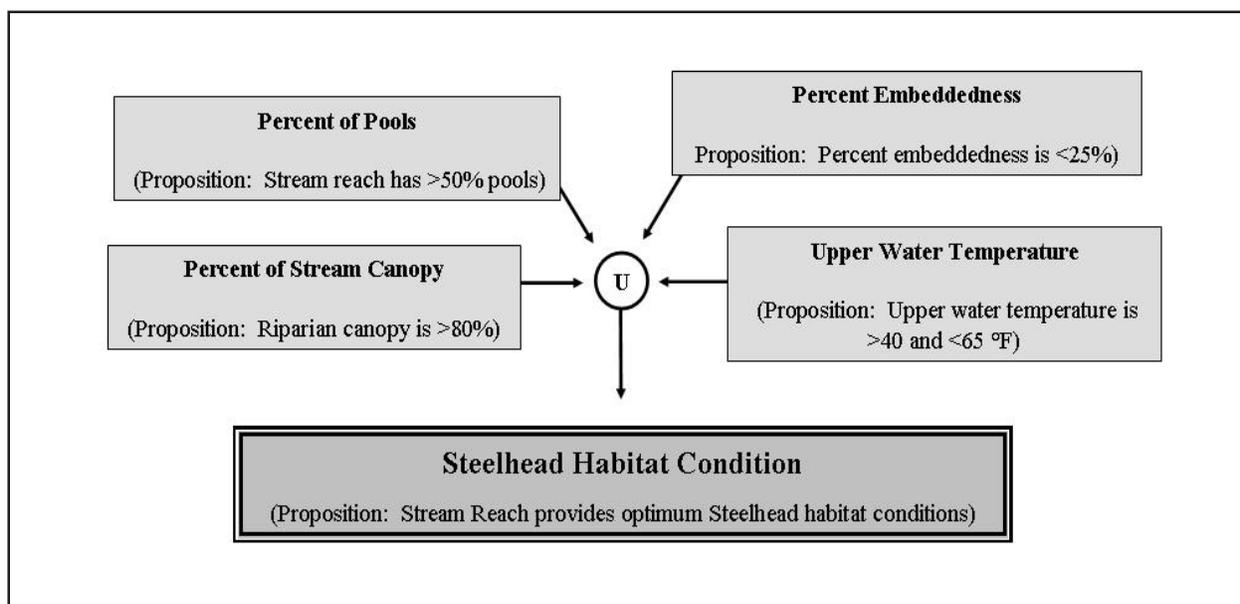
Figure 5. Knowledge base schematic for the Steelhead Habitat Condition ranking criterion.

In a knowledge base, the assessment is based on a proposition that defines the optimal, ideal, or, in this case, reference condition for each indicator. The propositions for the indicators in the Steelhead Habitat Condition knowledge base are shown in Figure 5. For example, for the Percent of Stream Canopy indicator, >80% stream canopy cover is considered the optimal habitat condition for steelhead. Each indicator is evaluated in terms of trueness or “truth-value” of the indicator metric in relation to the proposition. That is, a truth-value is assigned to an indicator based on a

formal relationship between the indicator and the proposition. The formal relationship is defined based on field data, literature values, expert opinion, intuitive reasoning, or it is derived empirically from the range of indicator values collected during the project. In the case of the hypothetical Steelhead Habitat Condition knowledge base, the relationships between indicators and truth-values are based on optimal steelhead habitat conditions identified in the Russian River Basin Fisheries Restoration Plan (CDFG 2002).

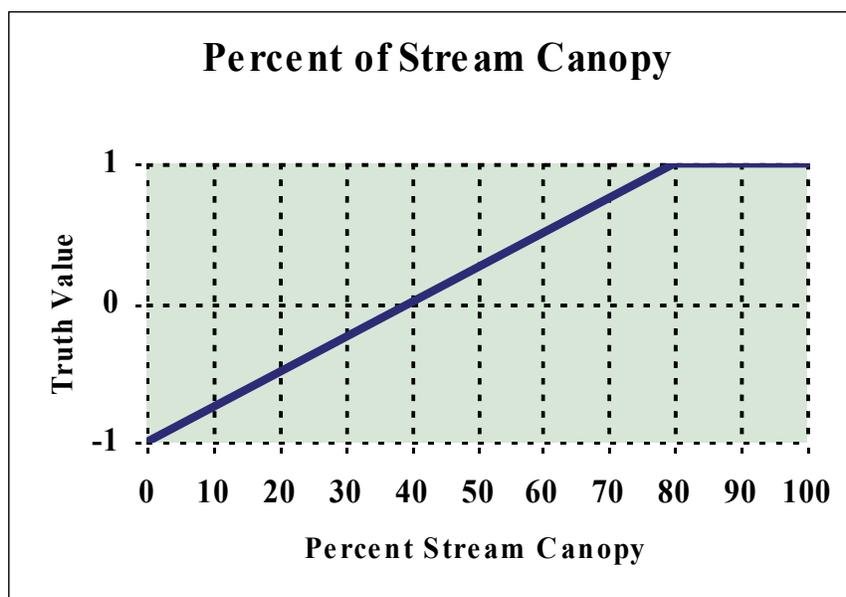
Figure 6. Relationship between the Percent Canopy Cover indicator and truth-value.

Figure 6 shows the relationship between the Percent of Stream Canopy indicator and the truth-value. If the Percent of Stream Canopy is $\geq 80\%$, a truth-value of "1" (i.e., totally true) is assigned. If the Percent of Stream Canopy is 0%, a truth-value of "-1" (i.e., totally false) is assigned. If the Percent of Stream Canopy is between 0% and 80%, a truth-value between "1" and "-1" is assigned based on fuzzy logic. Fuzzy logic makes it possible to incorporate "partial truth," as opposed to classical Boolean logic, where things are either totally true or totally false.

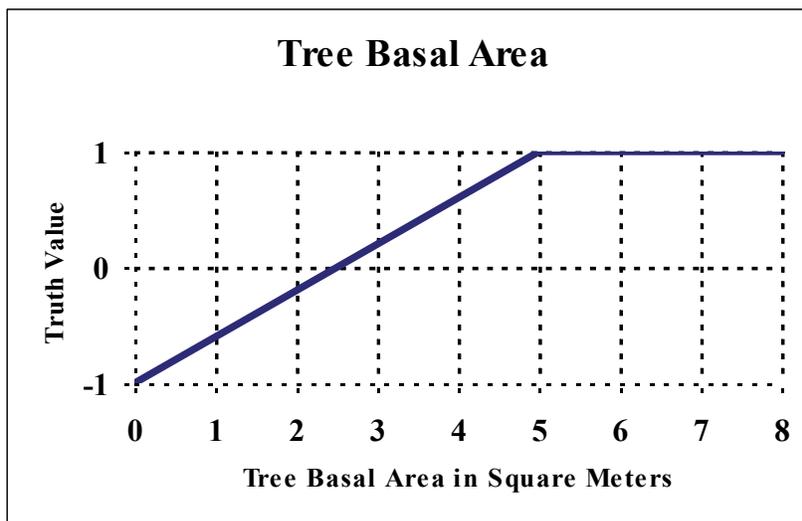
Figure 7. Relationship between Tree Basal Area indicator and truth-value.

which an indicator is assigned either a totally true or totally false truth-value. For example, in Figure 7 the totally true breakpoint for “large” trees is defined at a basal area of 5.0 m². Any tree with a basal area ≥ 5.0 m² is assigned a truth-value of “1.” The totally false breakpoint for “large” trees is defined at a basal area of 0.1 m². Any tree with a basal area ≤ 0.1 m² is assigned a truth-value of “-1.” For trees with a basal area between 0.1 m² and 5.0 m², an intermediate truth-value is assigned to reflect its degree of largeness. For example, a tree with a basal area of 4.0 m² is assigned a truth-value of “0.8,” and a tree with a basal area of 1.0 m² is assigned a truth-value of “-0.75,” and so forth.

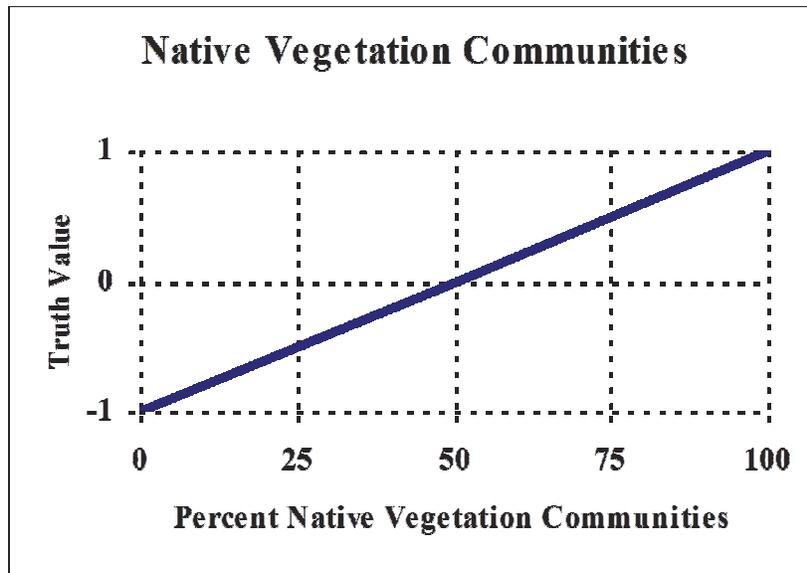
Figure 8. Relationships between indicators and truth-values for the Native Vegetation Community indicator.

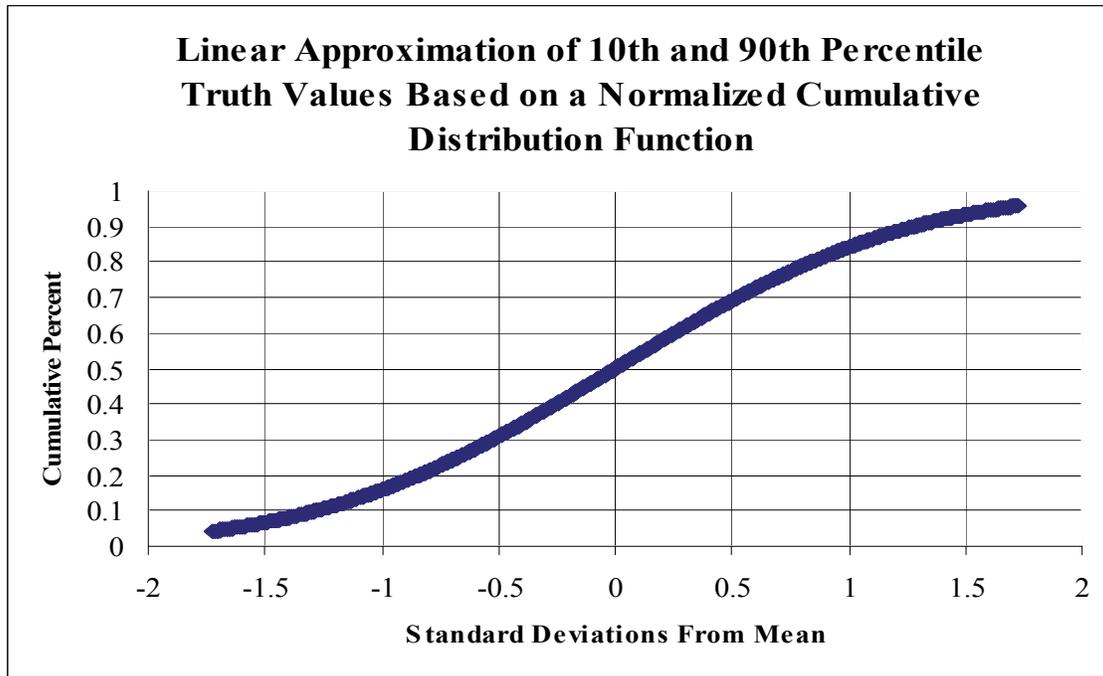
Figure 9. Normalized cumulative distribution function with linear approximation of 10th and 90th percentiles.

For some indicators there are no field data, literature values, expert opinion, or intuitive bases for defining the relationship between an indicator and truth-values. In these situations, an empirical approach is used to establish the relationship. Conceptually, this involves using the range of indicator values from WAAs across the watershed and setting the totally true breakpoint slightly below the maximum indicator value, and the totally false breakpoint slightly below the minimum indicator value. Specifically, this was accomplished by calculating the mean and standard deviation of all indicator values and using the 10th and 90th percentiles of the linear approximation of the normalized cumulative distribution function as the totally false ("-1") and totally true ("1") truth-value breakpoints, respectively (Figure 9). While not valid outside the context of the project watershed, this approach provides reproducible, relative relationships between indicator values and truth-values for indicators that lack the information to establish a relationship between an indicator and truth-value. As with the previously described index model method, a variety of ecosystem assessment indices can be generated using this knowledge base approach.

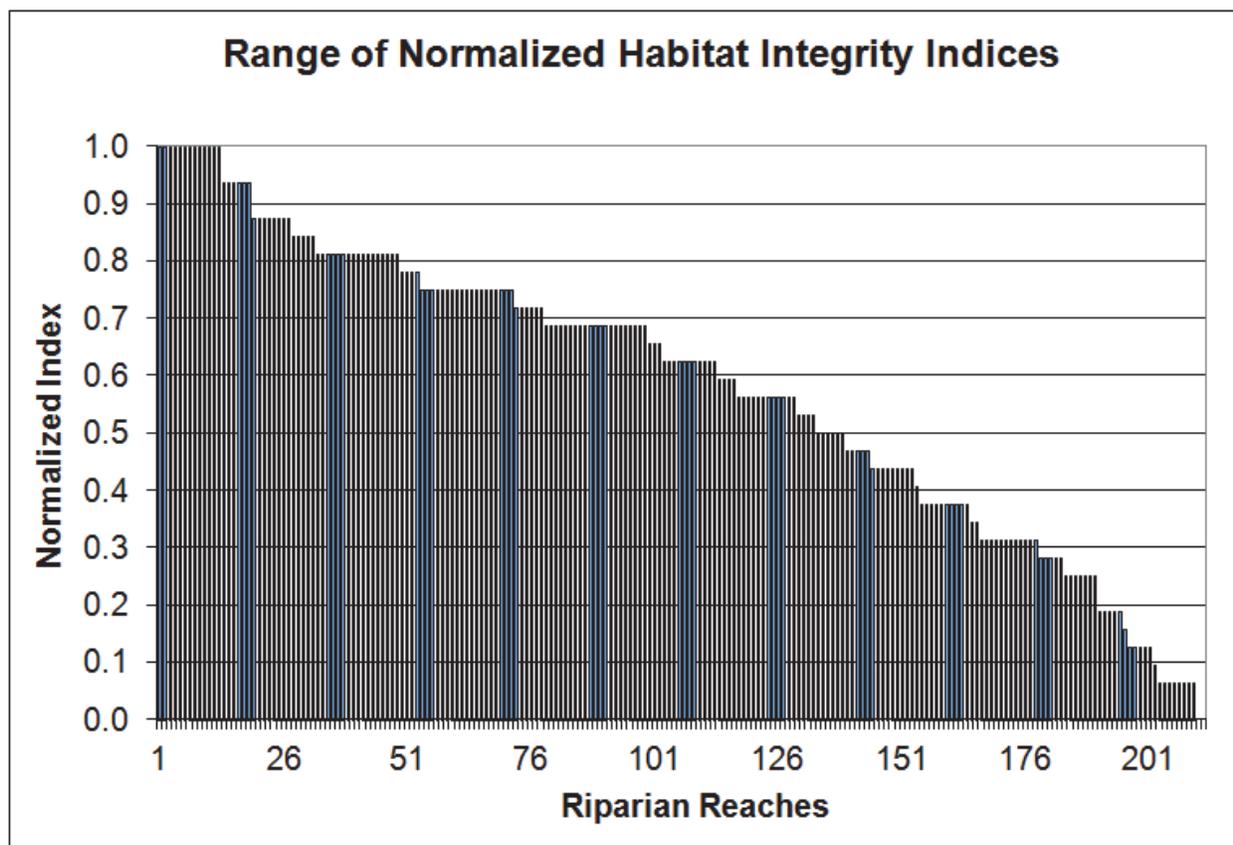
Figure 11. Summary of normalized indices of habitat integrity.

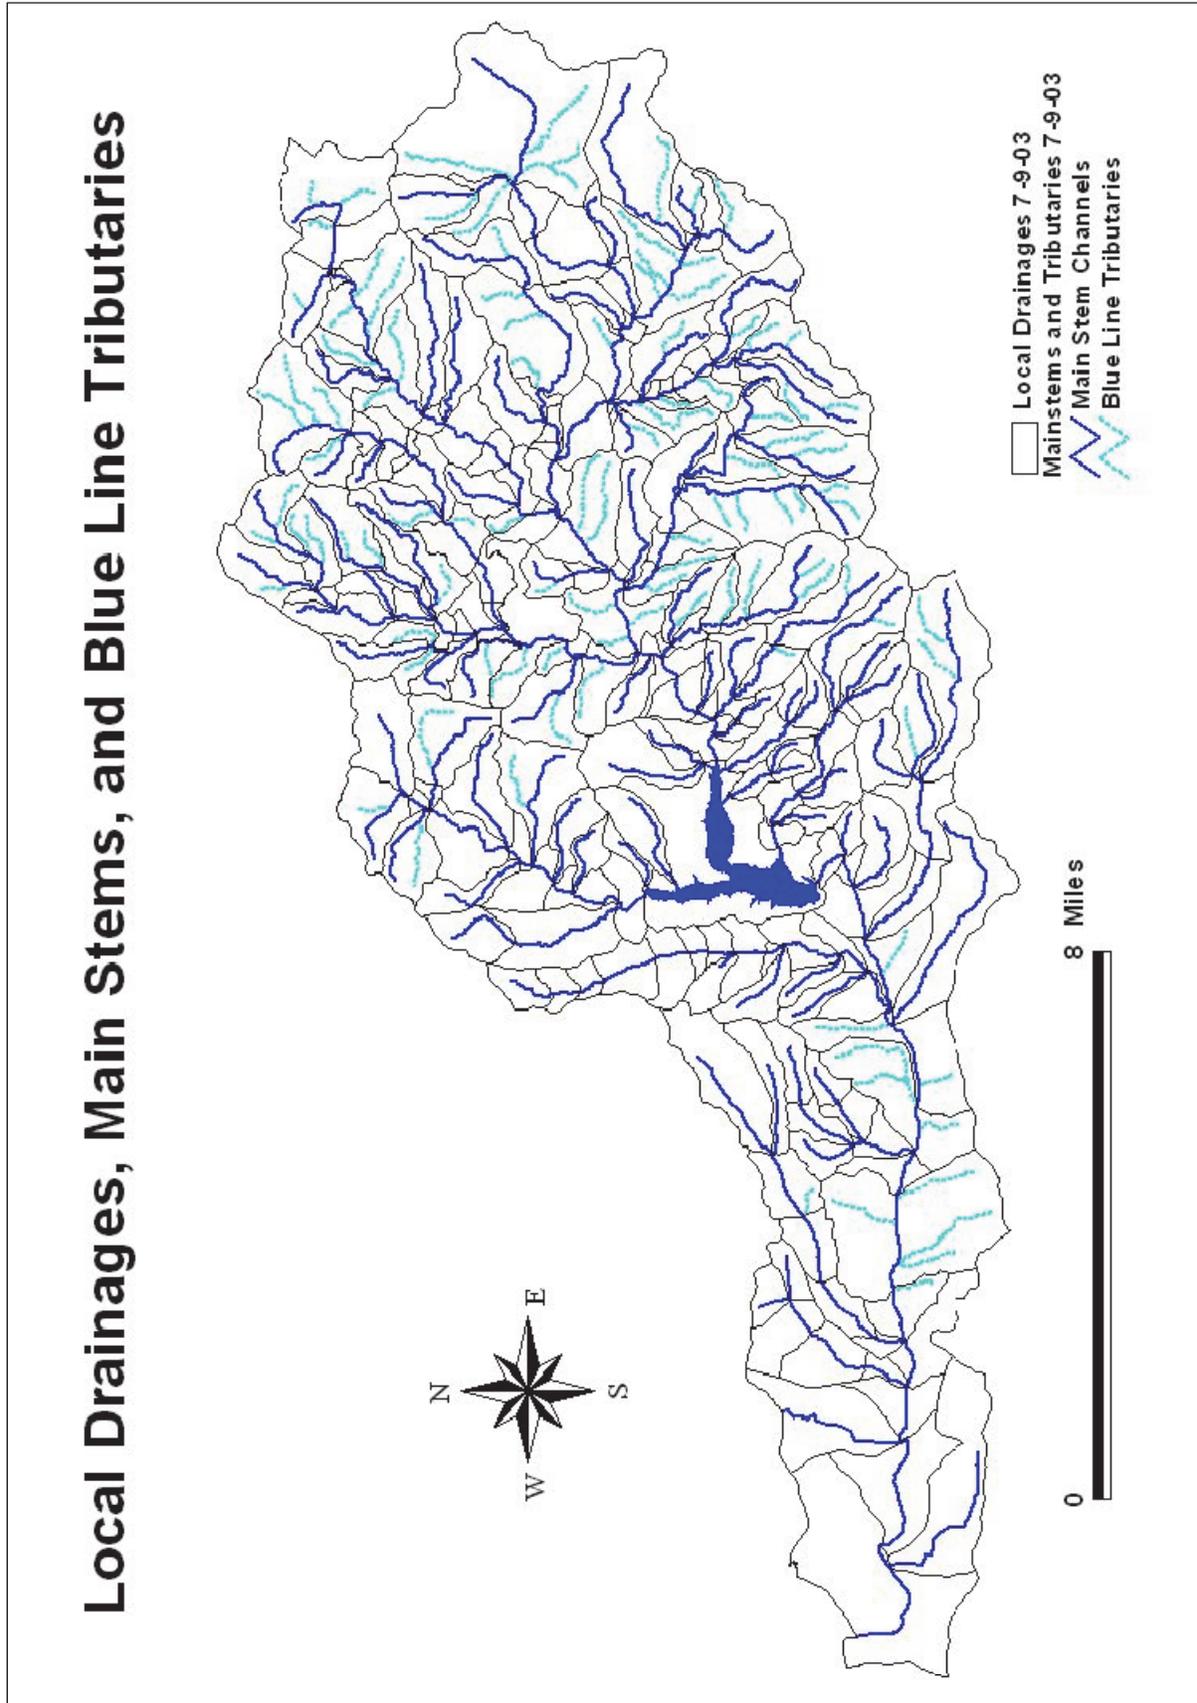
Figure 13. Otay River watershed showing WAA local drainage boundaries, main stem channels, and tributaries.

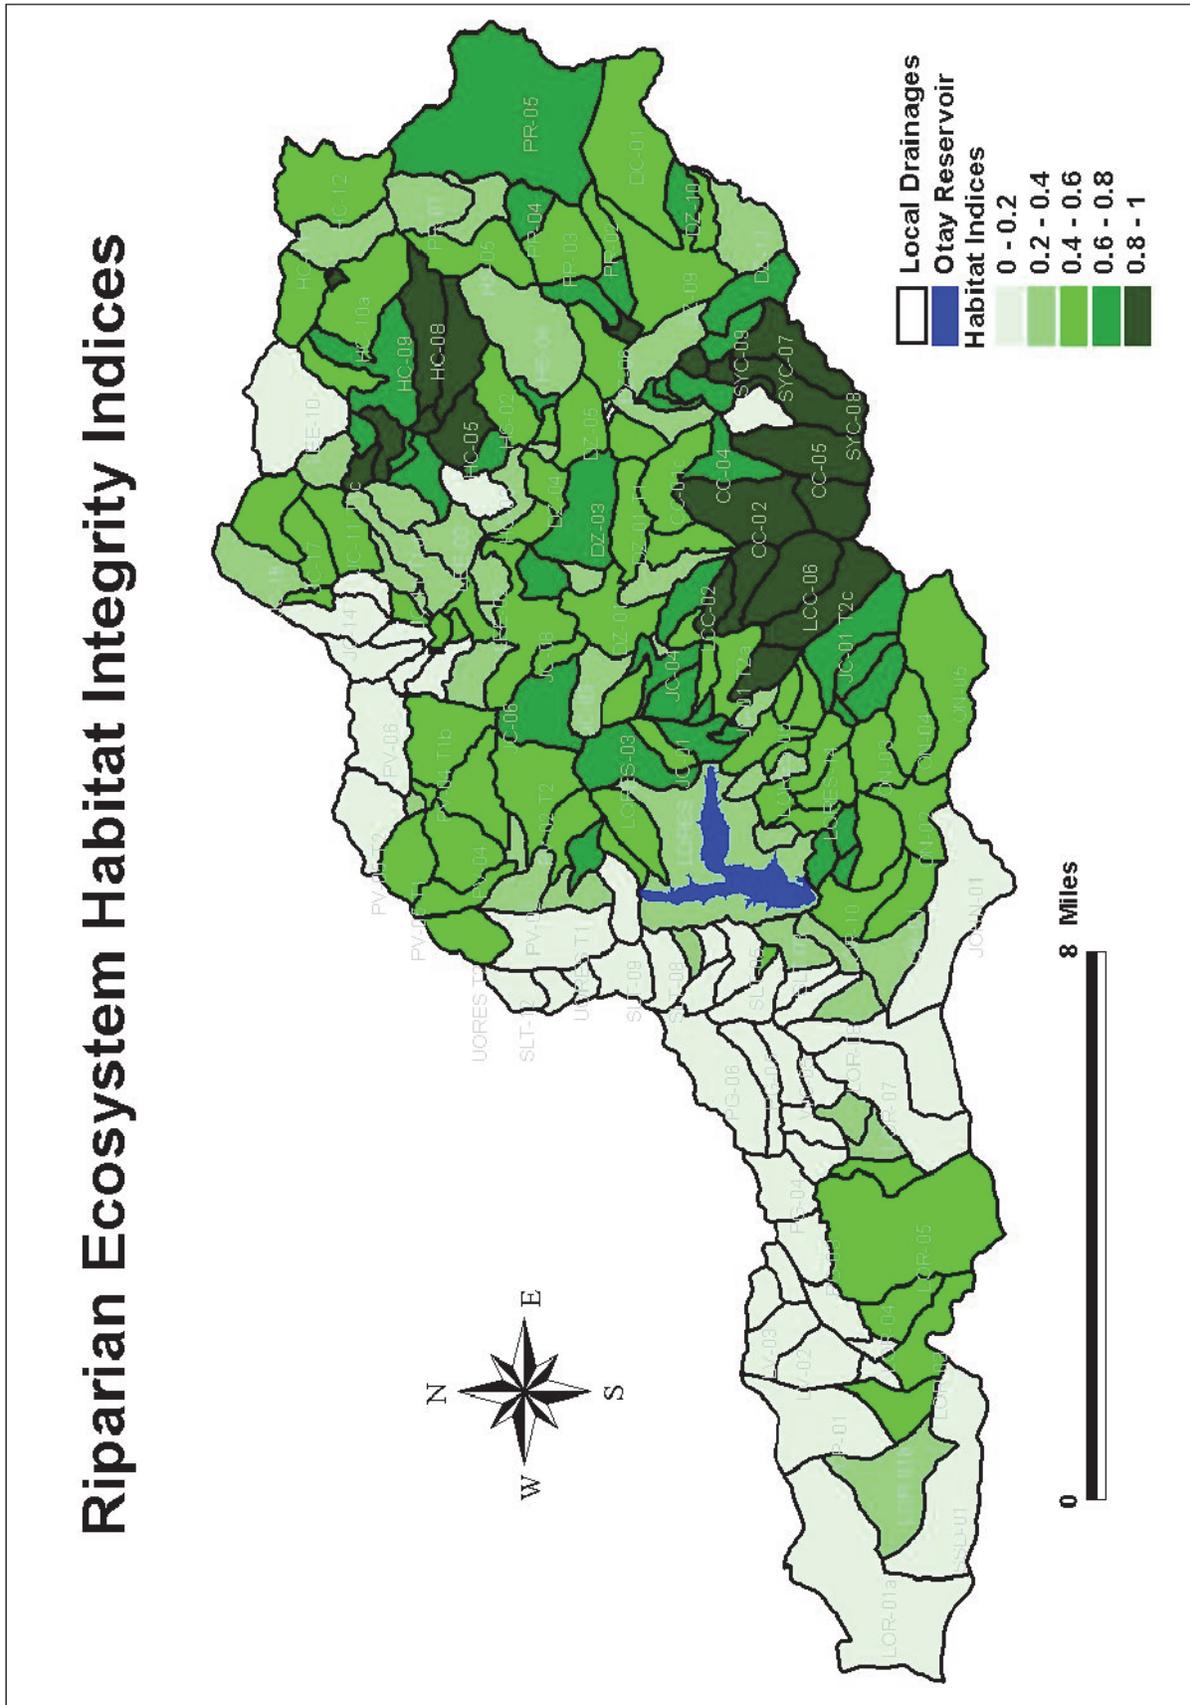
Figure 14. Habitat integrity indices for riparian reaches extrapolated WAAs for display purposes.

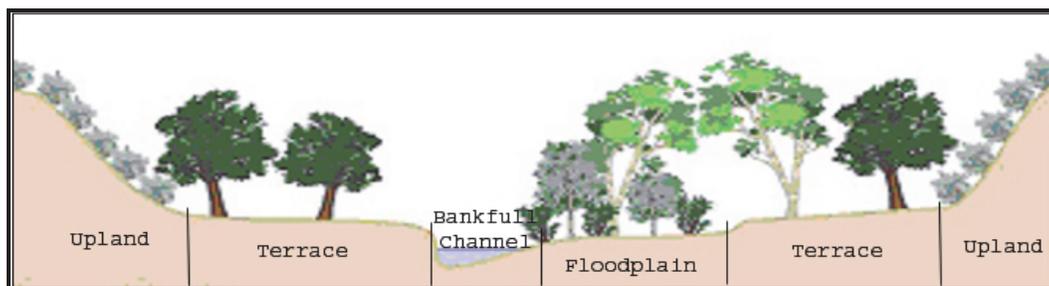
Figure A2. Generalized cross section of a riparian ecotone.

Riparian ecotones are a three-dimensional space of interaction that include terrestrial and aquatic ecosystems that extend down into the groundwater, up above the canopy, outward across the floodplain, up the near-slopes that drain to the water, laterally into the terrestrial ecosystem, and along the water course at a variable width.

The second zone includes one or more terraces that are abandoned (i.e., historical) floodplains formed by fluvial processes under historical, and often different, climatic conditions or hydrologic regimes (Knox et al. 1975, Graf et al. 1991, Rumsby and Macklin 1994). Under current climatic conditions and hydrologic regimes, terraces are typically flooded infrequently during larger magnitude events (Dunne and Leopold 1978). Vegetation communities on terraces normally consist of woody perennials that require the shallow high water table, or bank storage, that is often present in the riparian ecotones, and are adapted to survive, or reestablish after, large flood events.

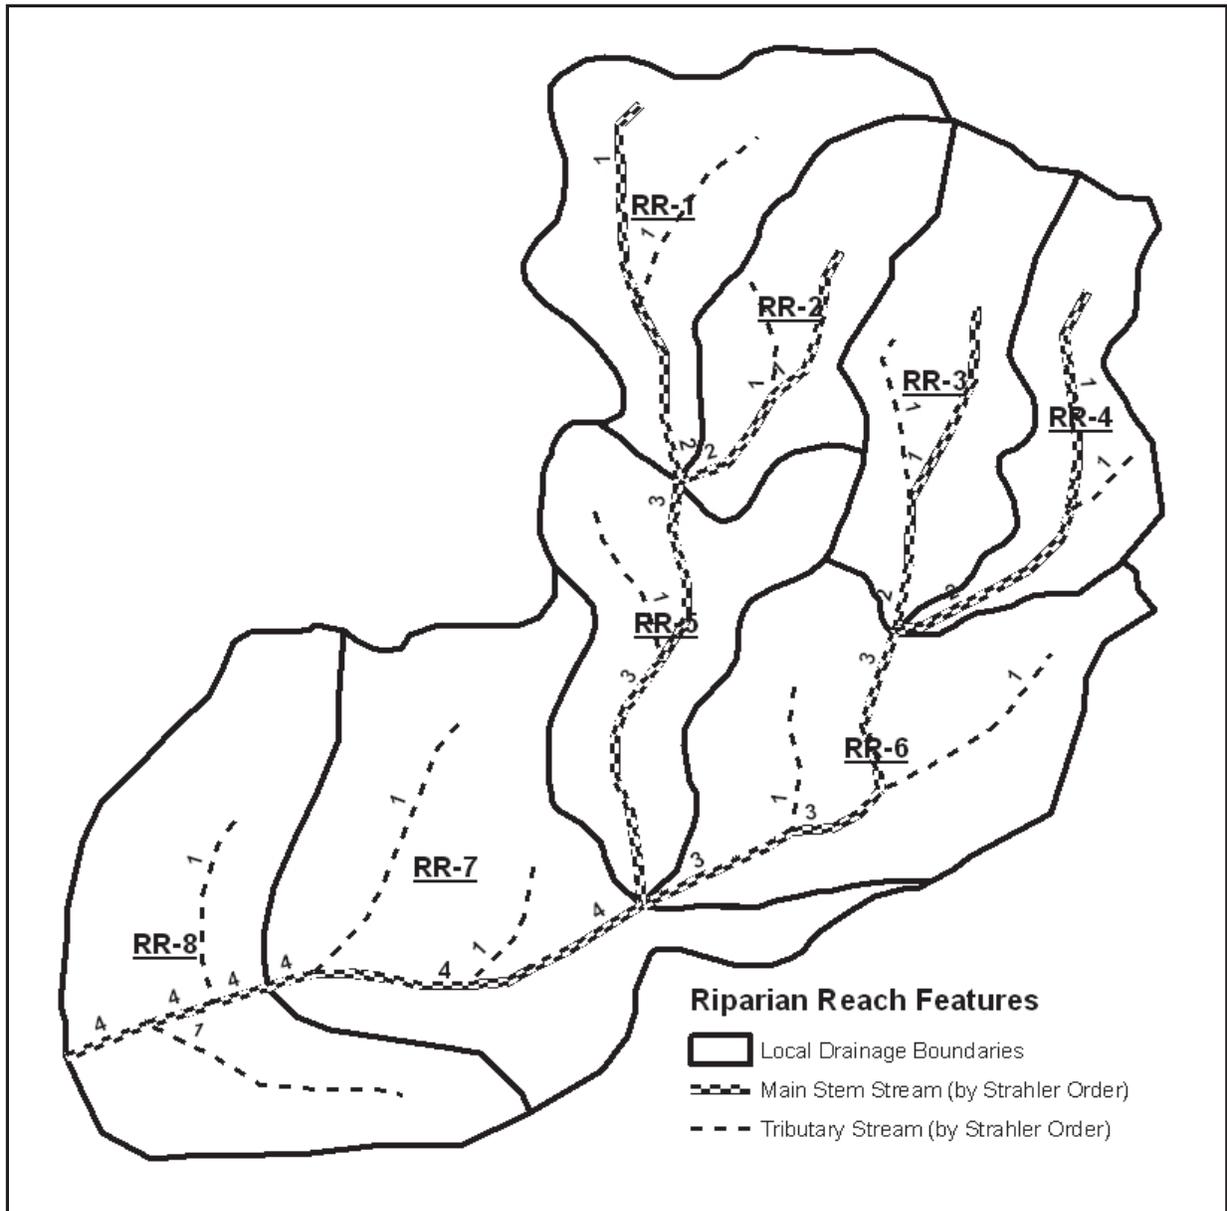
Figure A3. Schematic of riparian reach features.

were the area from which surface water drained directly to the main stem stream of the riparian reach. The boundaries for local drainages were digitized using the "contours_5ft_detailed" theme provided by the Sacramento County Planning and Community Development Department, and USGS 7.5-minute quad DRGs. Drainage basins included the local drainage of a specific riparian reach in addition to the local drainages of all upstream riparian reaches. Figure A3 explicitly illustrates all of these features except the drainage basin. In Figure A3, the drainage basin of riparian reach RR-1 is the same as the local drainage of riparian reach RR-1, since in this case there are no upstream riparian reaches. The drainage

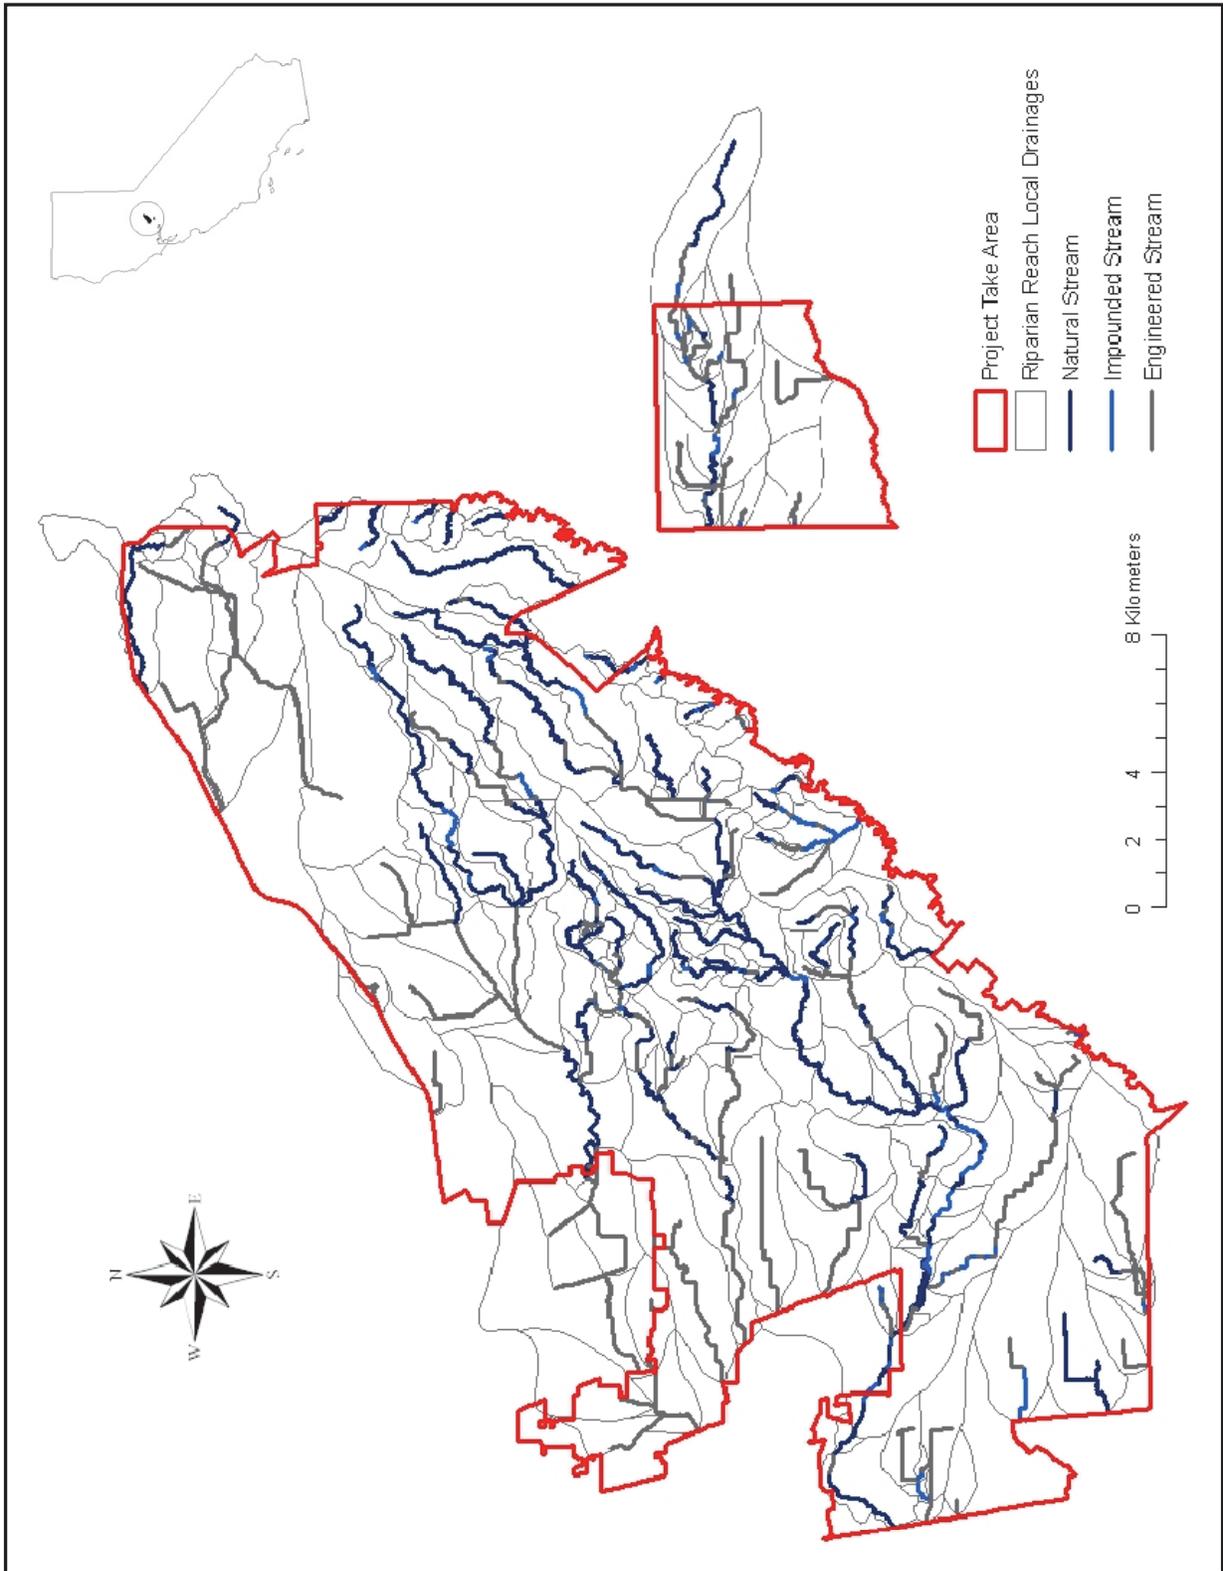
Figure A5. Riparian reach main stem streams by category.

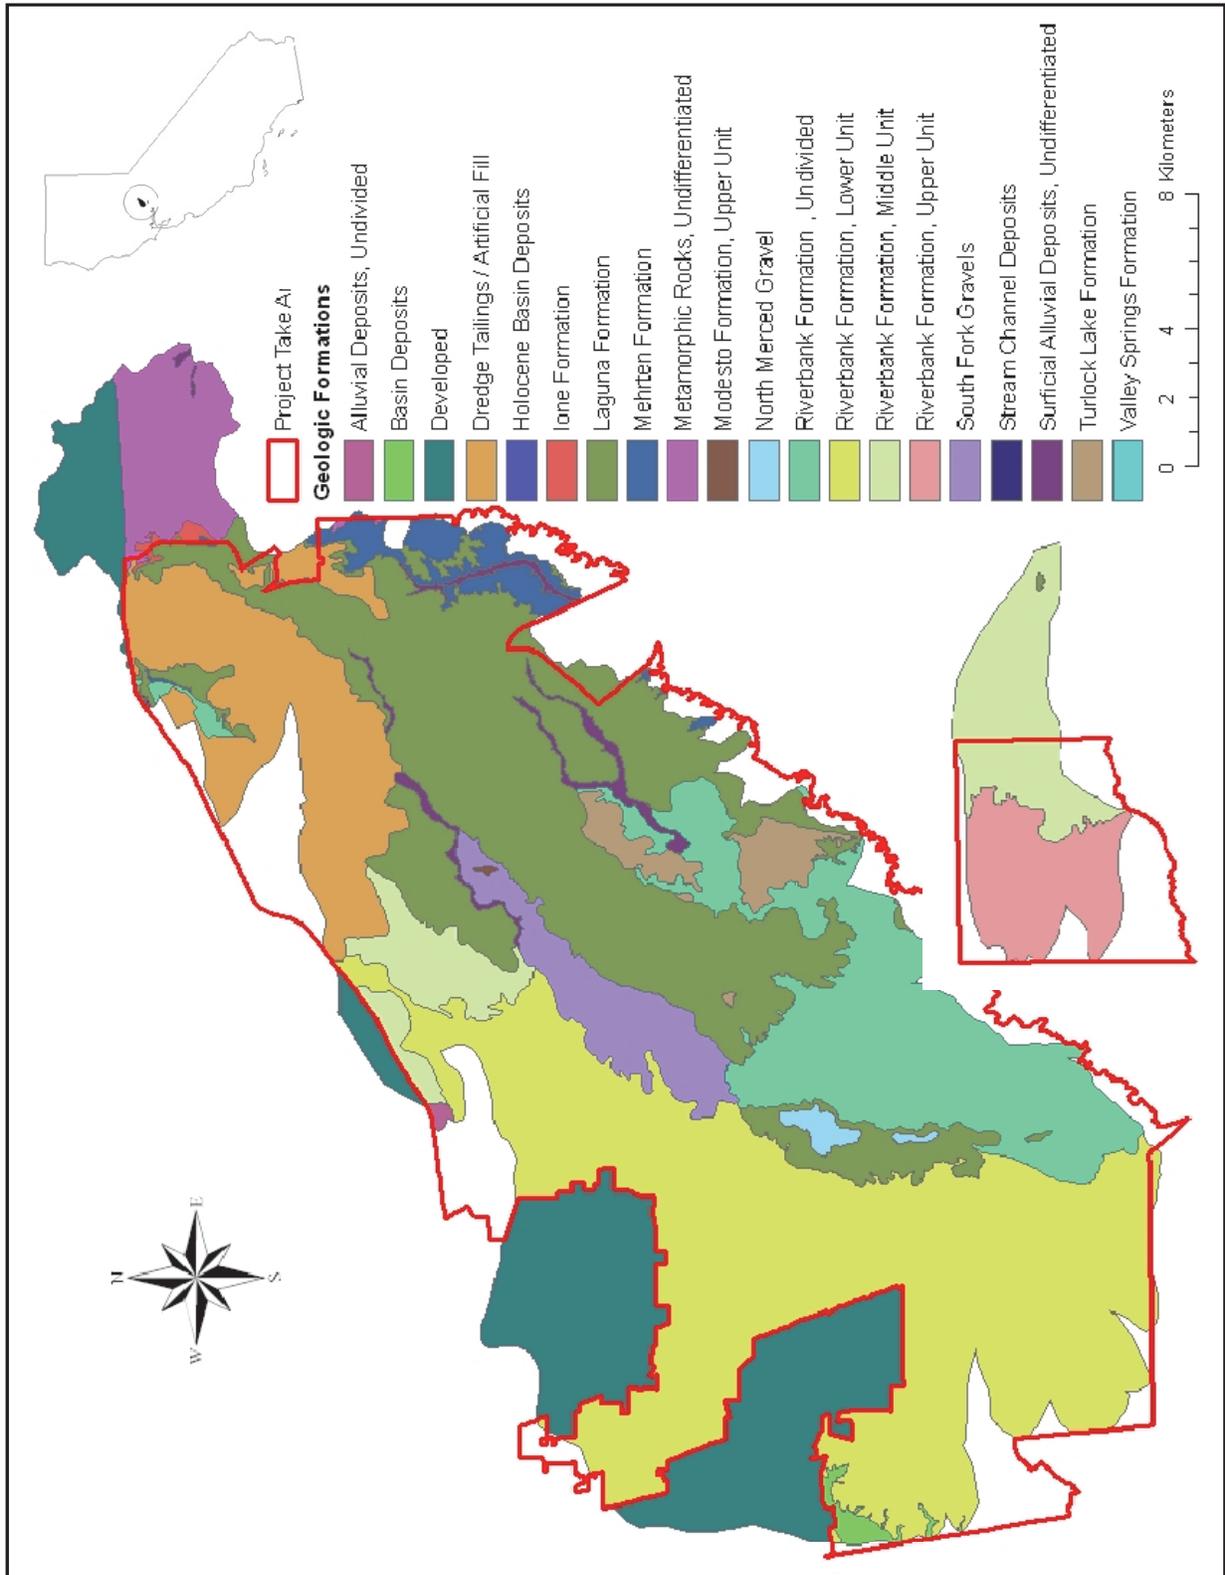
Figure A6. Geologic formations in the project take area.

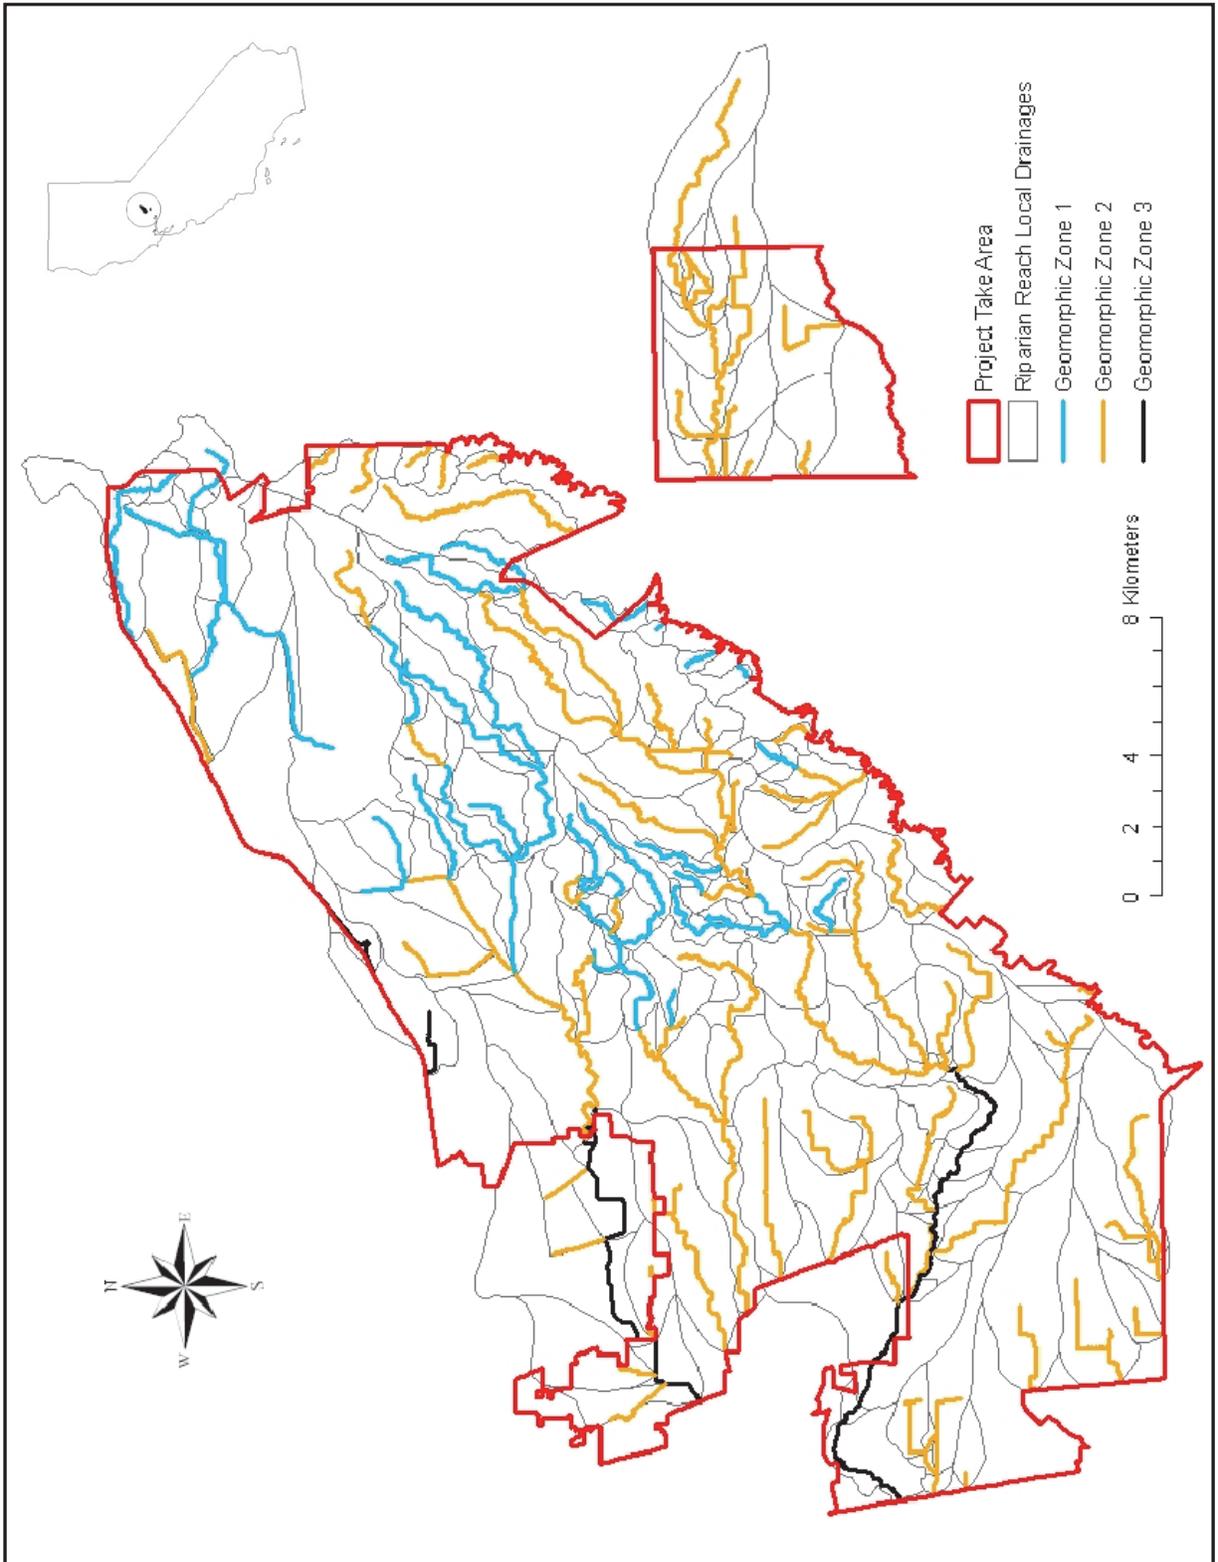
Figure A8. Riparian reach geomorphic zones.
