Ecosystem Management and Restoration Research Program

A Multi-Scale Approach to Assess and Restore Ecosystems in a Watershed Context

Ronald D. Smith and Charles V. Klimas

September 2013

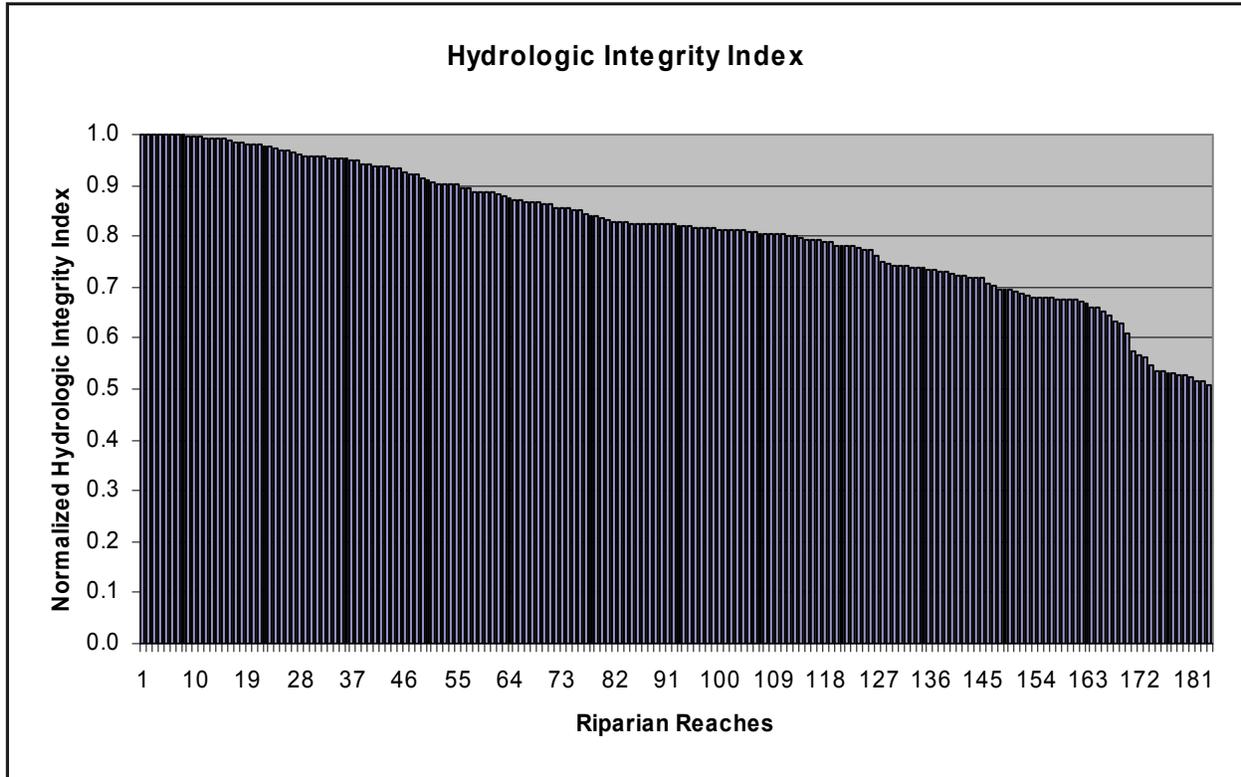
Figure A9. Range of normalized Hydrologic Integrity Indices for riparian reaches.

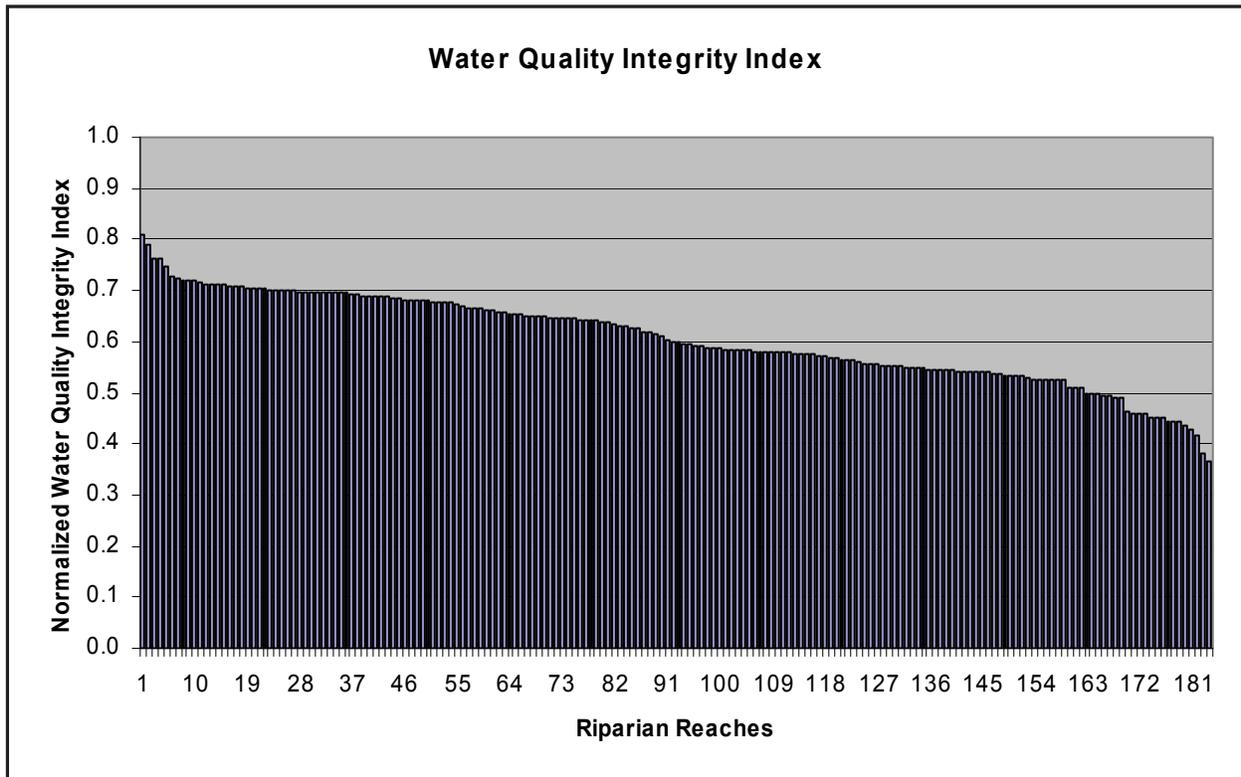
Figure A10. Range of normalized Water Quality Integrity Indices for riparian reaches.

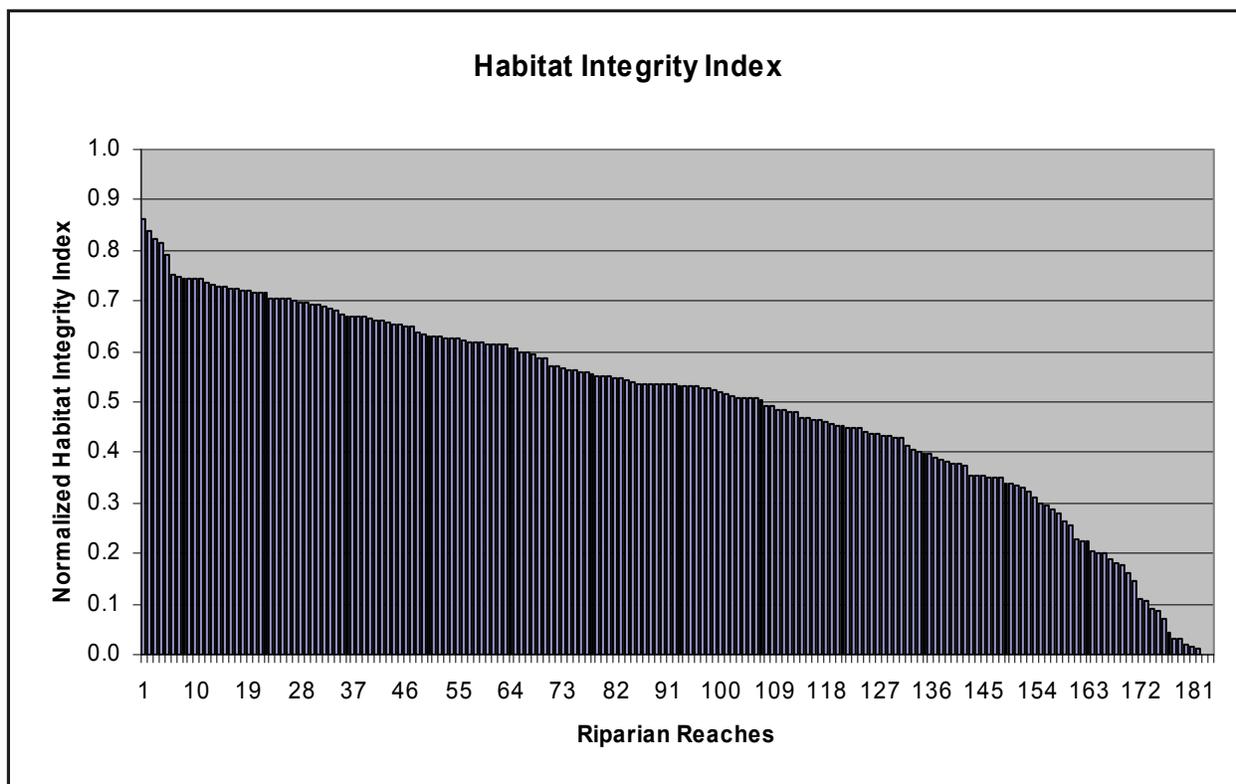
Figure A11. Range of normalized Habitat Integrity Indices for riparian reaches.

It is possible to make generalizations concerning which indicators have a significant influence on the integrity index of riparian reaches in the assessment area. However, care must be taken in applying these generalizations because each riparian reach represents a unique combination of indicators whose influence may be inconsistent with the generalizations. Consequently, the following generalizations should always be verified before applying them to a specific riparian reach.

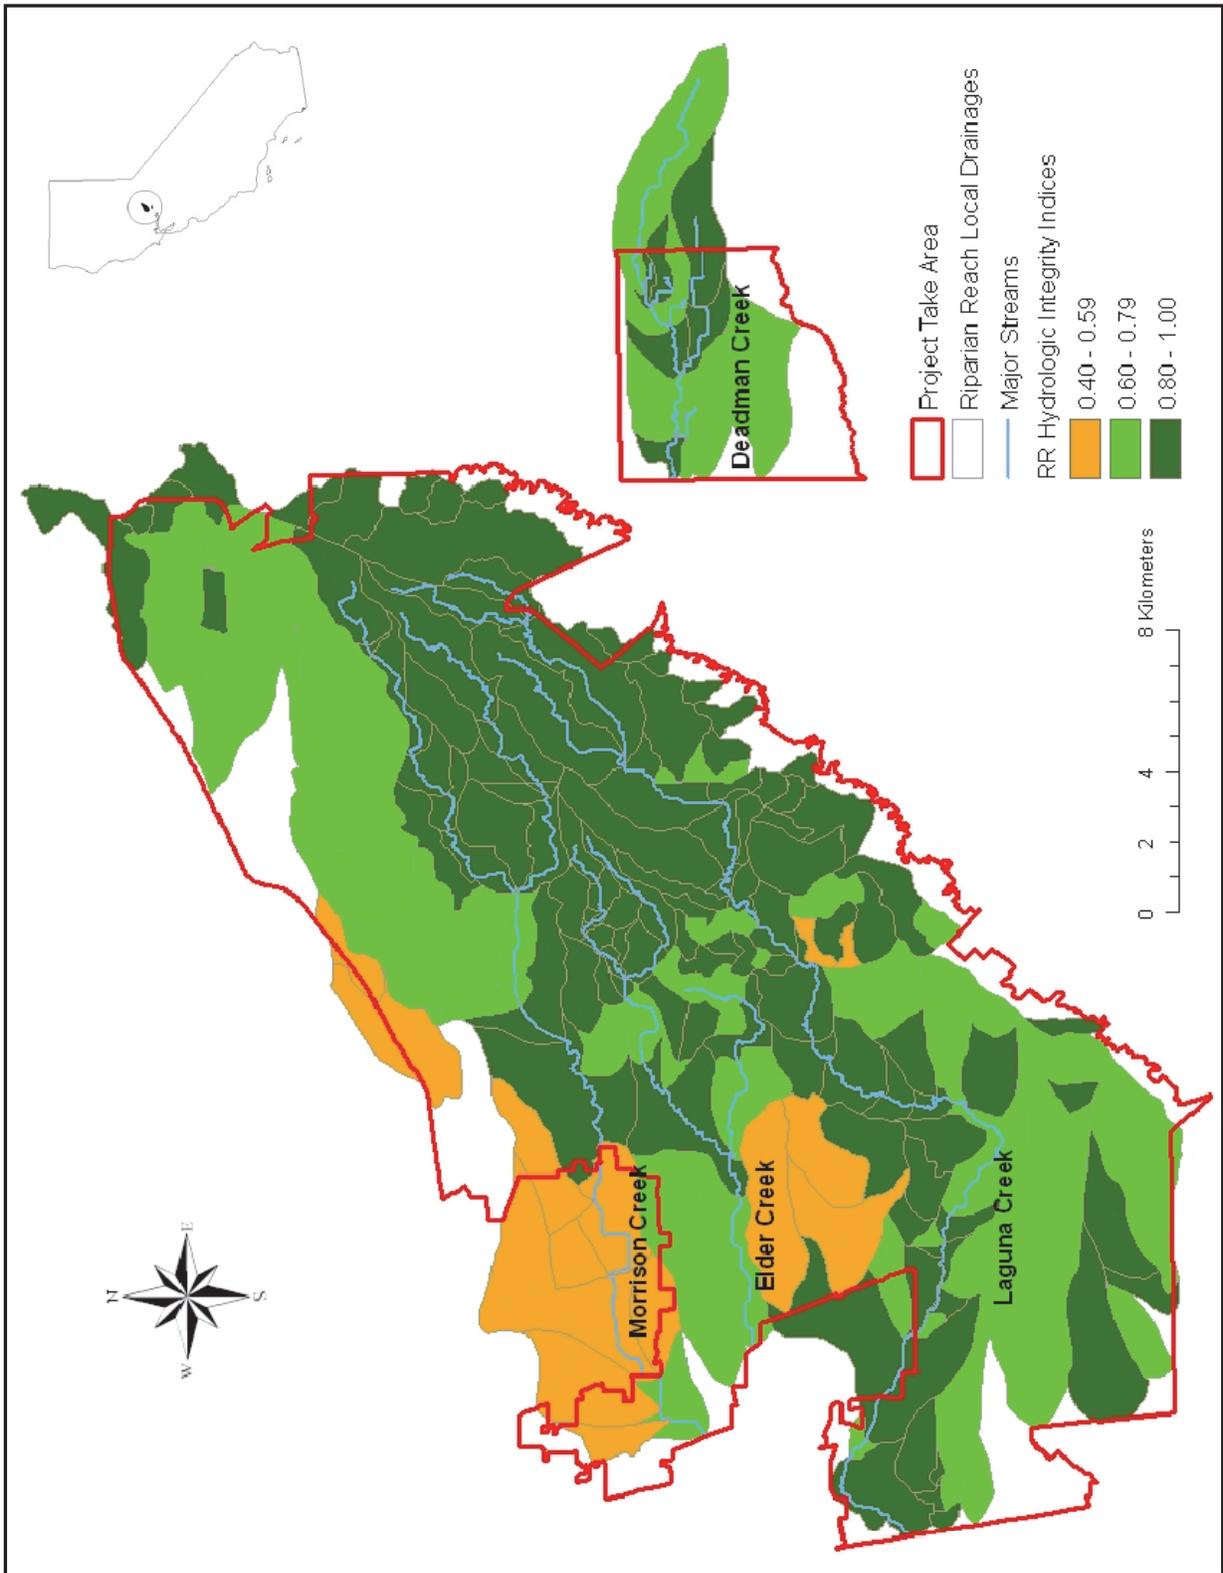
Figure A12. Hydrologic Integrity Indices for riparian reaches in the project take area.

normalized Hydrologic Integrity Index between 0.4 and 0.6. These riparian reaches are impacted by urbanization, which tends to reduce the indicator metric values for the Altered Hydraulic Conveyance, Modified Stream Flow, Stream Floodplain Interaction, and Sediment Regime at the riparian reach spatial scale and Surface Water Detention at the local drainage and drainage basin spatial scales.

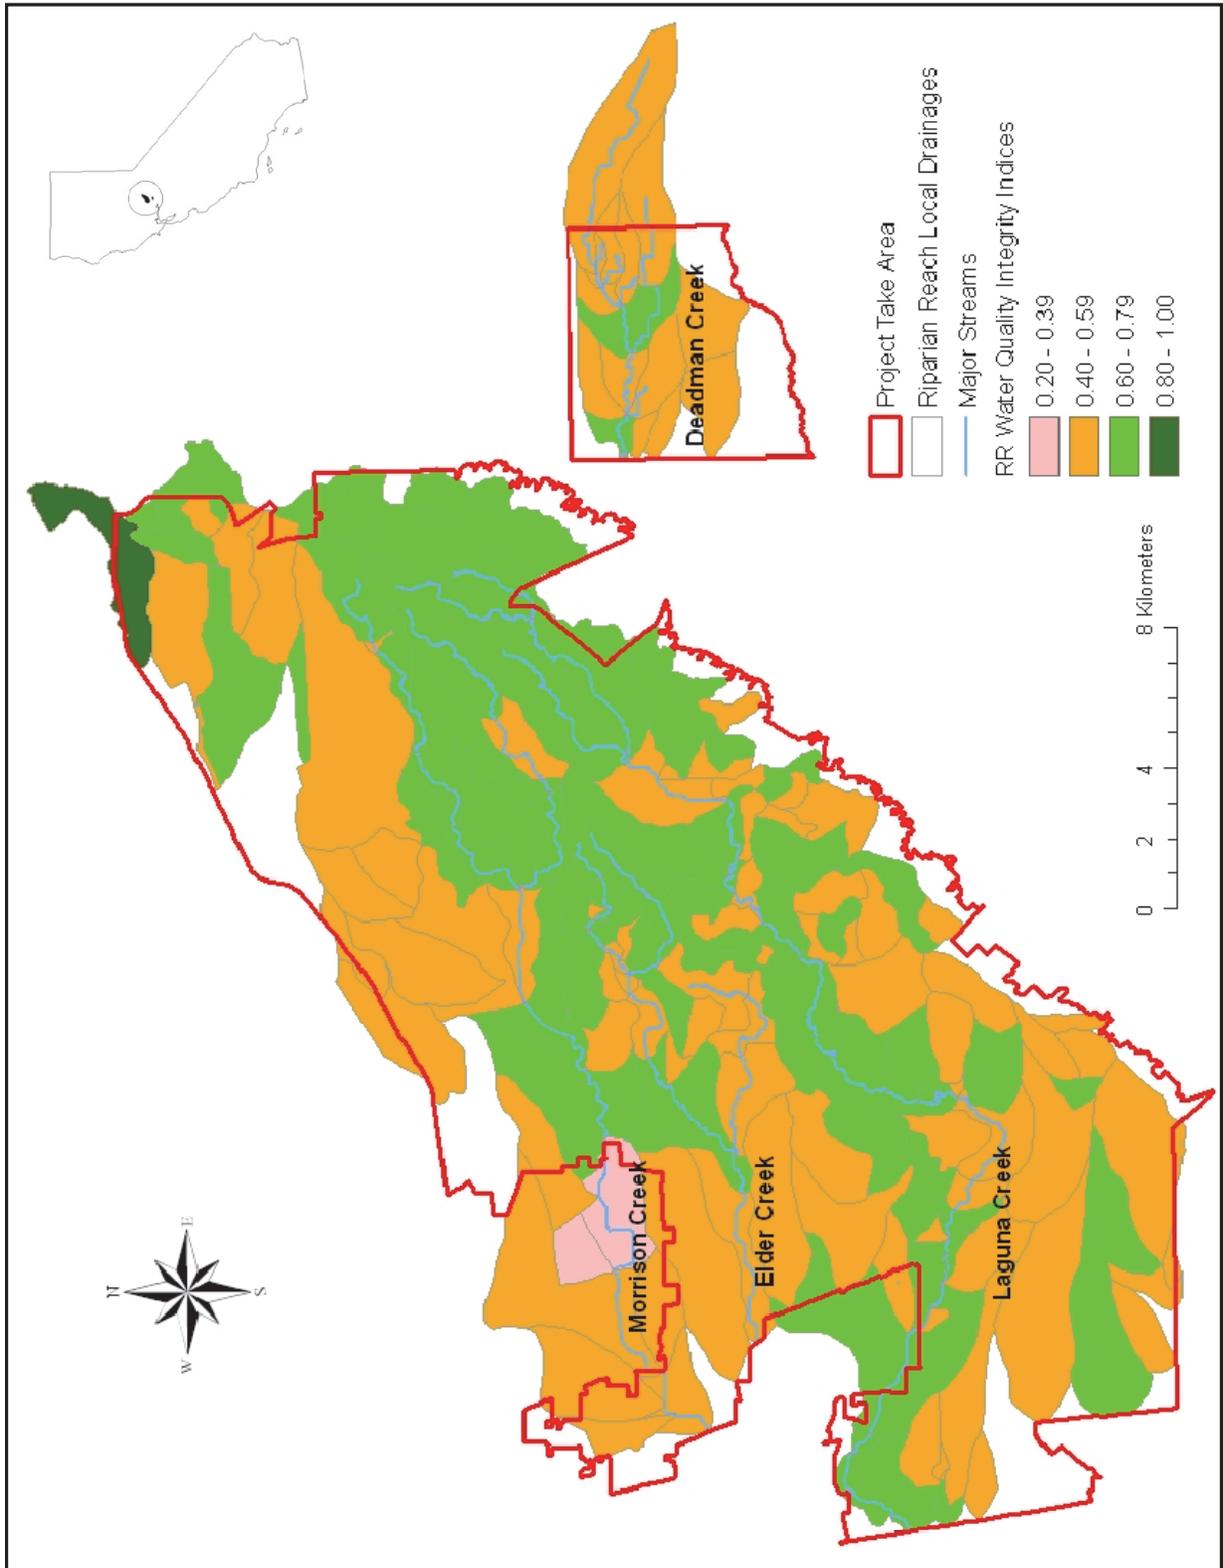
Figure A13. Water Quality Integrity Indices for riparian reaches in the project take area.

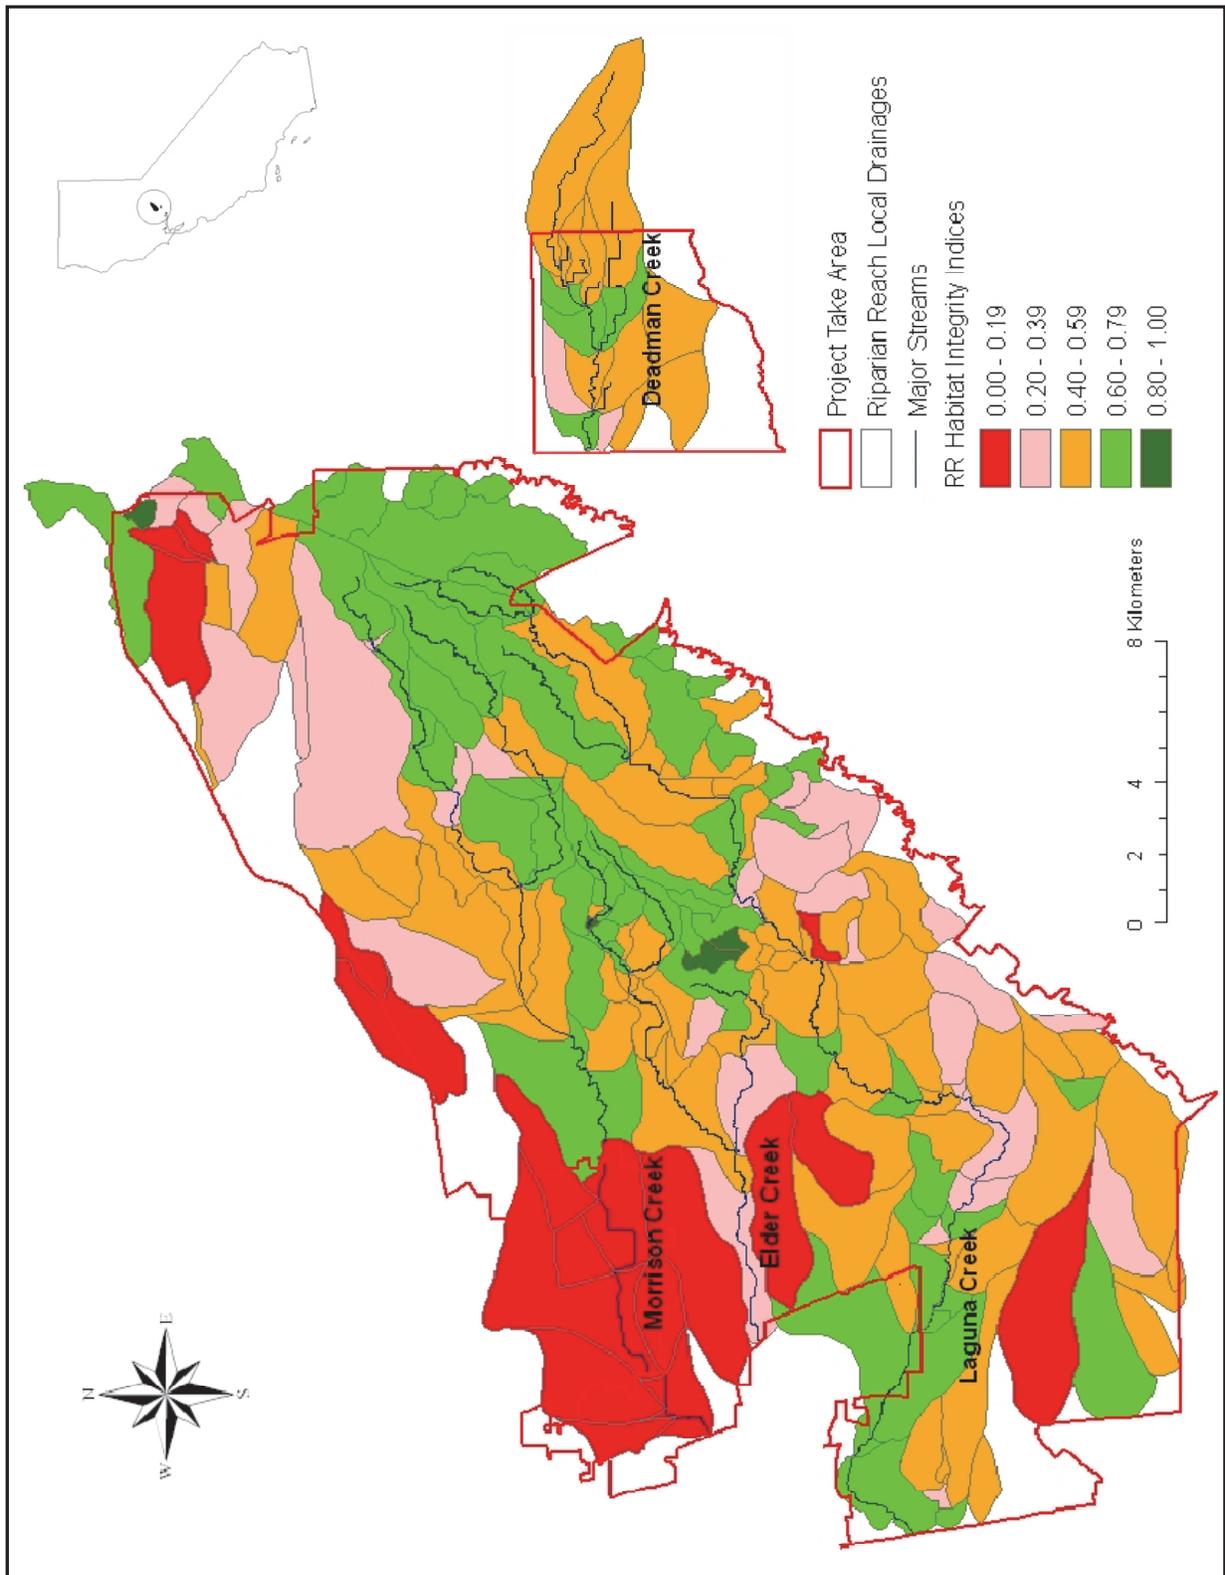
Figure A14. Habitat Integrity Indices for riparian reaches in the project take area.

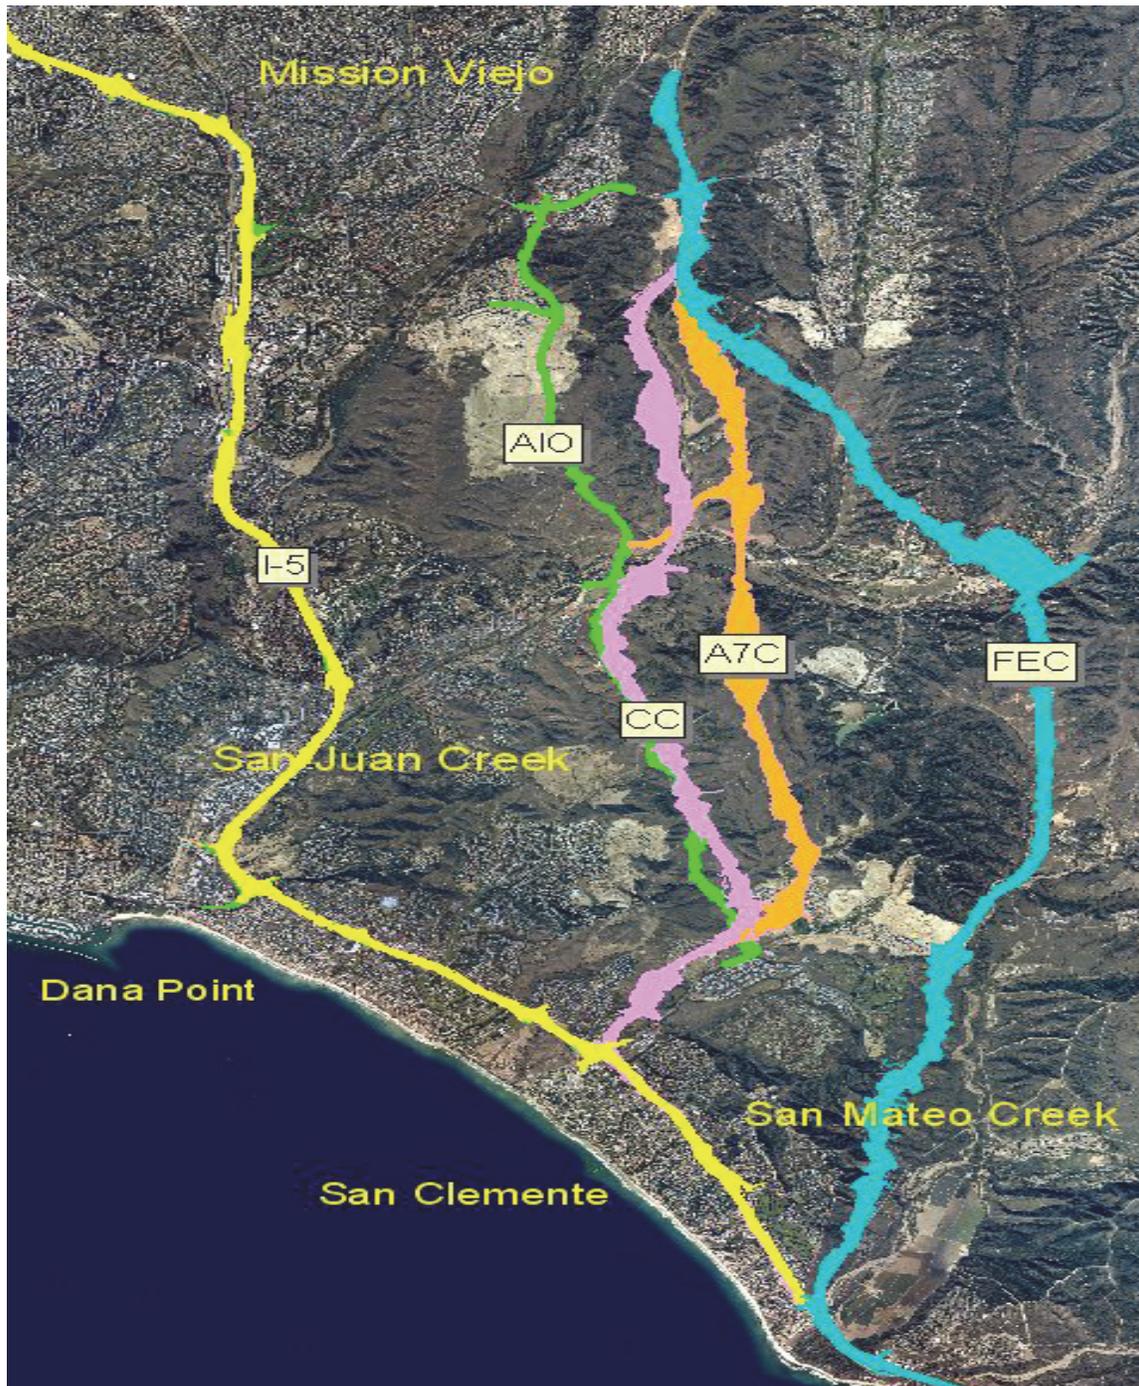
Figure B1. Study area showing major alternative corridor alignments.

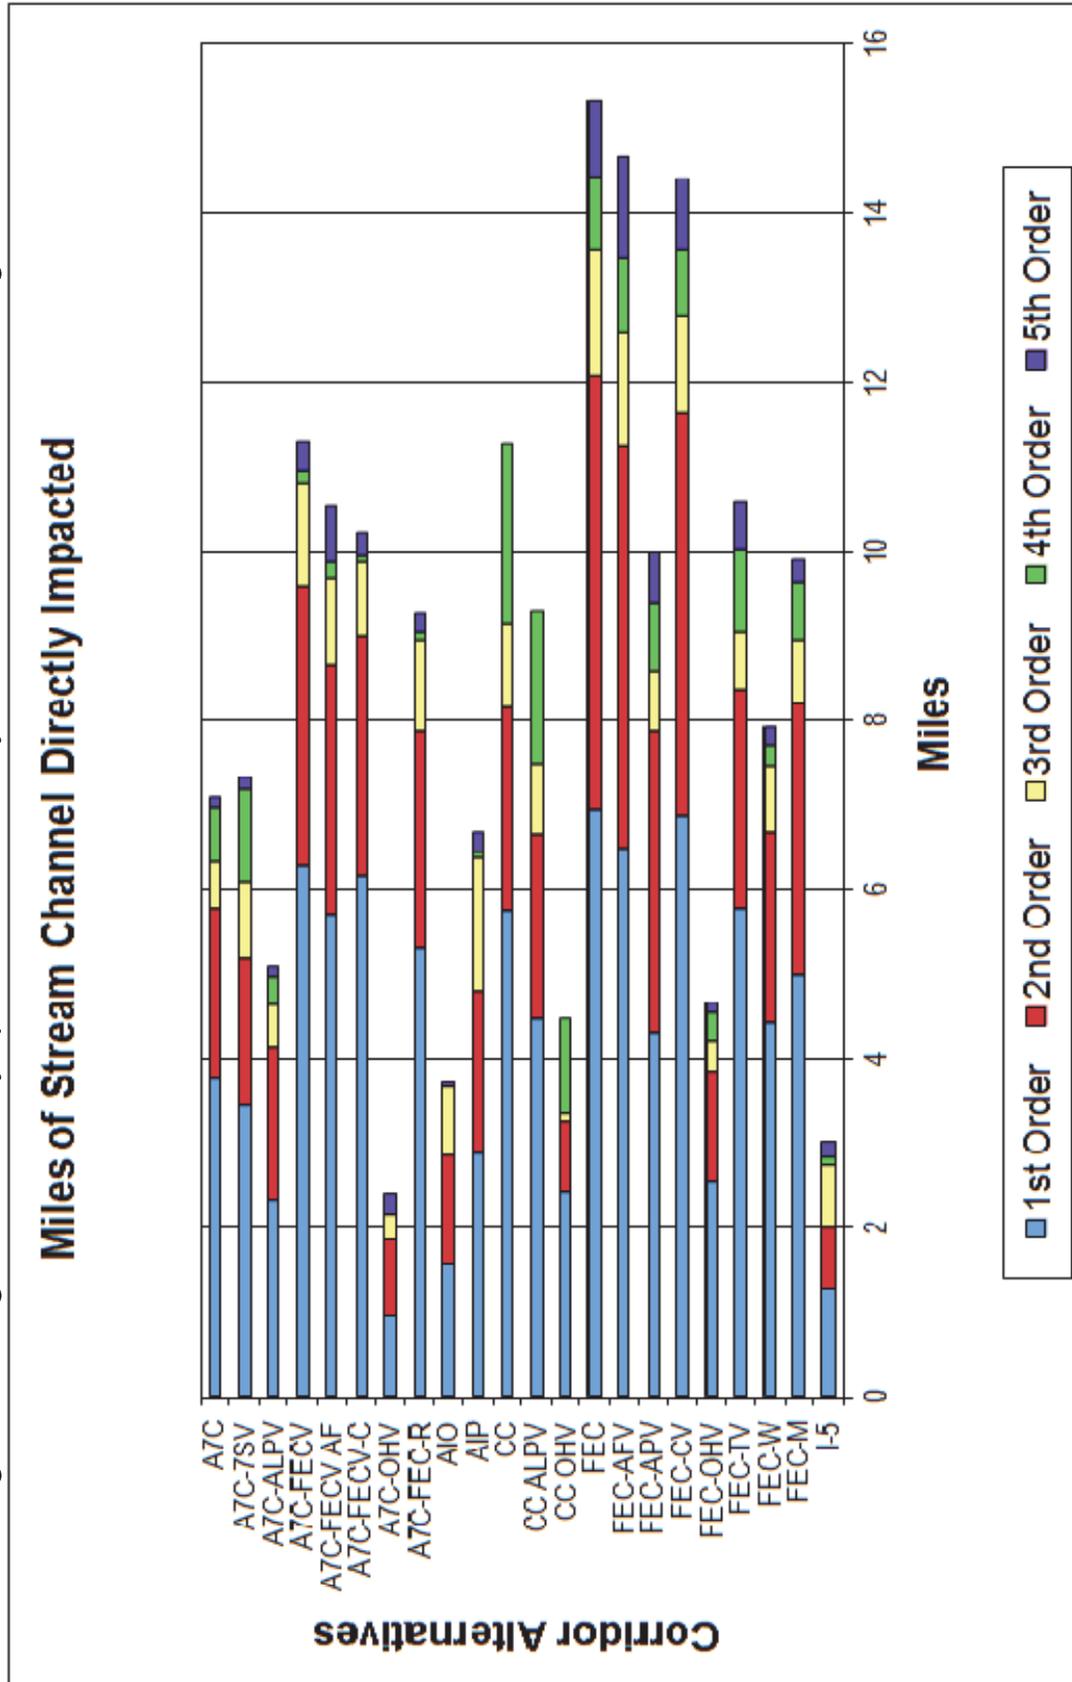
Figure B2. Ranking Criterion 1: Directly impacted stream channels by Strahler order for alternative corridor alignments.

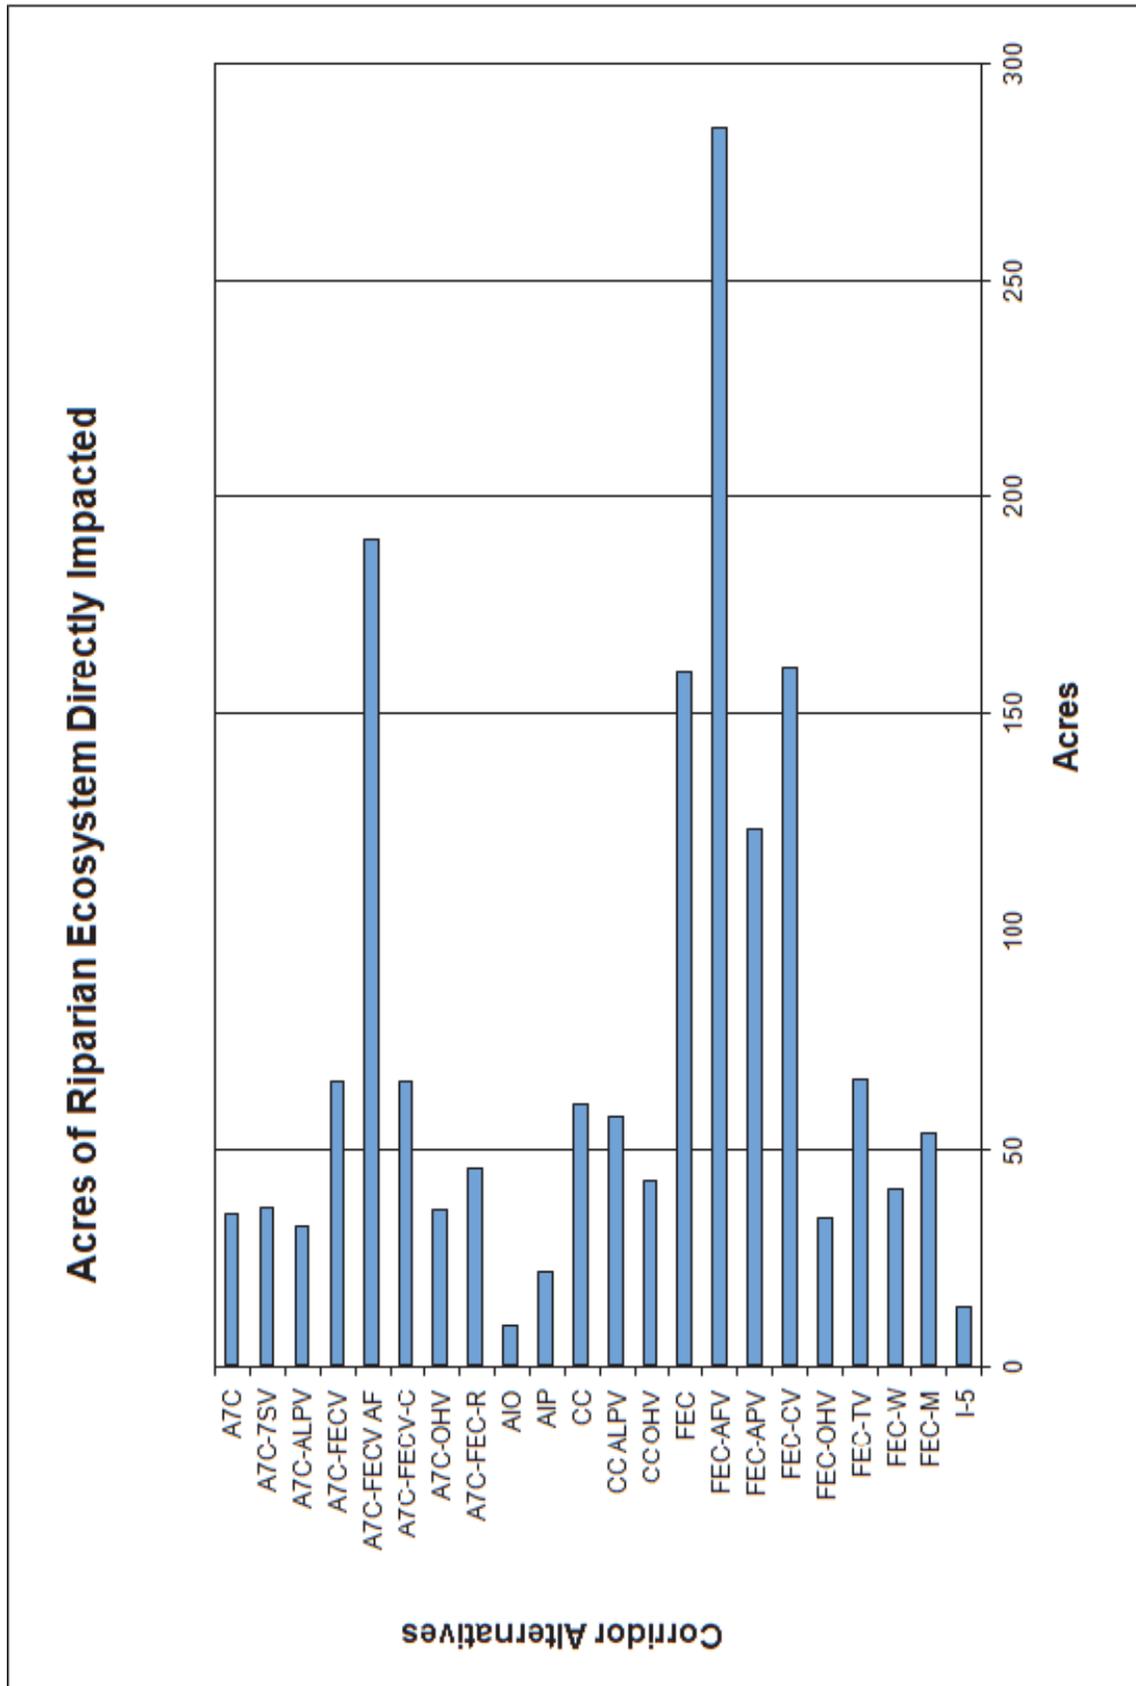
Figure B3. Ranking Criterion 2: Acres of riparian ecosystem directly impacted by alternative corridor alignments.

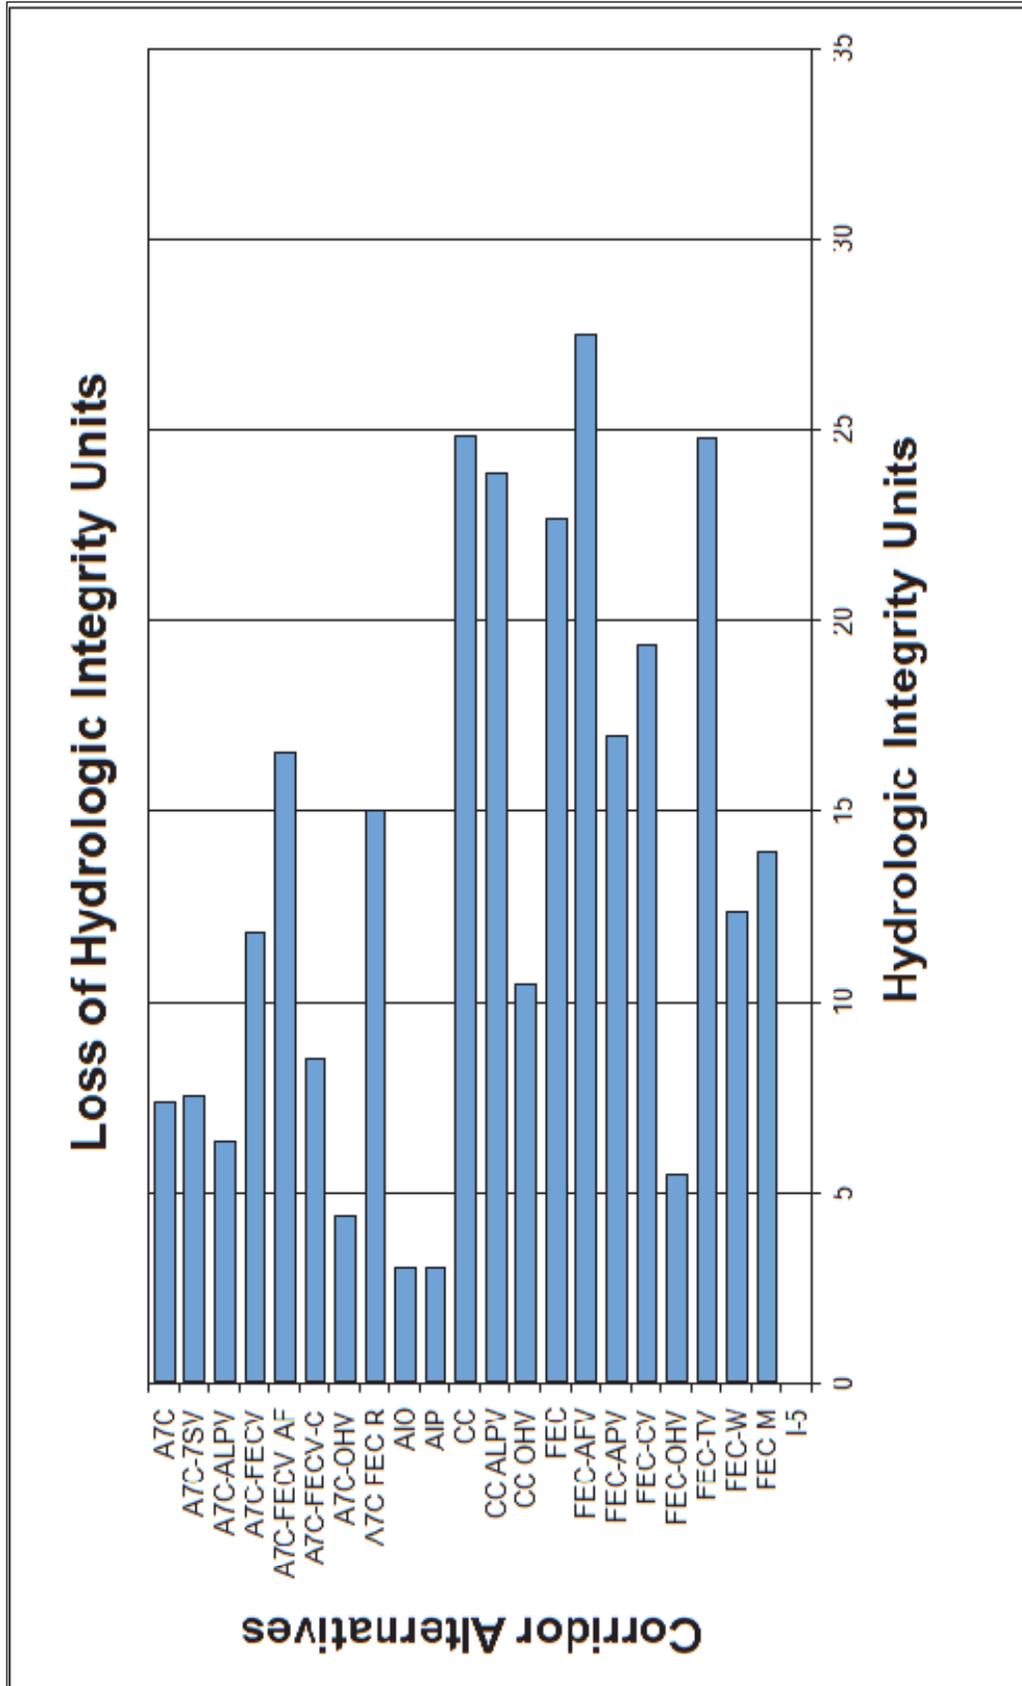
Figure B4. Ranking Criterion 3a: Total loss of hydrologic integrity units for all WAAs under each alternative corridor alignment.

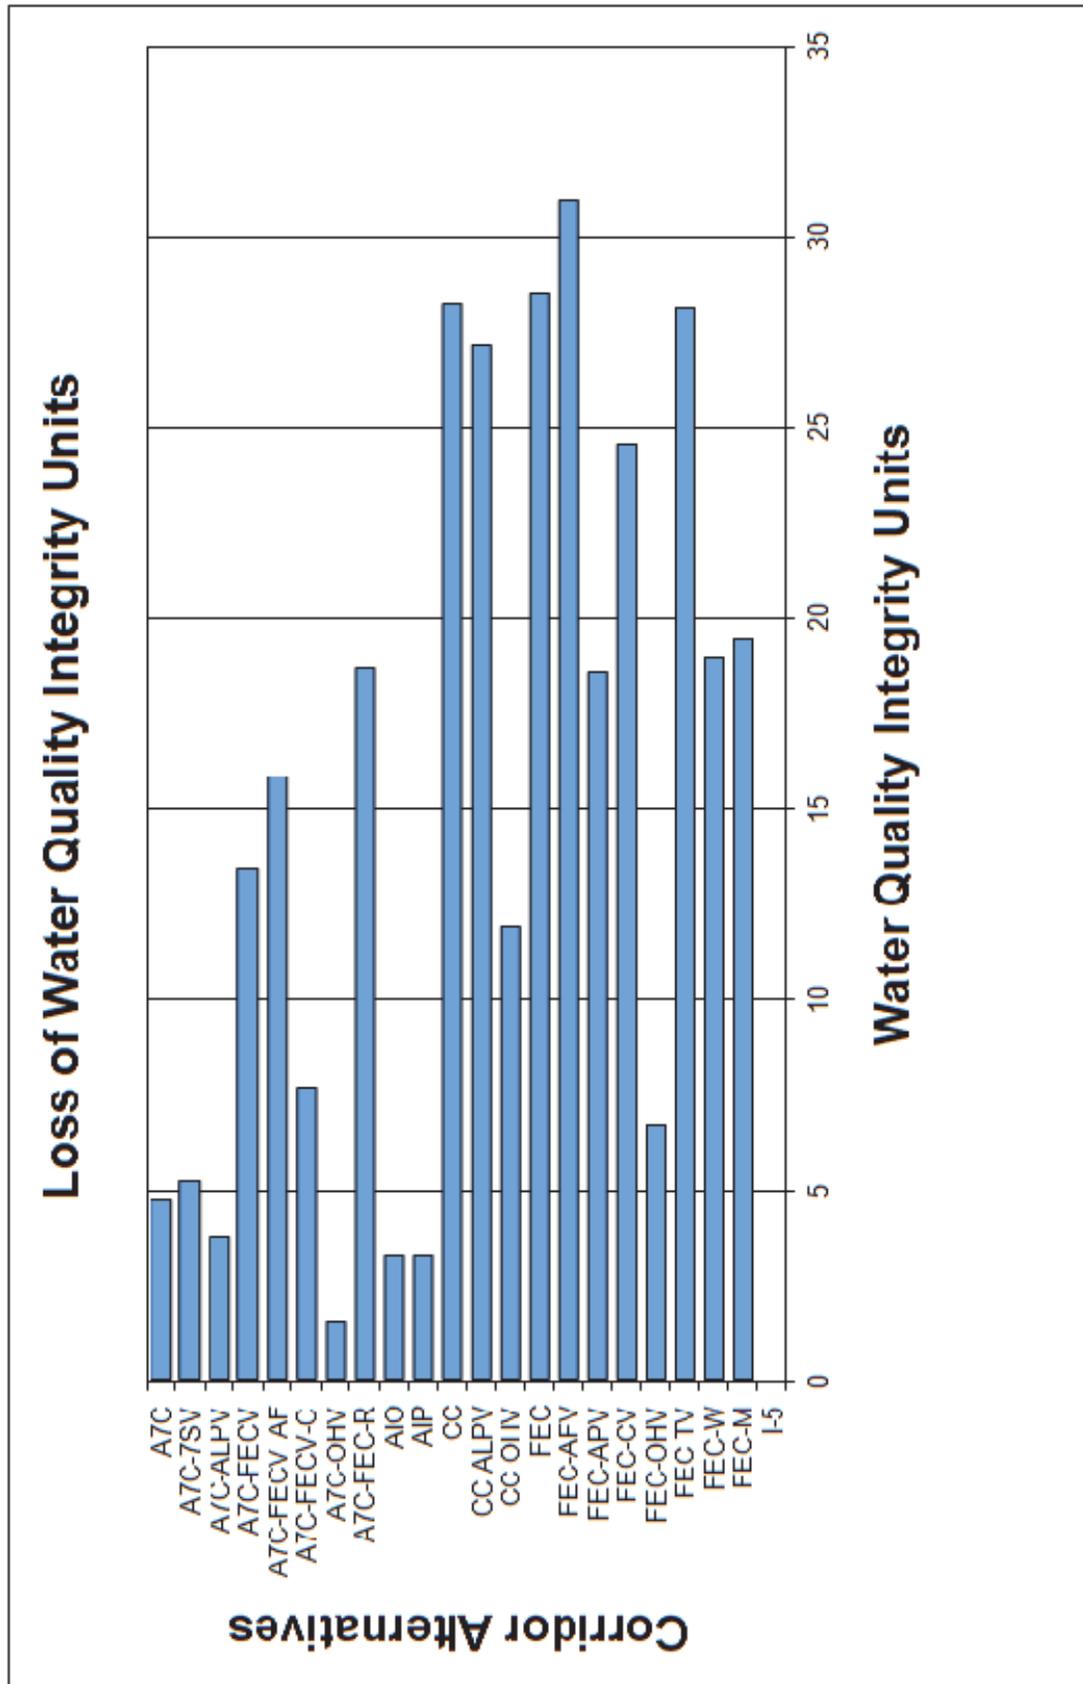
Figure B5. Ranking Criterion 3a: Total loss of water quality integrity units for all WAAs under each alternative corridor alignment.

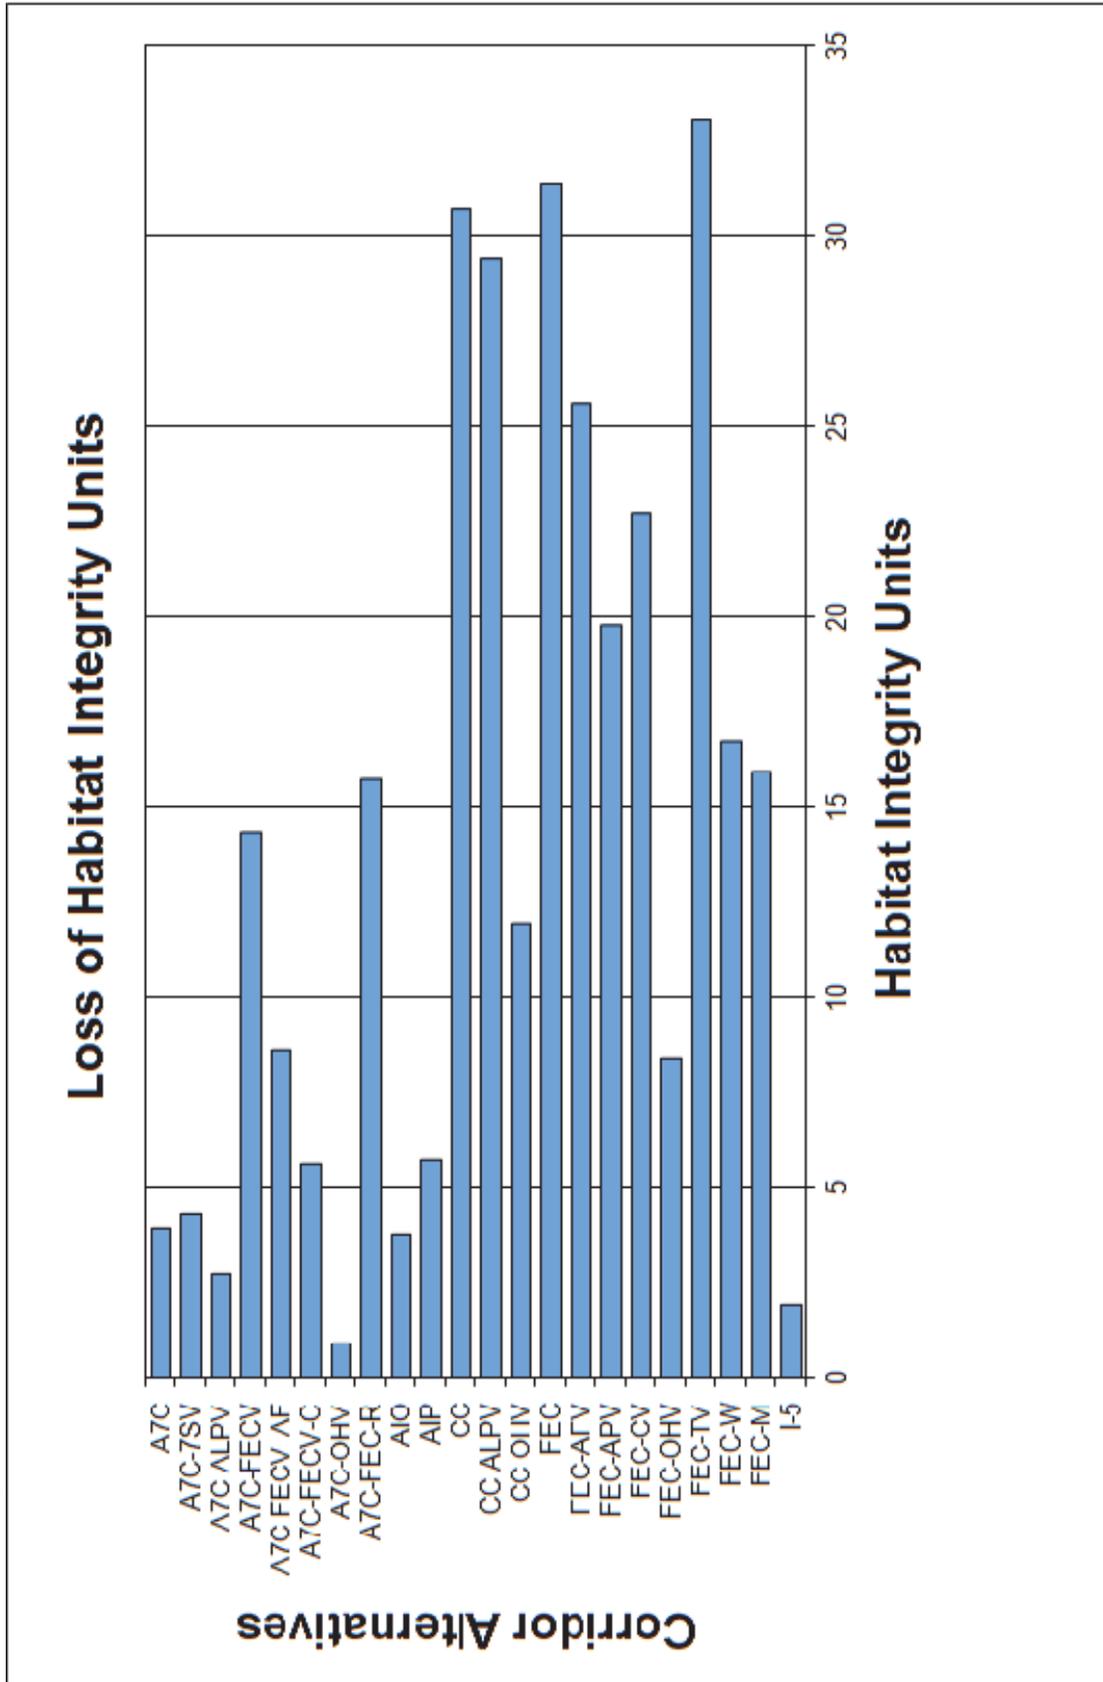
Figure B6. Ranking Criterion 3c: Total loss of habitat integrity units for all WAAs under each alternative corridor alignment.

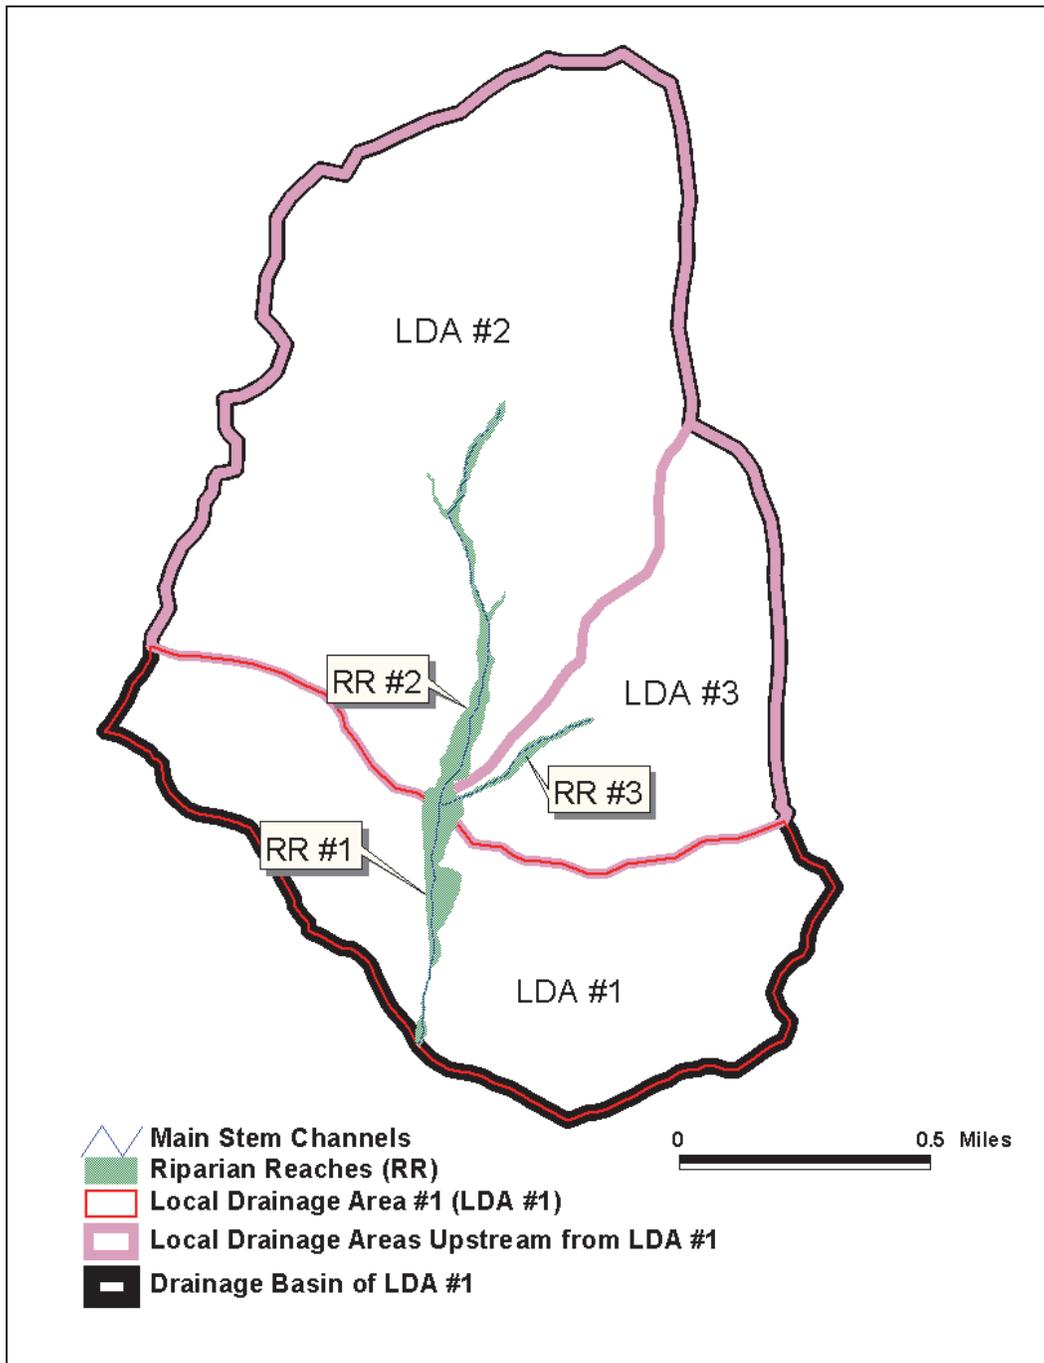
Figure C2. Relationships of riparian reaches, local drainage areas, and drainage basins.

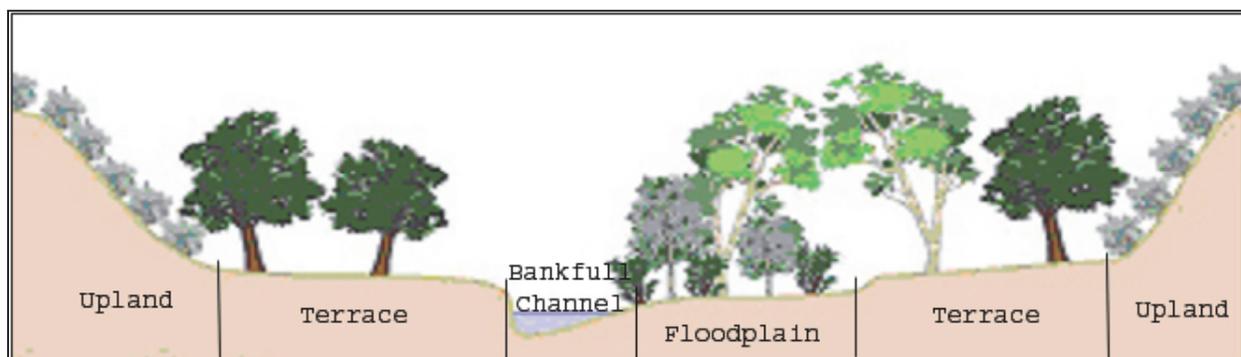
Figure C3. Riparian ecosystem geomorphic surfaces.

Floodplain: Technically, the floodplain is the valley floor level corresponding to the bank-full stage, but in fact various "floodplains" (e.g. 5-year, 10-year, etc.) include surfaces inundated at flow depths or frequencies that are of interest in a particular situation. For the purposes of this study, the floodplain corresponds to the "floodprone area" as defined by Rosgen (1996), minus the area of the bank-full channel. This is the area above the bank-full channel that is flooded when maximum channel depth is twice the maximum depth at the bank-full stage. The floodprone area usually includes most or all of the point bar deposits below the scarp rising to the lowest distinct terrace.

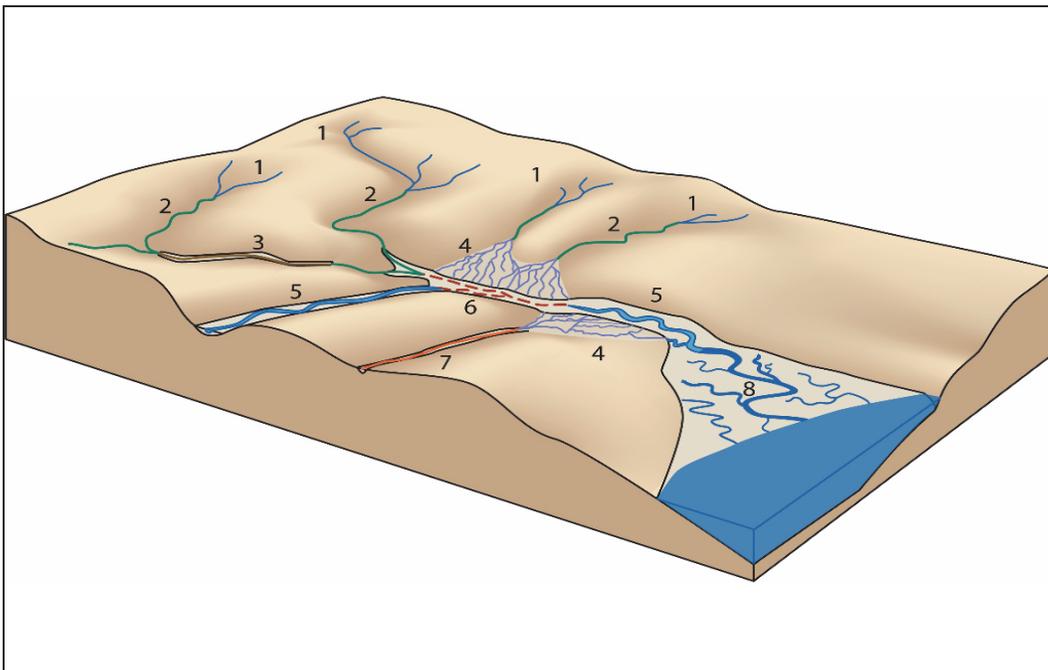
Figure C4. Generalized representation of landscape settings associated with geomorphic zones.
