Ecosystem Management and Restoration Research Program

A Multi-Scale Approach to Assess and Restore Ecosystems in a Watershed Context

Ronald D. Smith and Charles V. Klimas

September 2013

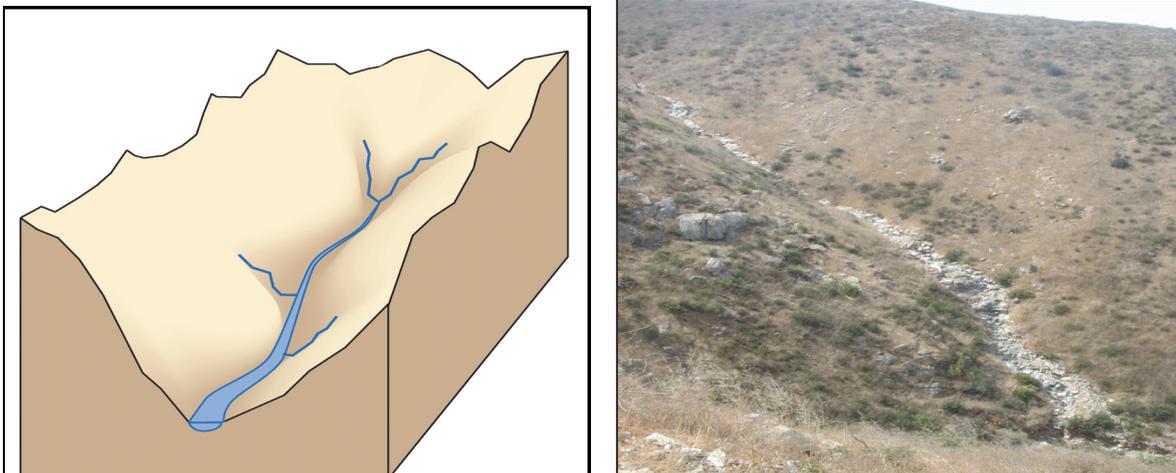
Figure C5. General form of Geomorphic Zone 1 and view of typical reach.

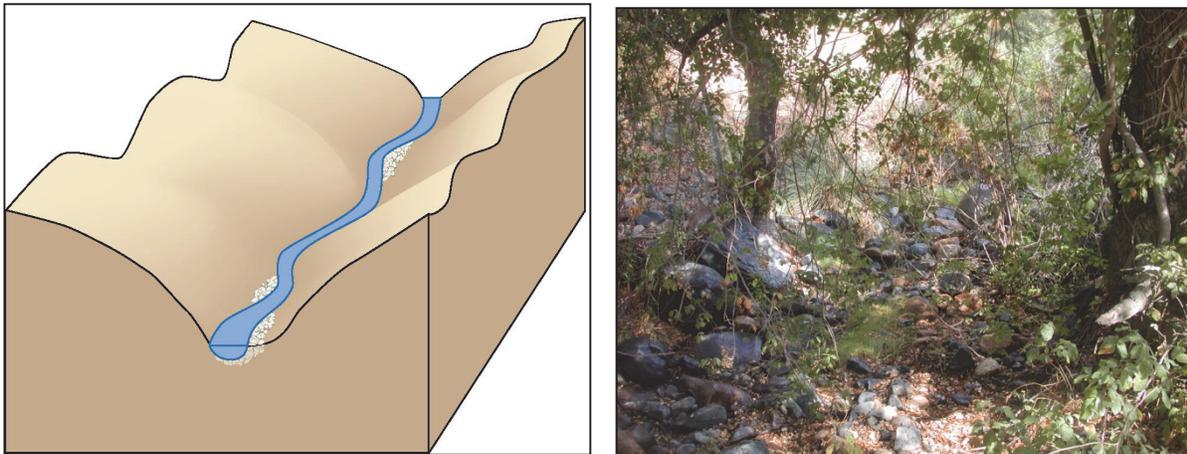
Figure C6. General form of Geomorphic Zone 2 and view of typical reach.

Geomorphic Zone 2: Small floodplains and terrace fragments in mountain and foothill valleys

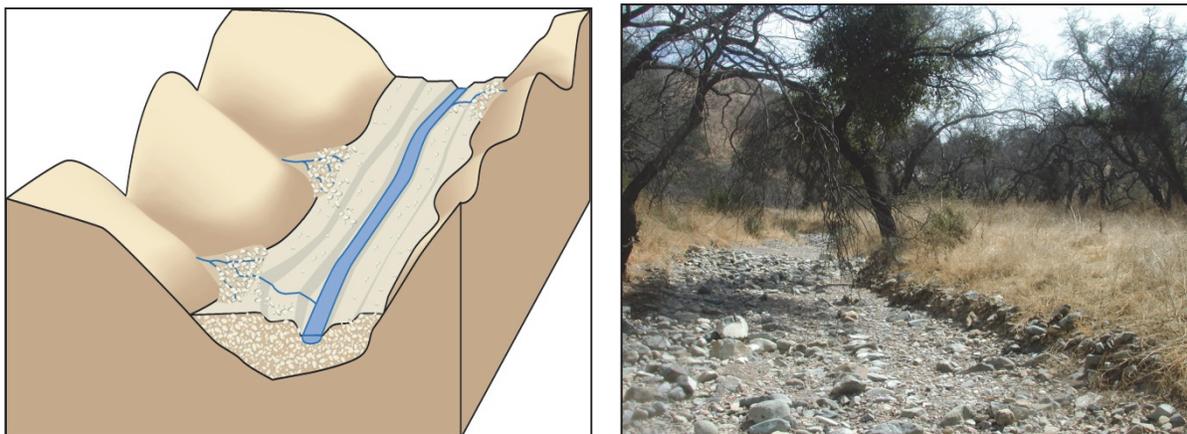
Figure C7. General form of Geomorphic Zone 3 and view of typical reach.

Geomorphic Zone 3: Boulder-dominated floodplain and terrace complexes

Zone 3 reaches occur at and below the confluence of high-gradient tributary streams with larger channels. The steep tributaries deliver coarse, unsorted materials, which are distributed downstream. Usually, the main channel runs across bare cobbles and boulders, while the slightly higher adjacent terraces will have a shallow soil that fills between the rocks and forms a rough, but fairly level surface. Because the terraces consist of very coarse material, they typically support upland shrubs. Oaks and sycamores are often present but usually as scattered individuals. Overall, however, continuous riparian communities are restricted to the immediate vicinity of the stream channels. Very few reaches were designated as Geomorphic Zone 3, but where it occurs, it is distinctive.

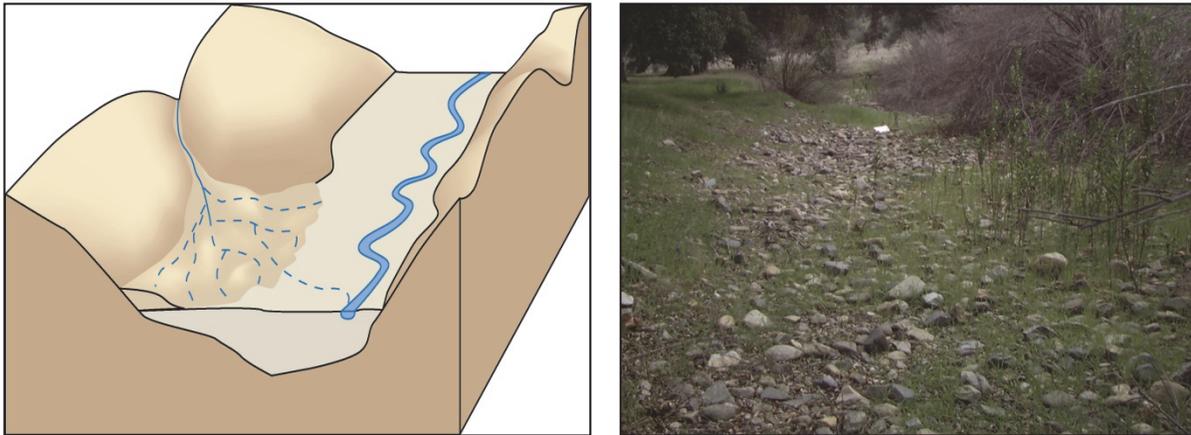
Figure C8. General form of Geomorphic Zone 4 and view of typical reach.

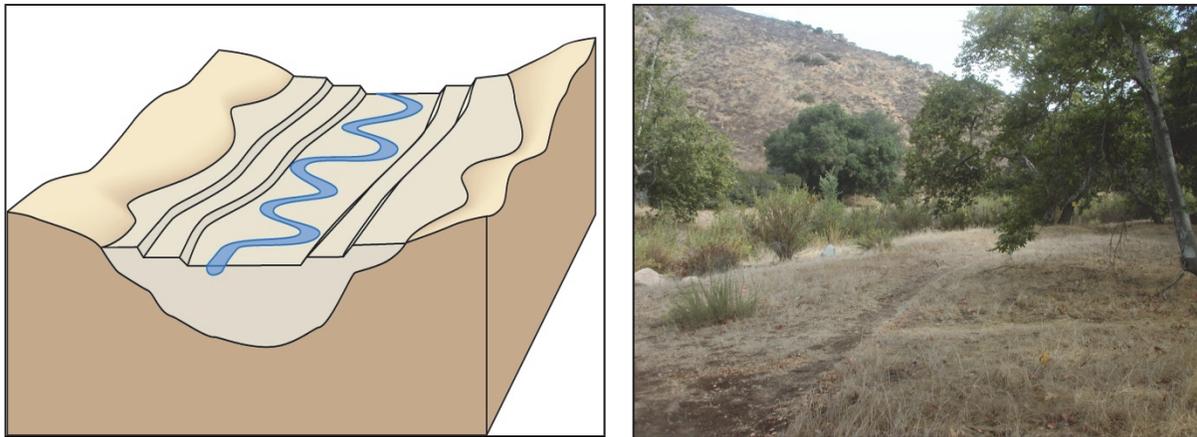
Figure C9. General form of Geomorphic Zone 5 and view of typical reach.

Geomorphic Zone 5: Alluvium of meandering streams in low-gradient valleys

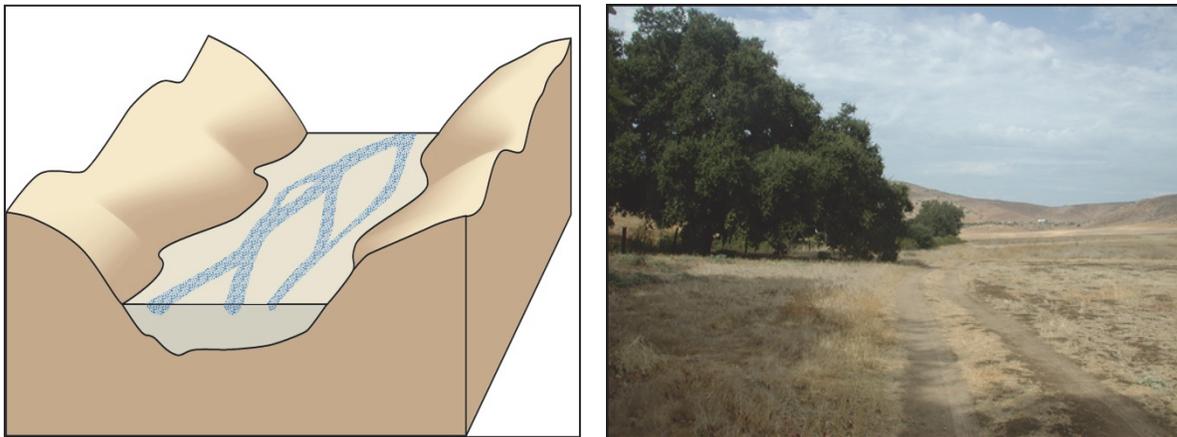
Figure 10. General form of Geomorphic Zone 6 and view of typical reach.

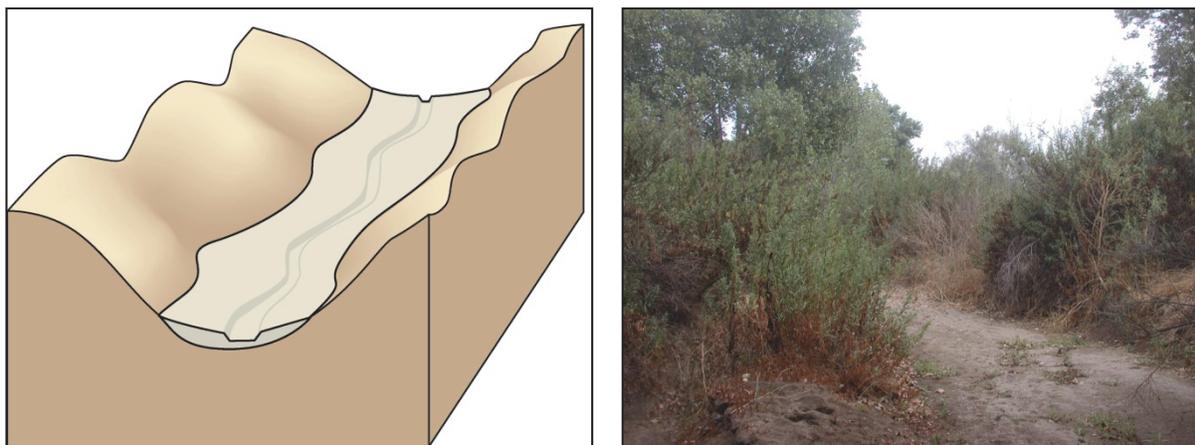
Figure C11. General form of Geomorphic Zone 7 and view of typical reach.

Geomorphic Zone 7: Sandy wash

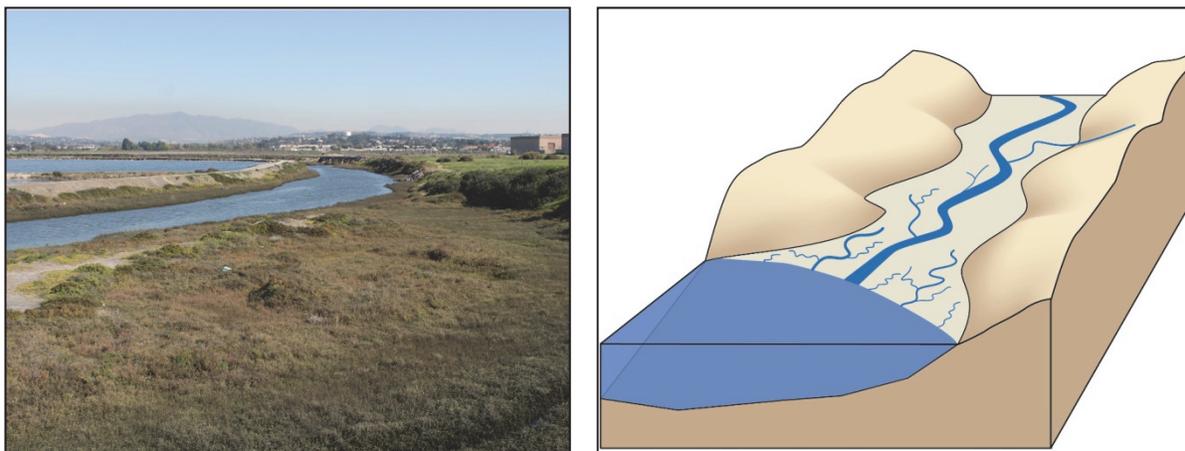
Figure C12. General form of Geomorphic Zone 8 and view of typical reach.

Geomorphic Zone 8: Tidal reaches

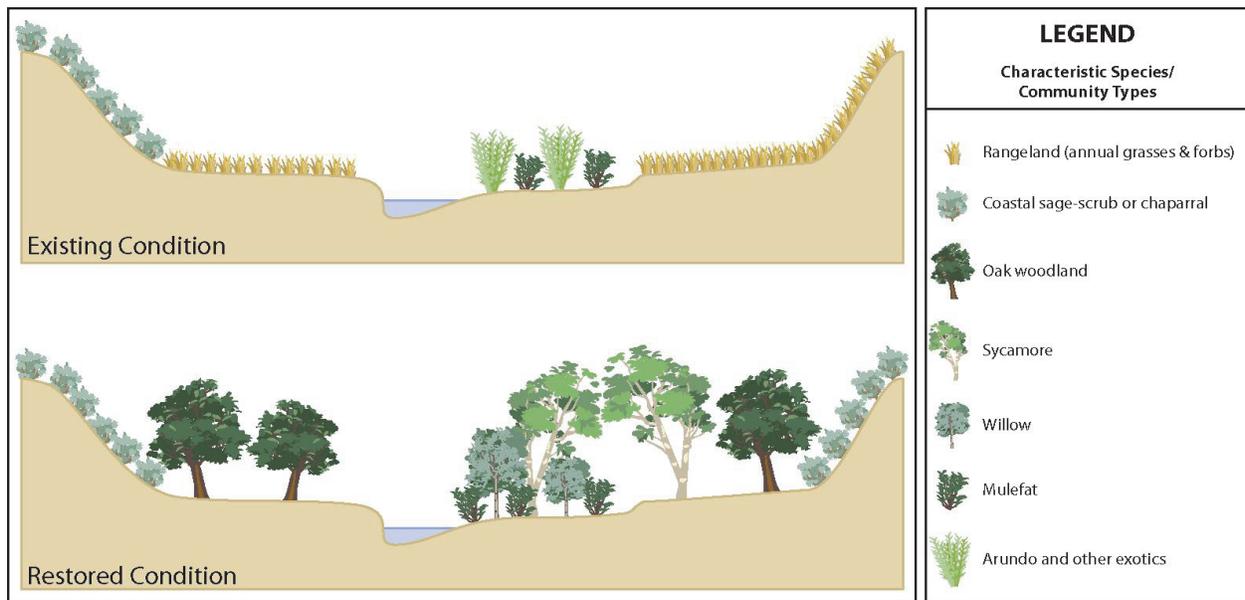
Figure C13. Typical pre- and post-restoration conditions of the Natural Template.

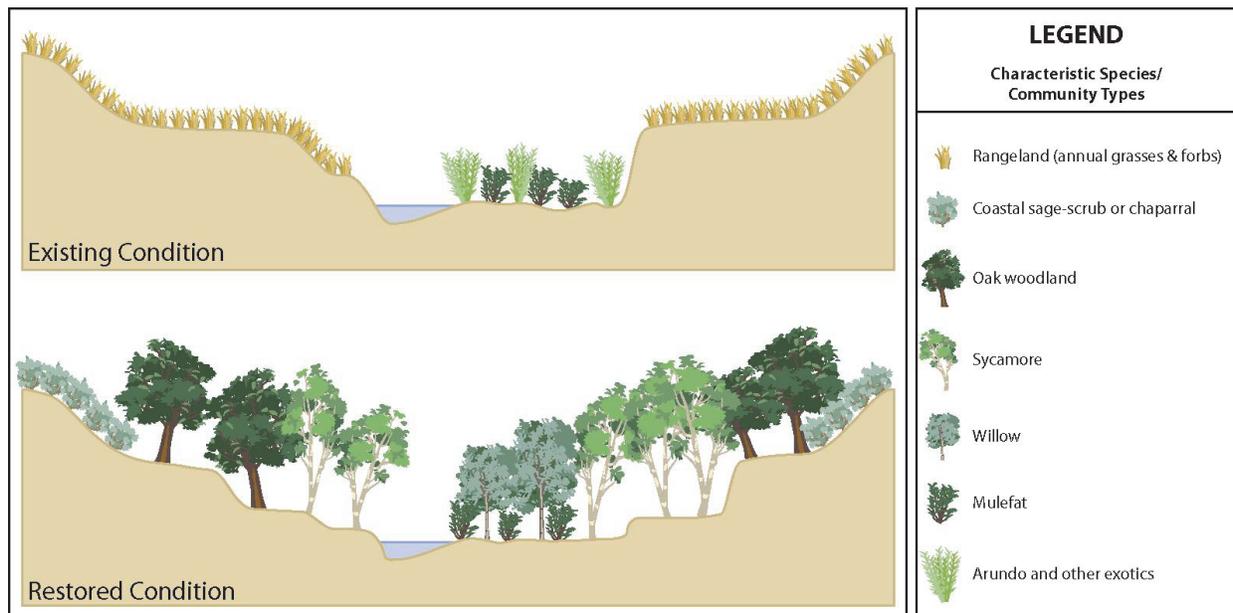
Figure C14. Typical pre- and post-restoration conditions of the Incised Template.

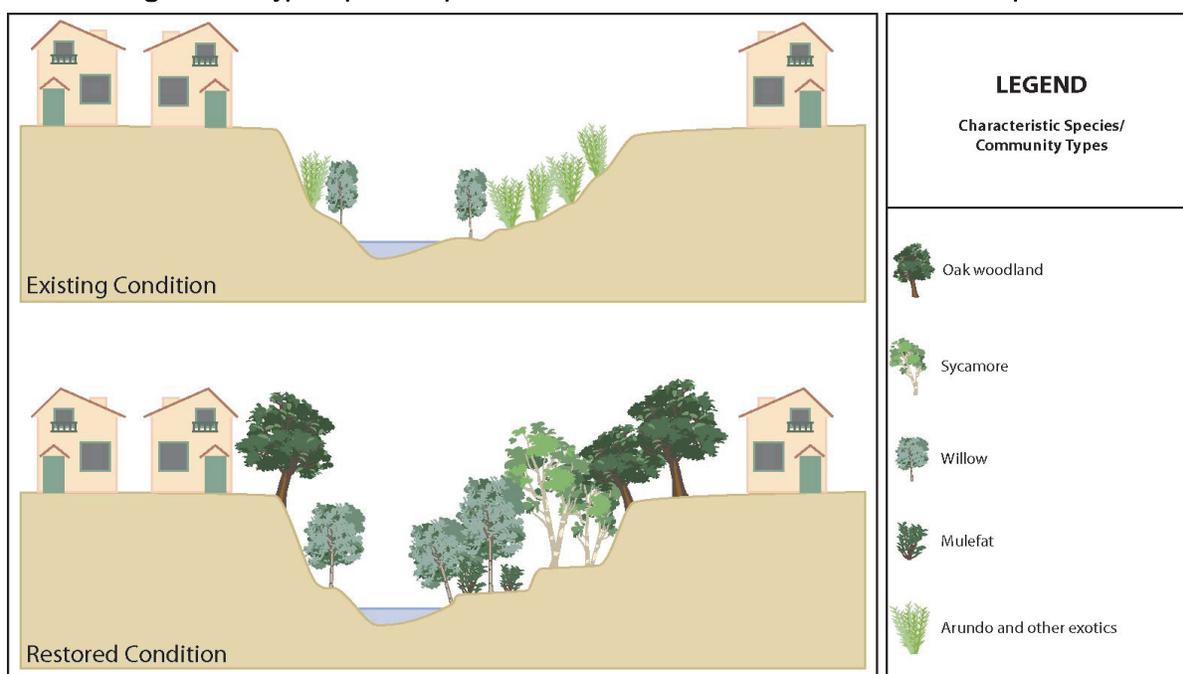
Figure C15. Typical pre- and post-restoration conditions of the Constrained Template.

Constrained Channel Template

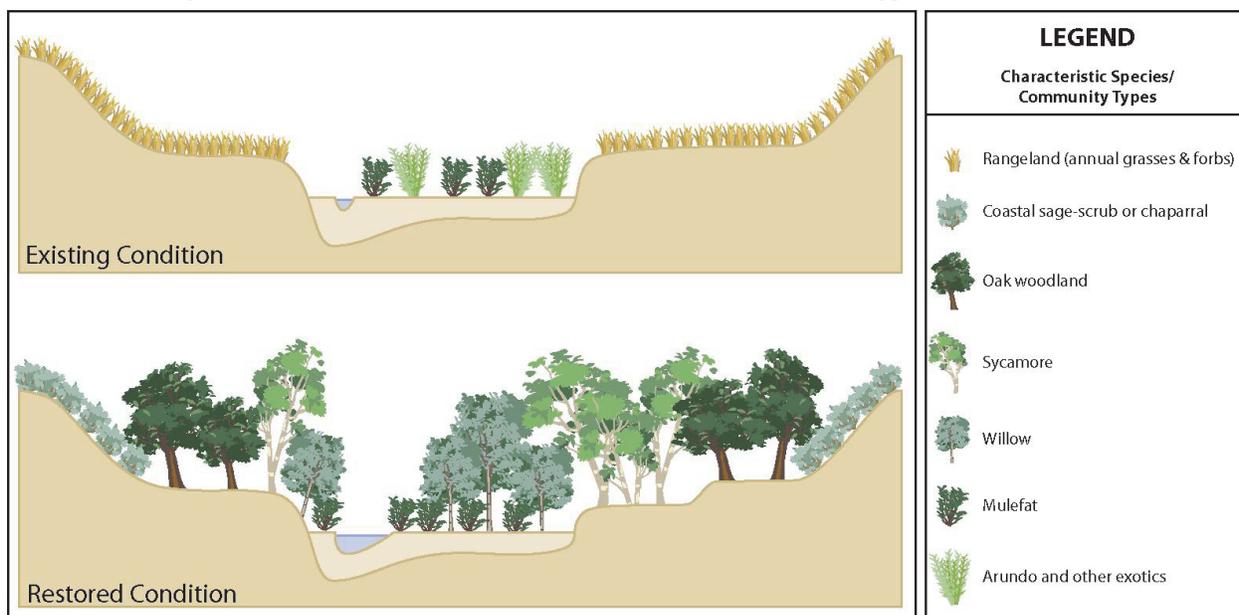
Figure C16. Typical pre- and post-restoration conditions of the Aggraded Template.

Aggraded Channel Template

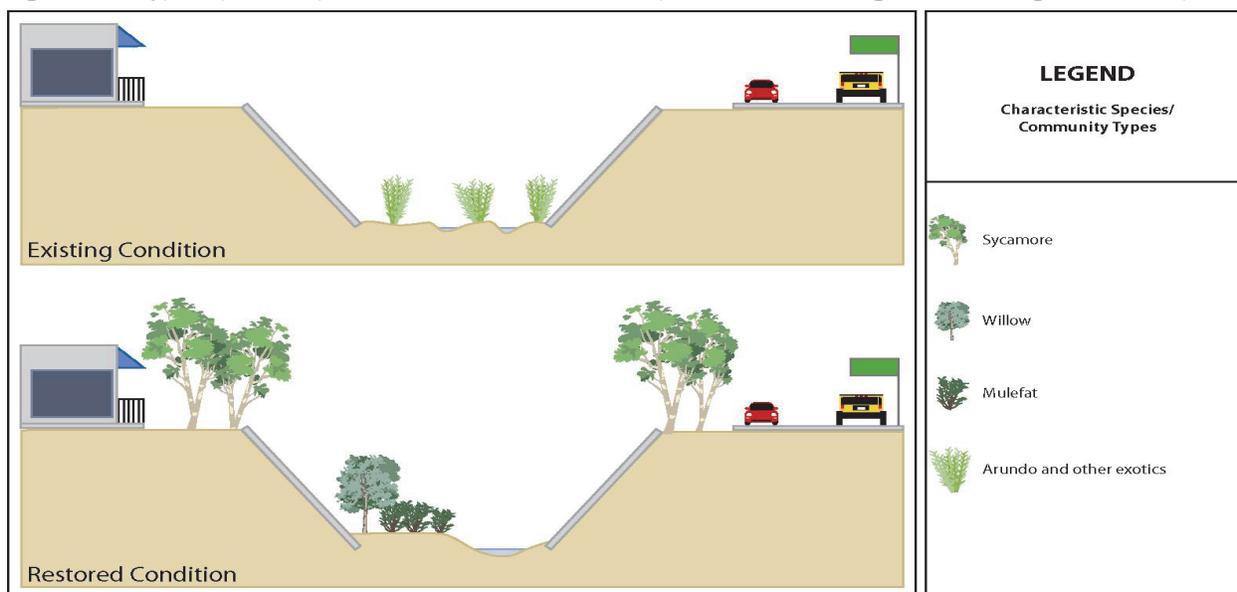
Figure C17. Typical pre- and post-restoration conditions of riparian reaches assigned to the Engineered Template.

Engineered Channel Template

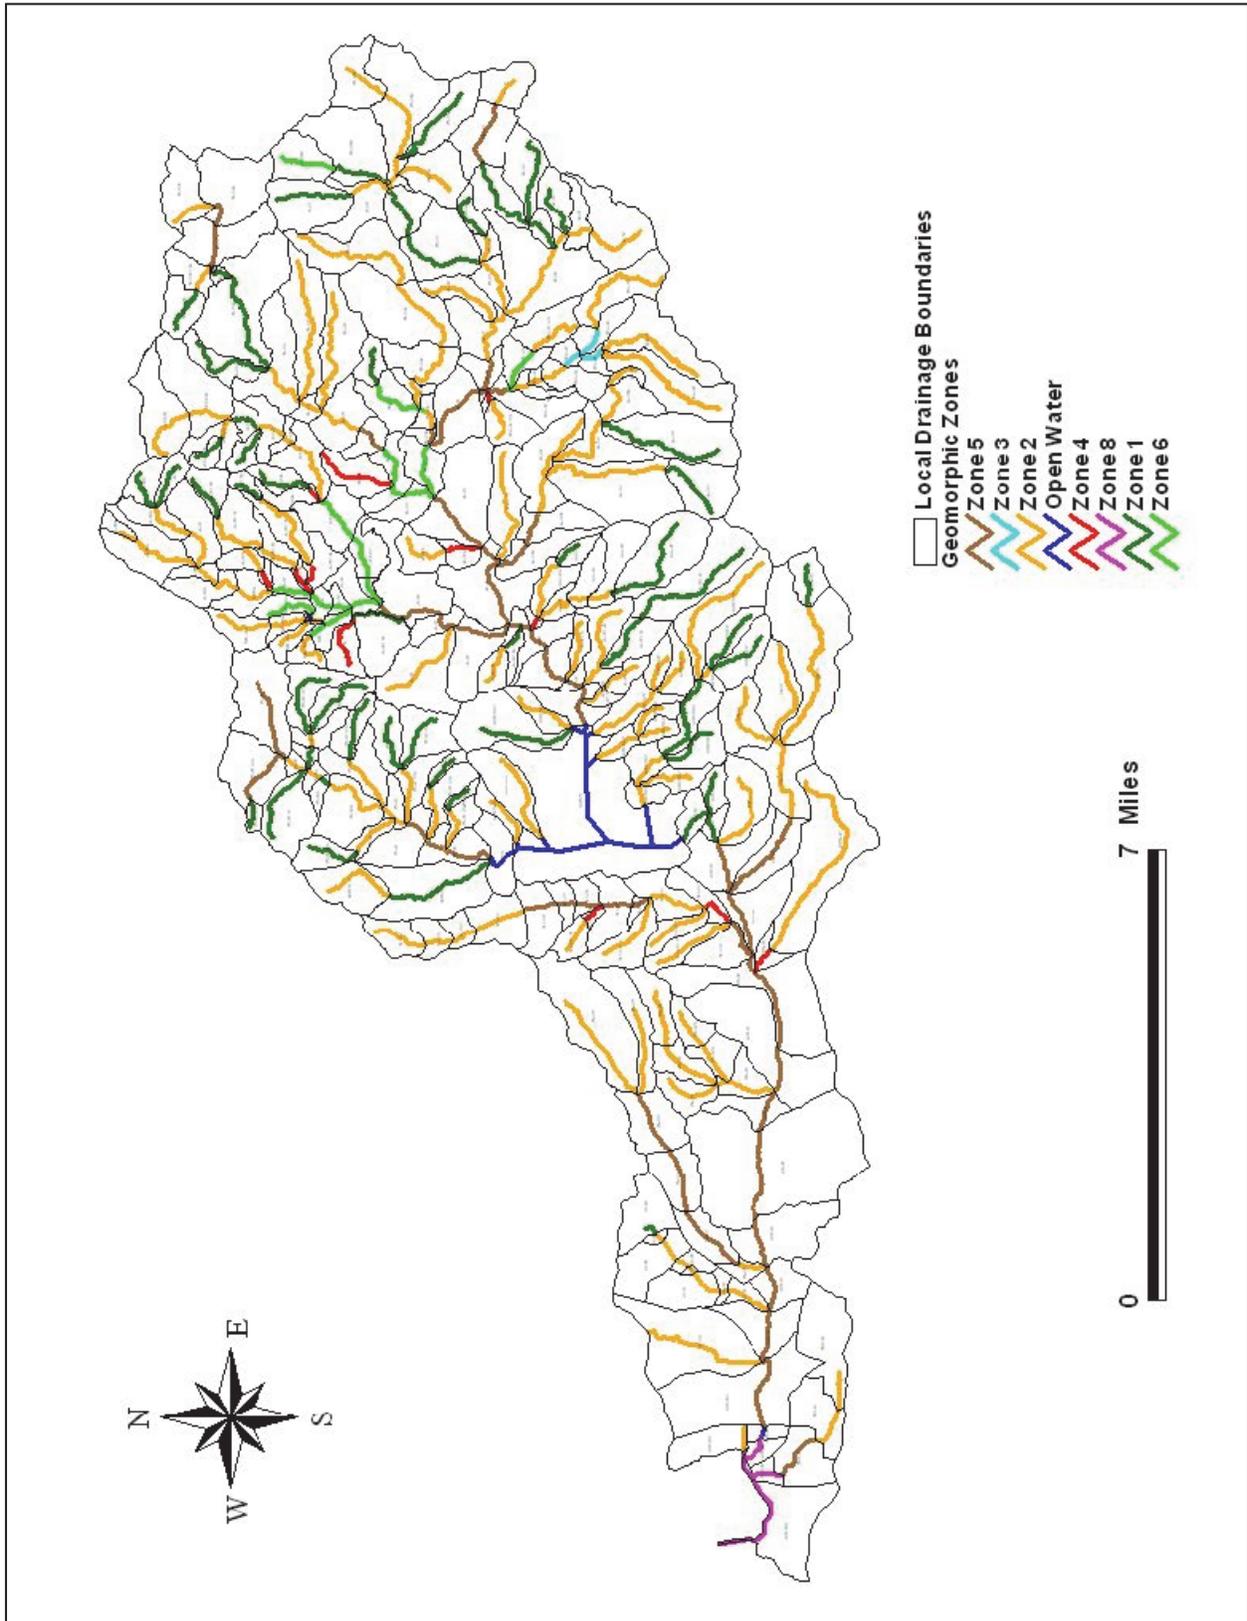
Figure C18. Geomorphic Zone assignments for riparian reaches.

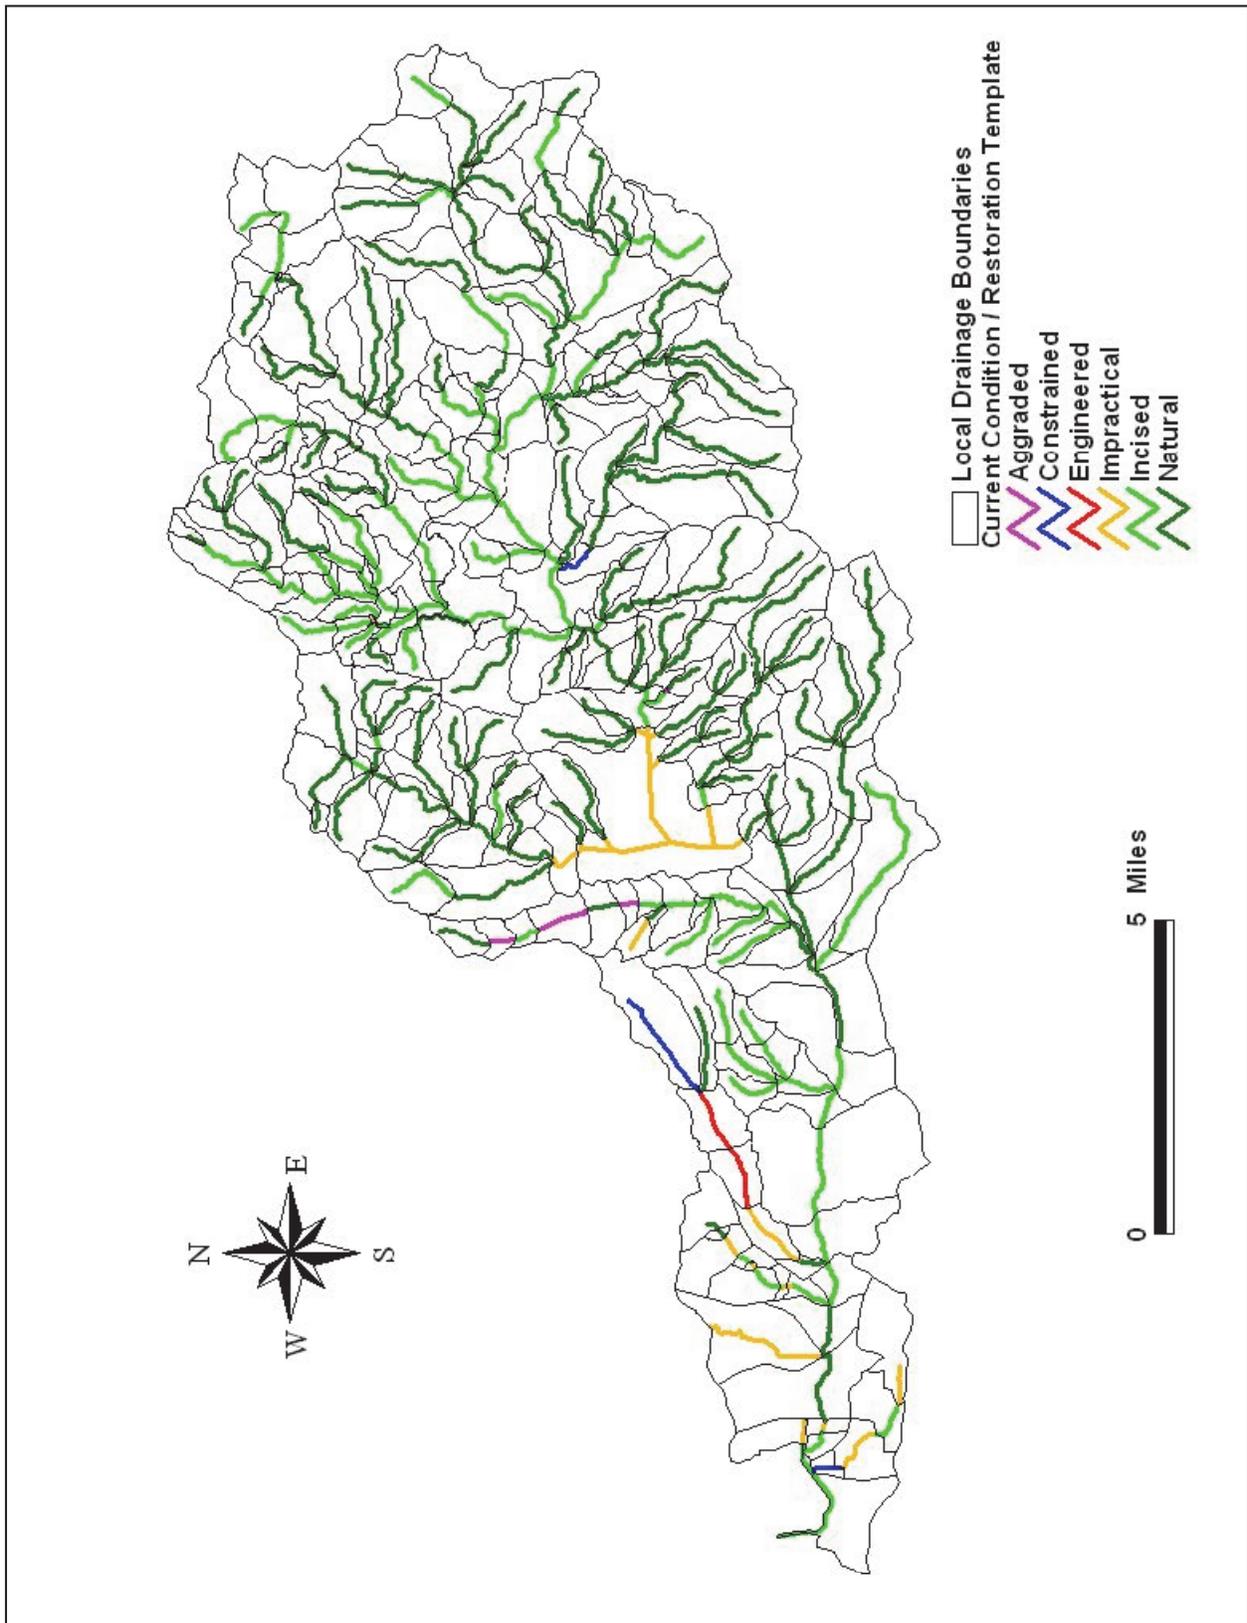
Figure C19. Restoration Template assignments for riparian reaches.

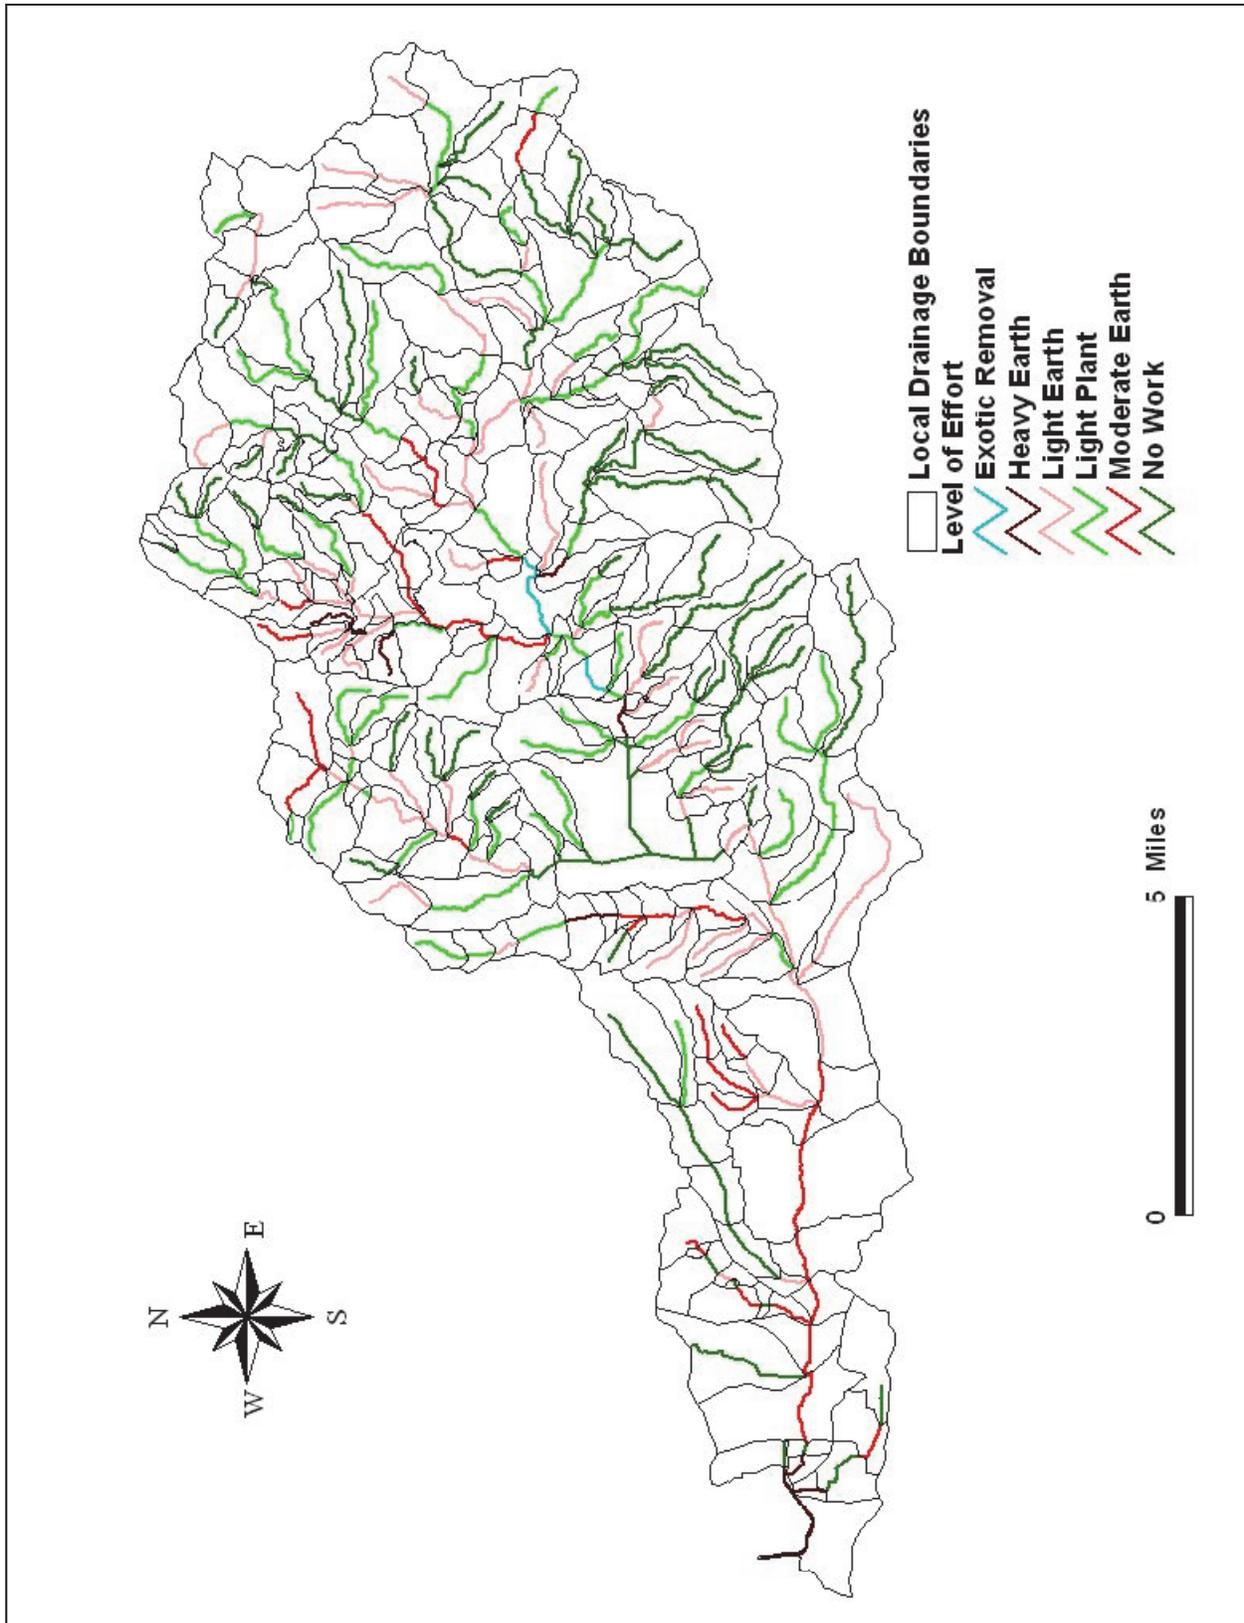
Figure C20. Level-of-Effort assignments for riparian reaches.

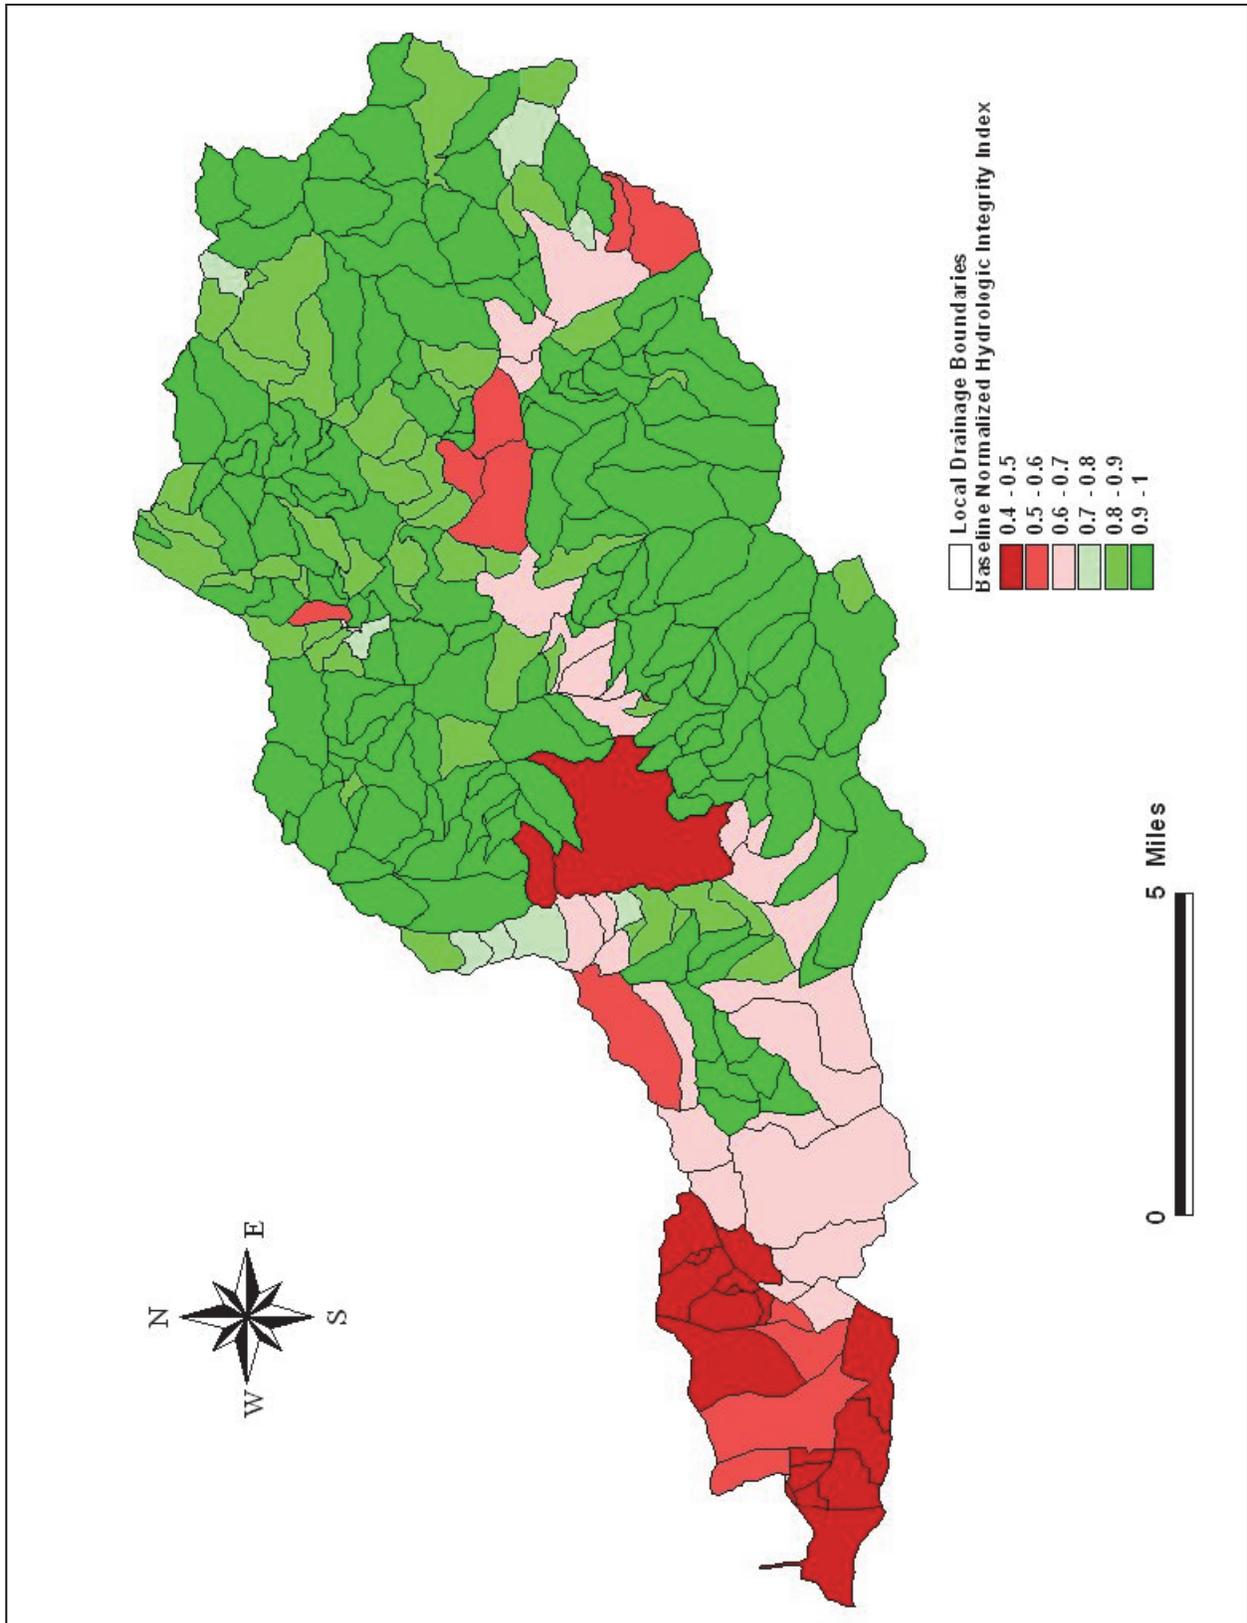
Figure C21. Normalized baseline hydrology integrity indices for riparian reaches.

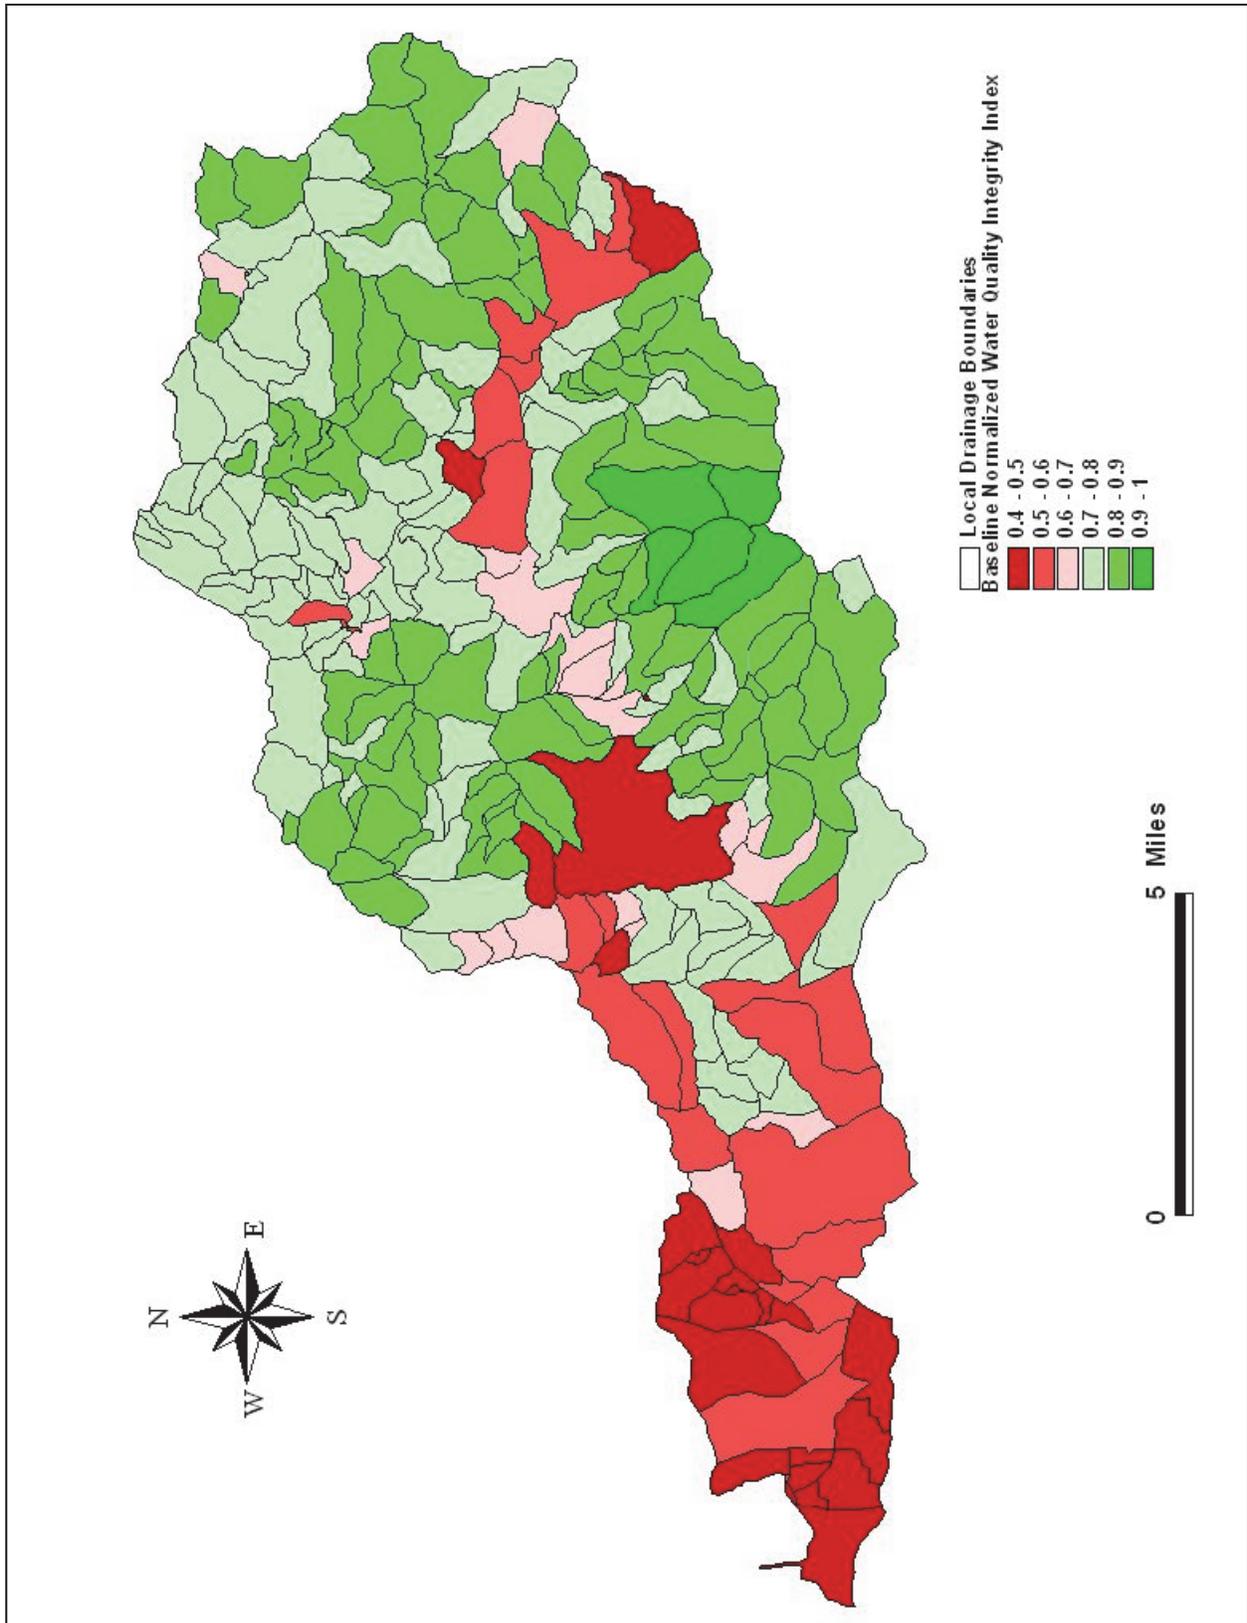
Figure C22. Normalized baseline water quality integrity indices for riparian reaches.

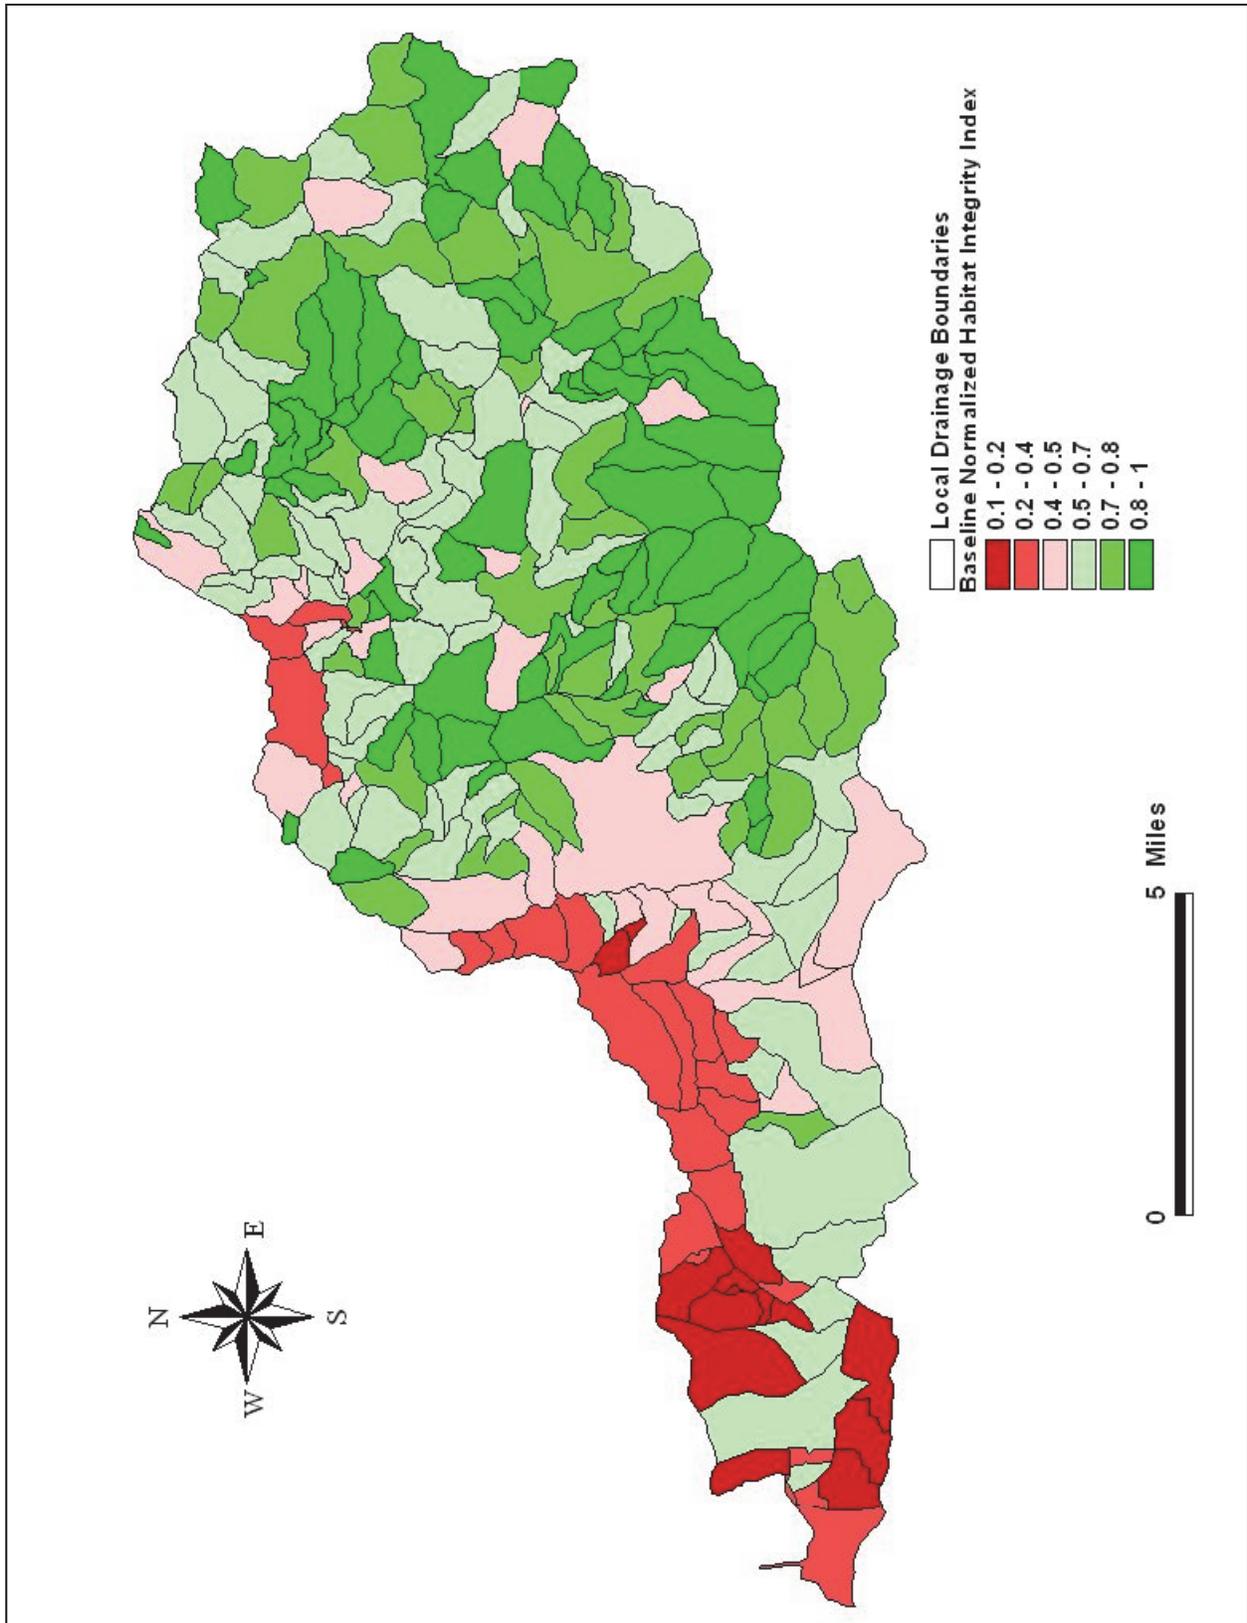
Figure C23. Normalized baseline habitat integrity indices for riparian reaches.

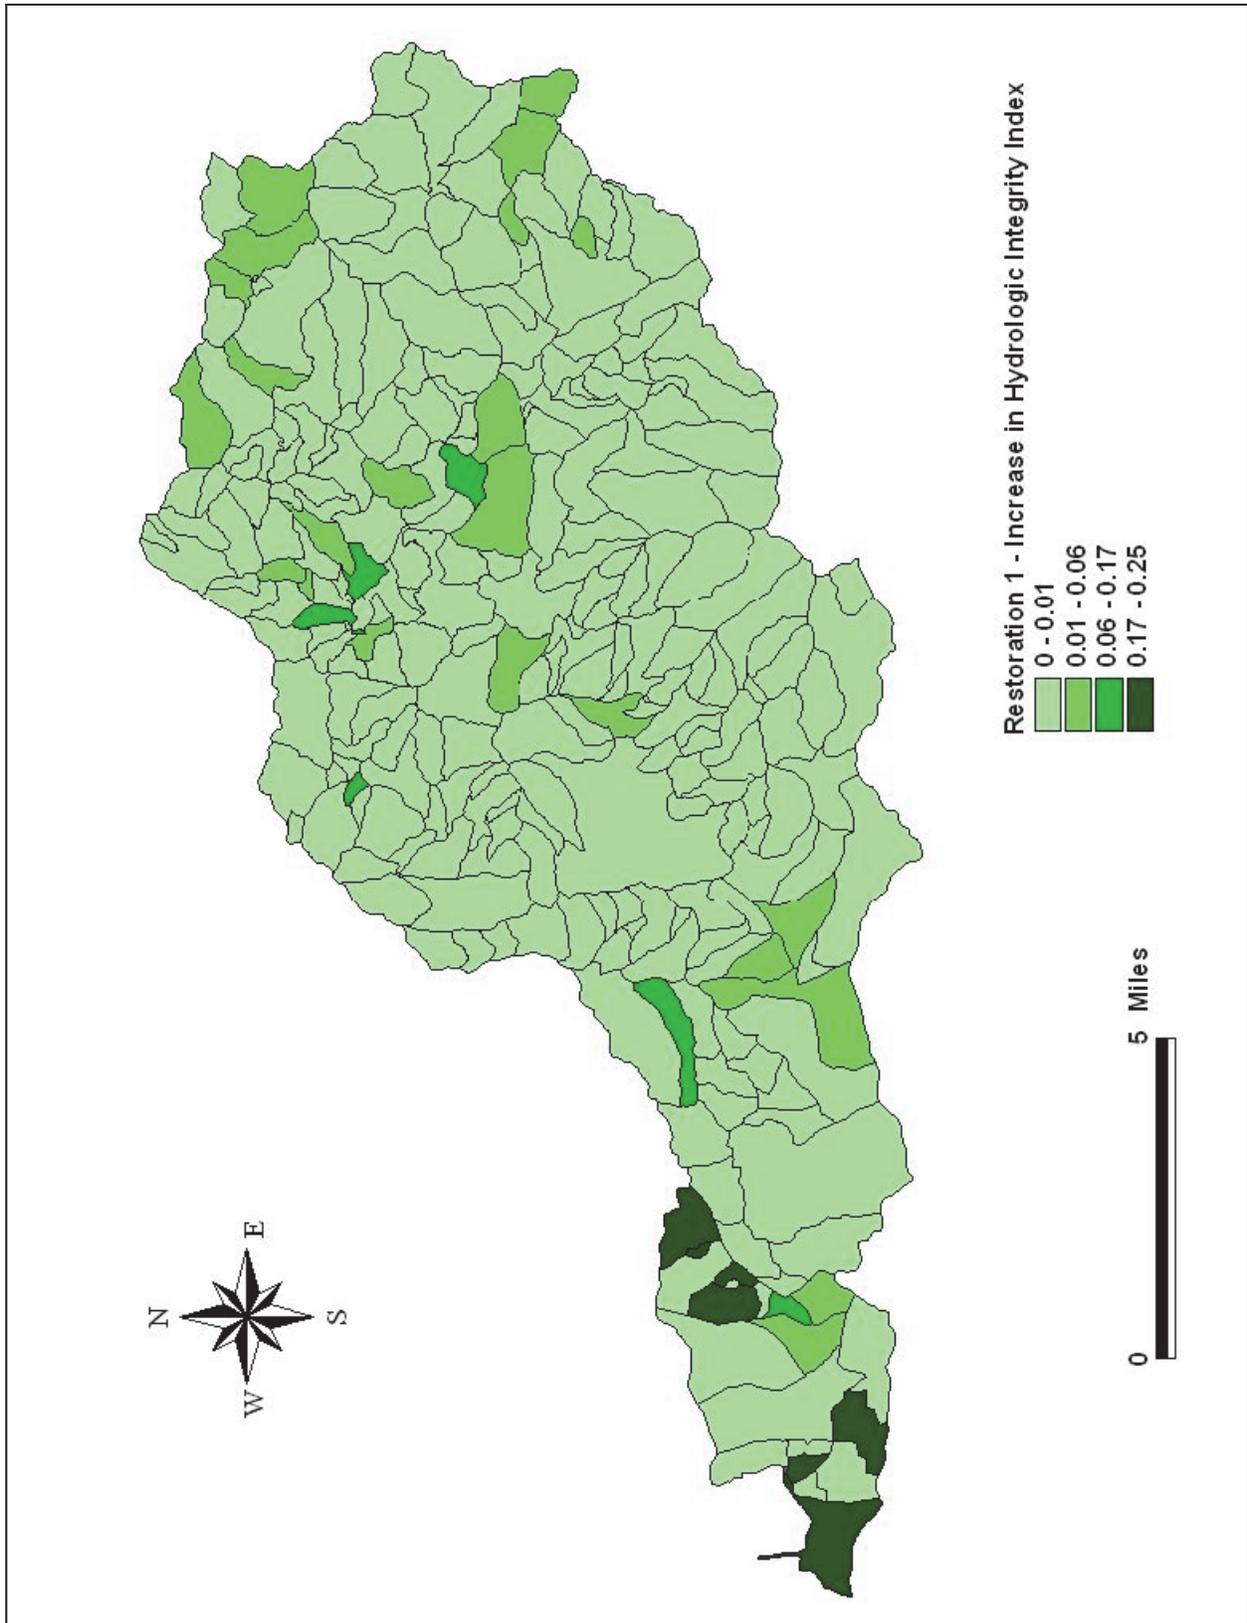
Figure C24. Increase in normalized hydrologic integrity index under Restoration Scenario 1.
