Ecosystem Management and Restoration Research Program

A Multi-Scale Approach to Assess and Restore Ecosystems in a Watershed Context

Ronald D. Smith and Charles V. Klimas

September 2013

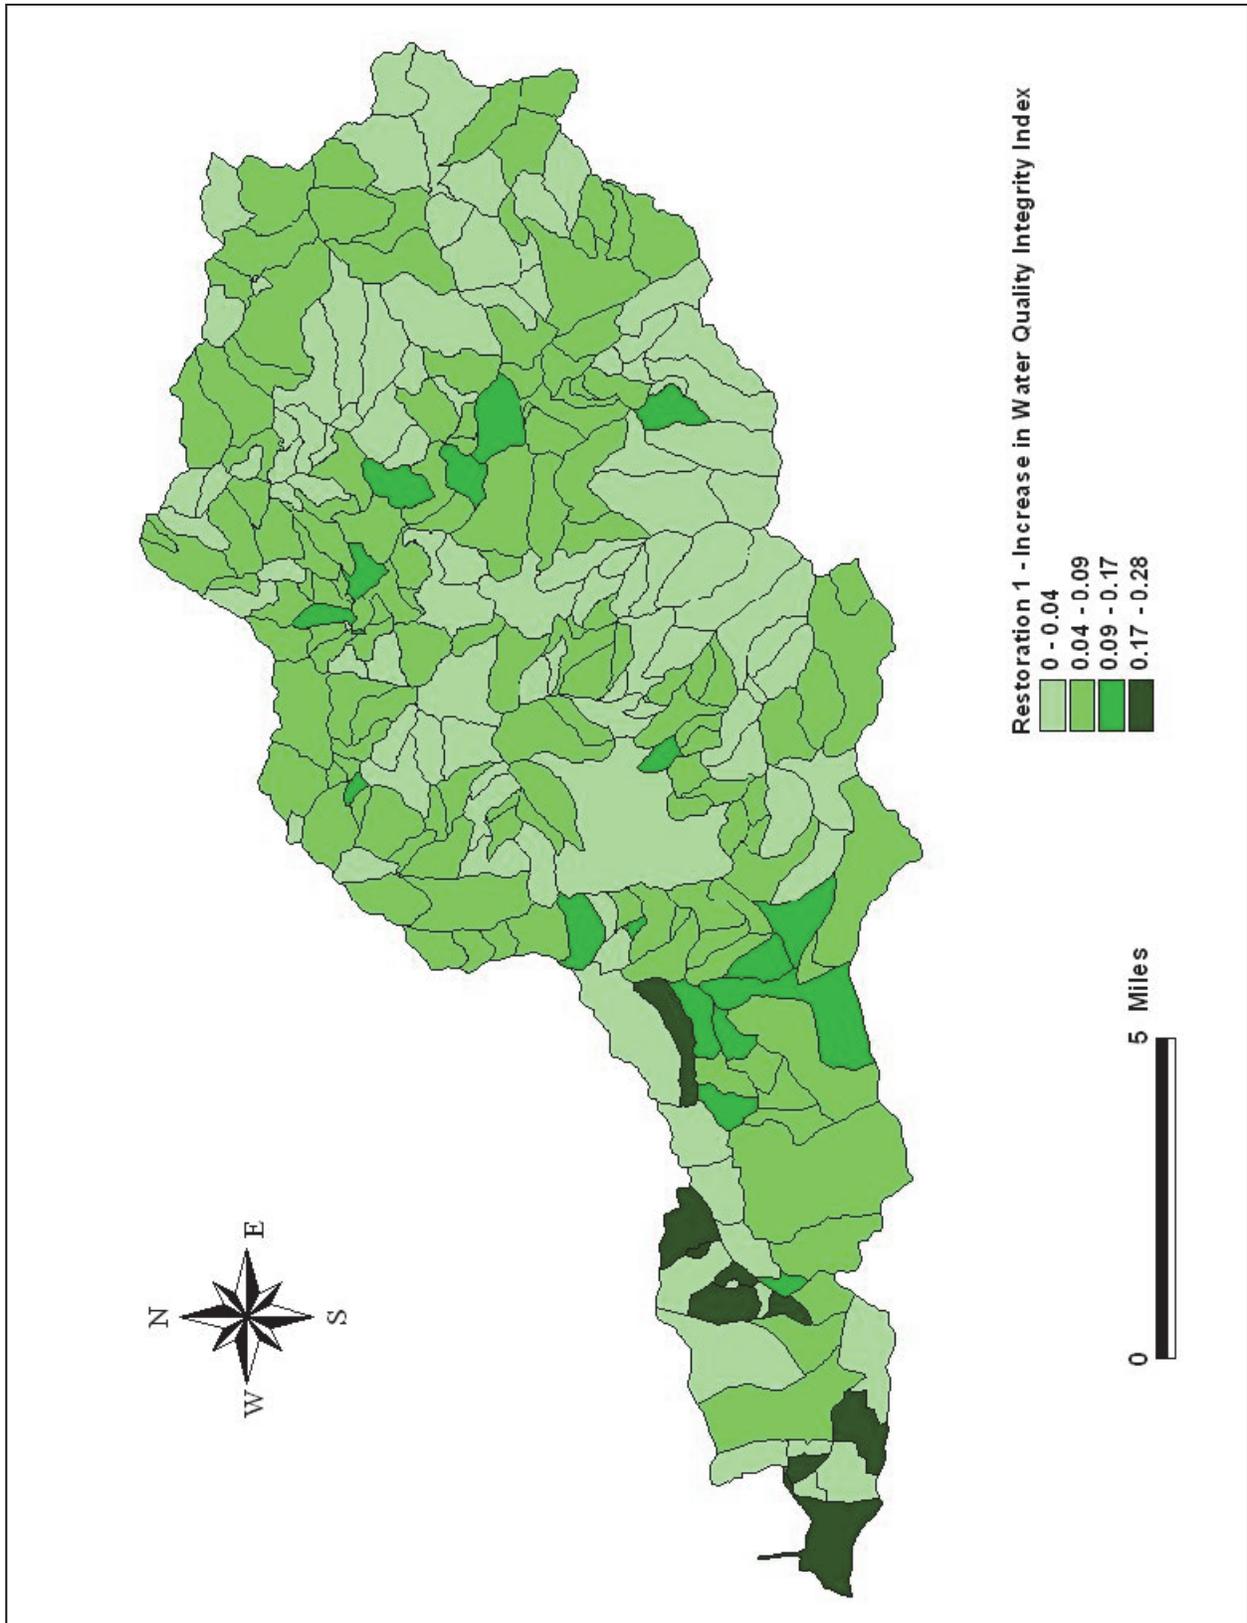
Figure C25. Increase in normalized water quality integrity index under Restoration Scenario 1.

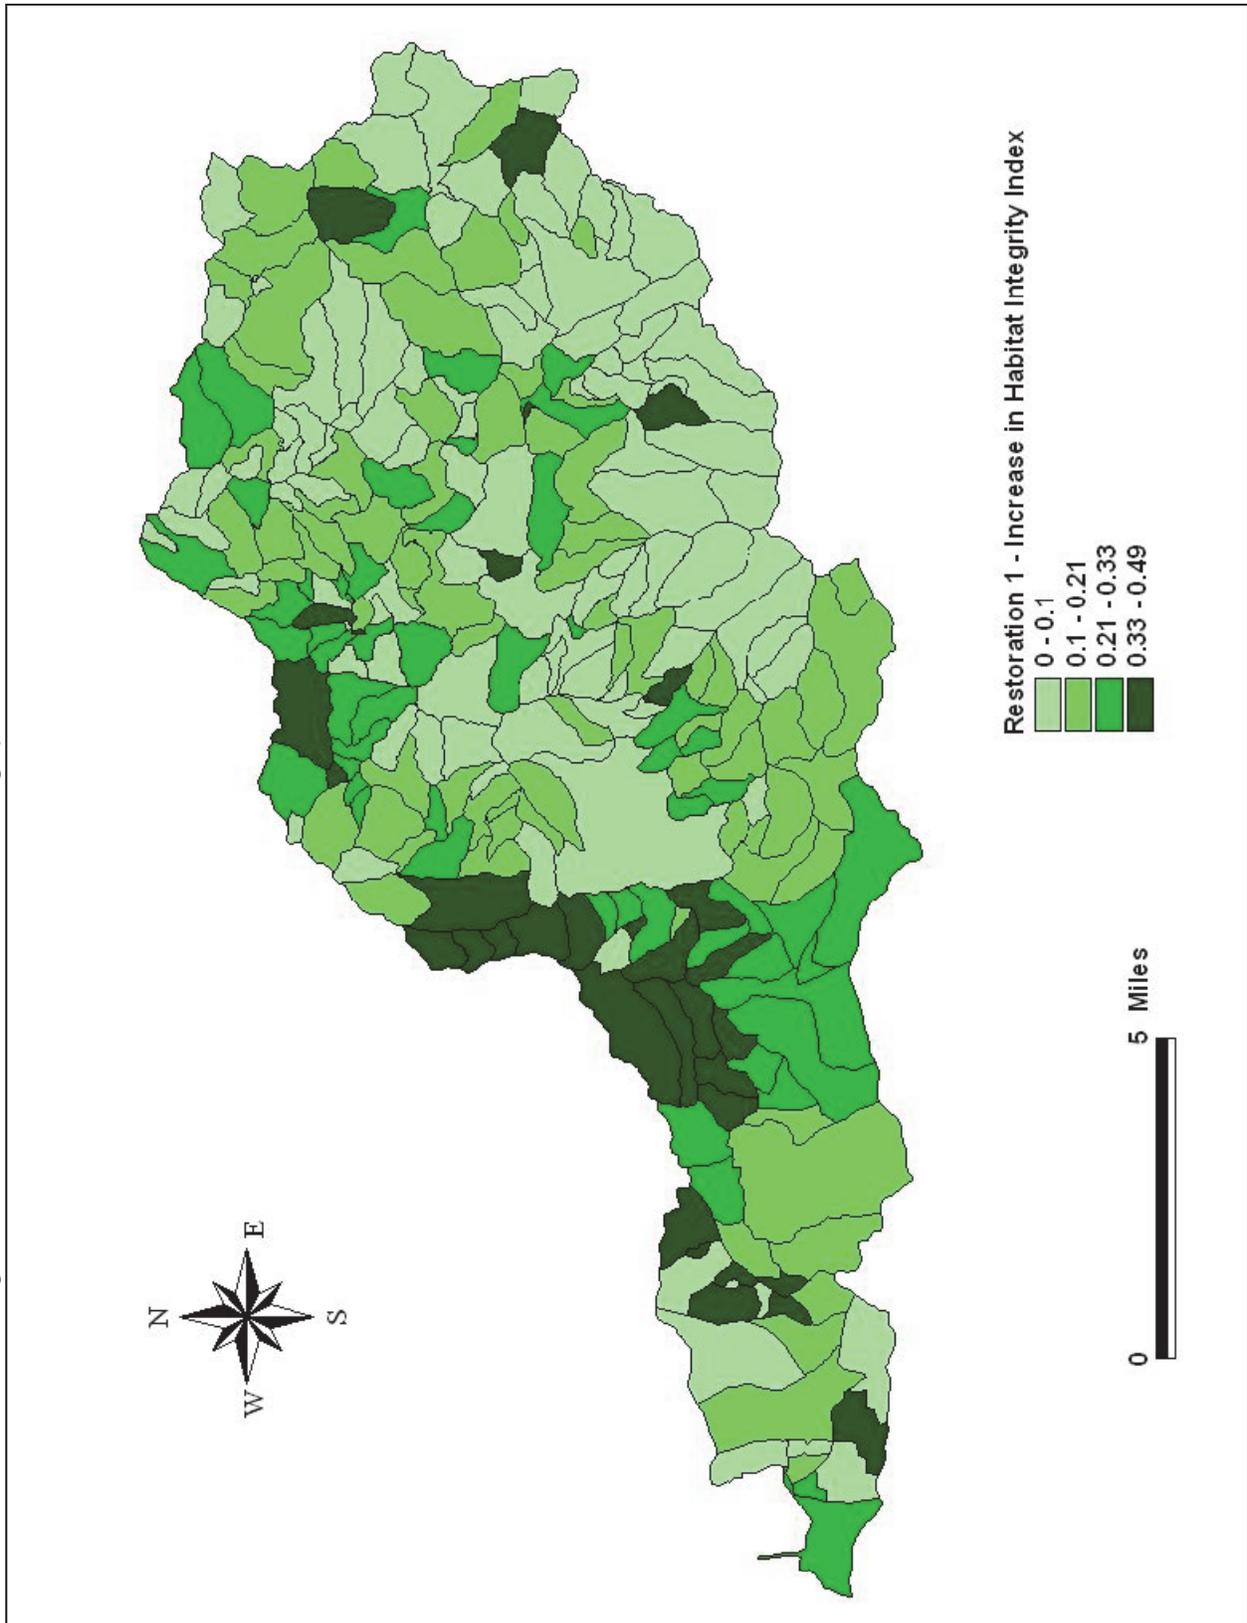
Figure C26. Increase in normalized habitat integrity index under Restoration Scenario 1.

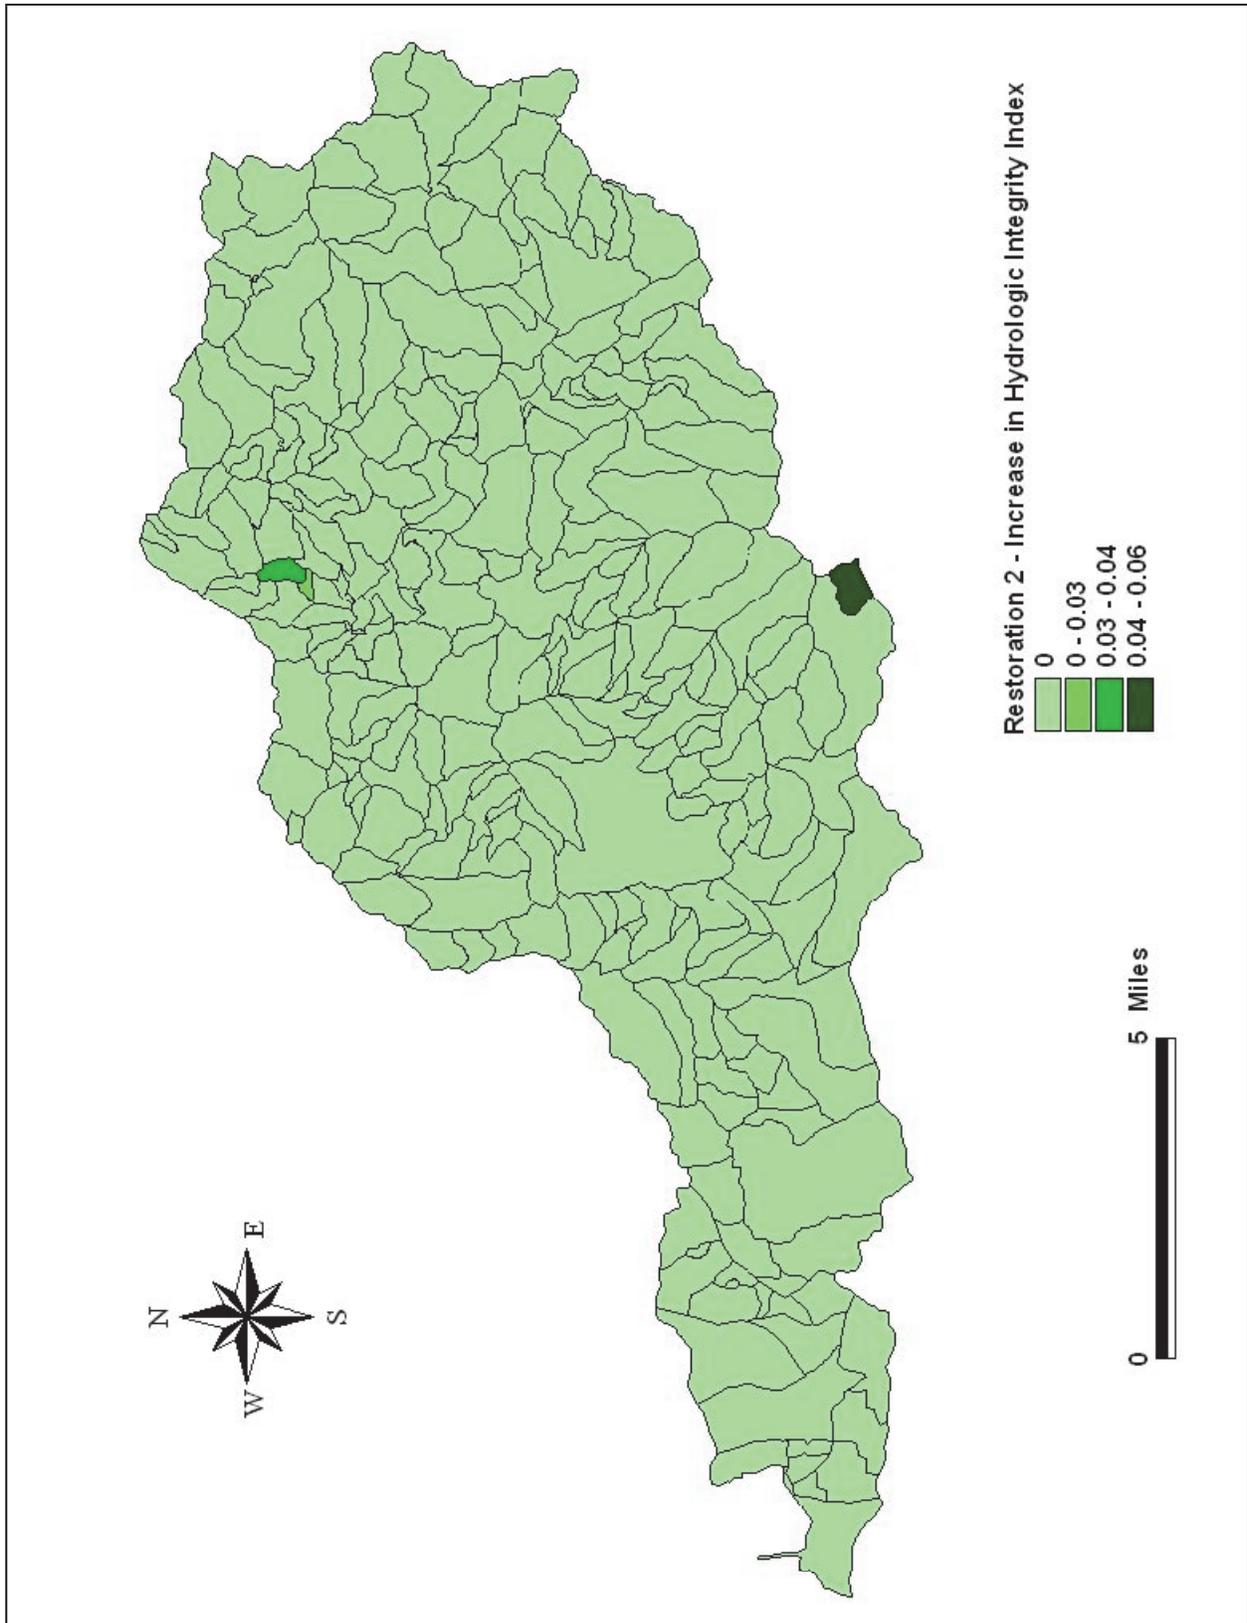
Figure C27. Increase in normalized hydrology integrity index under Restoration Scenario 2.

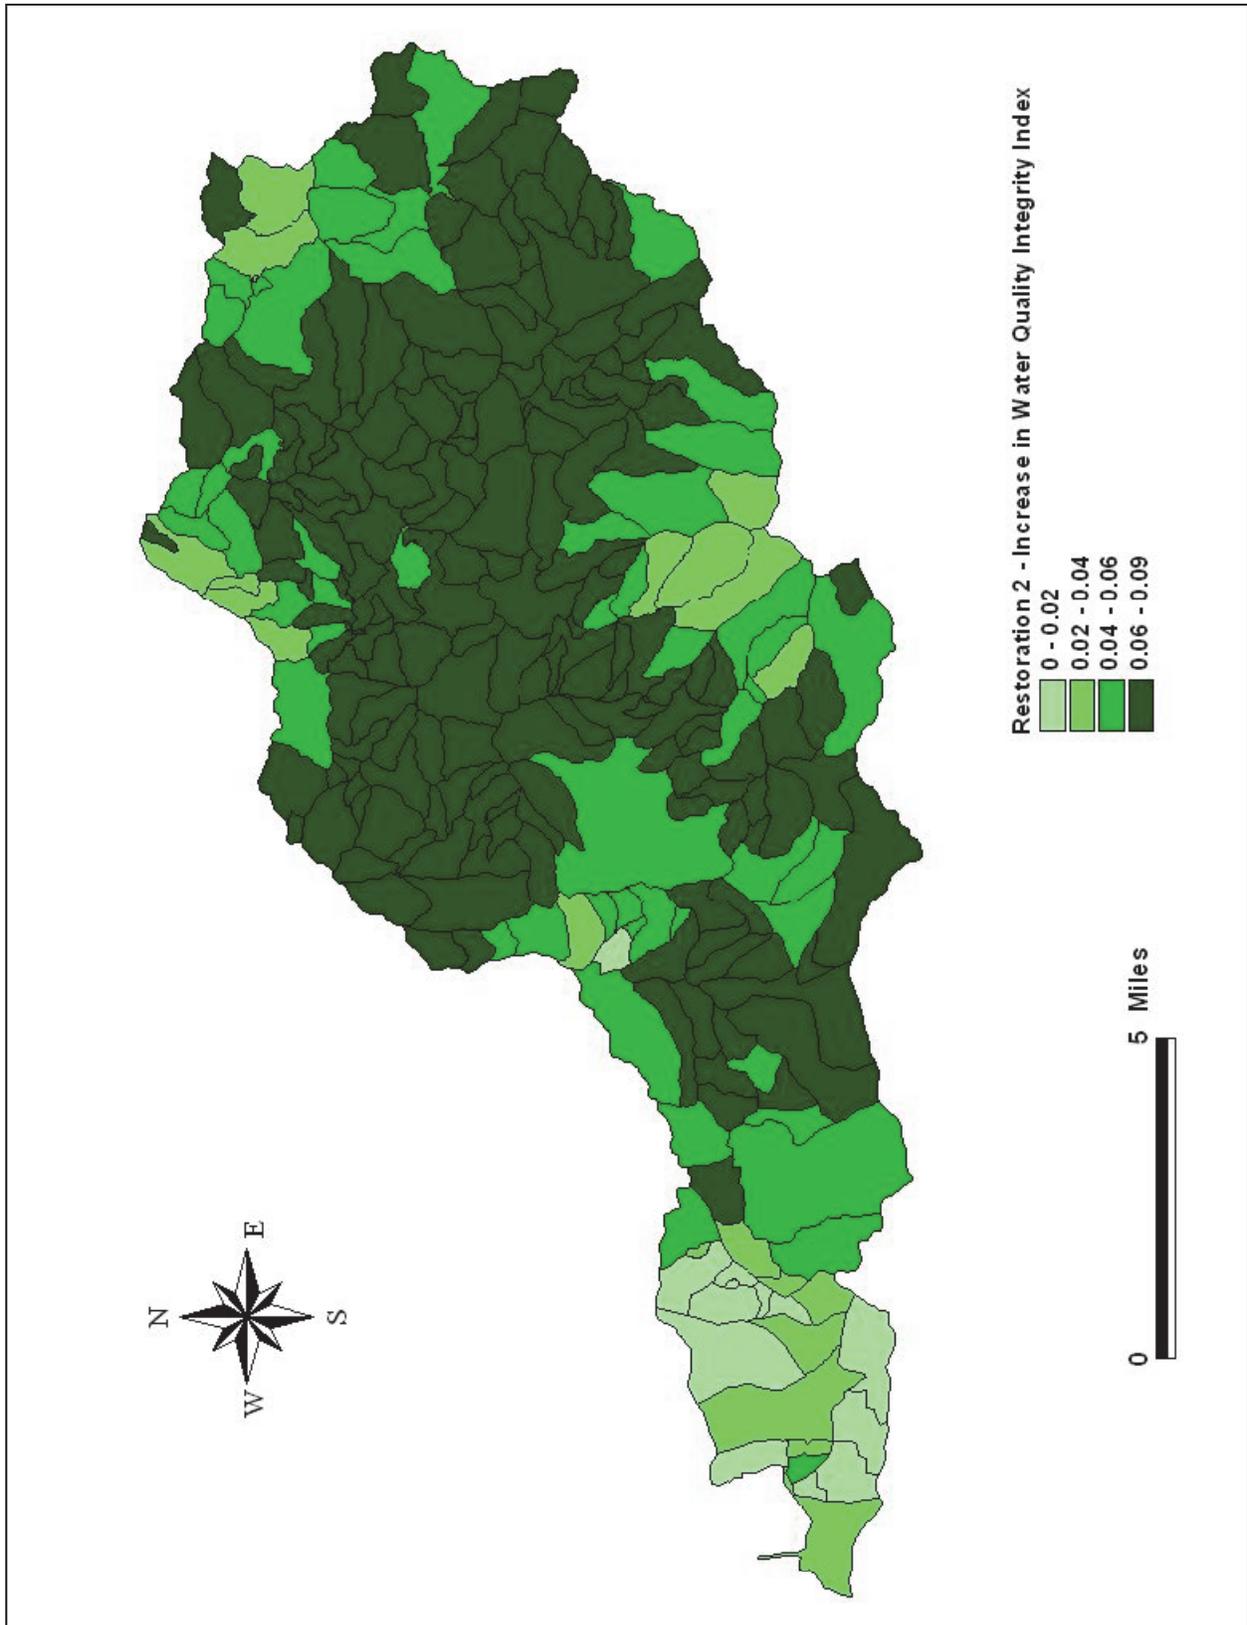
Figure C28. Increase in normalized water quality integrity index under Restoration Scenario 2.

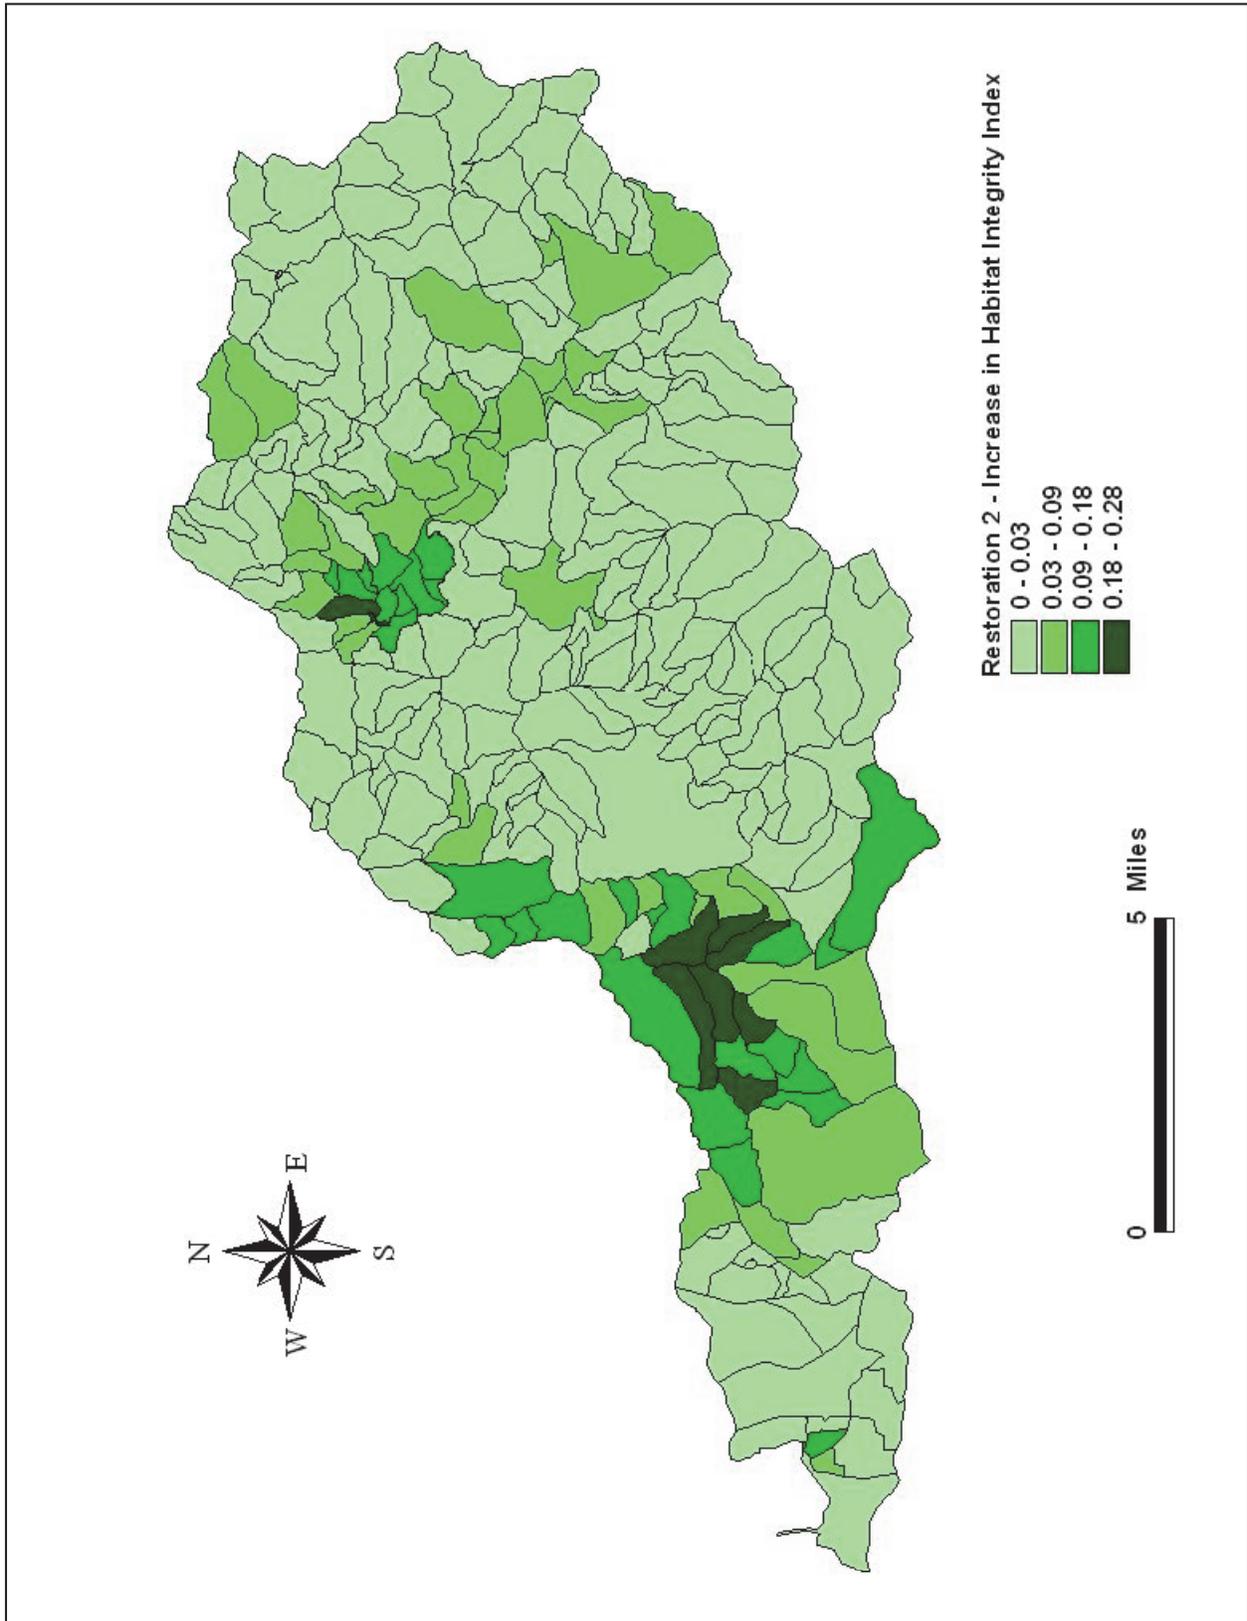
Figure C29. Increase in normalized habitat integrity index under Restoration Scenario 2.

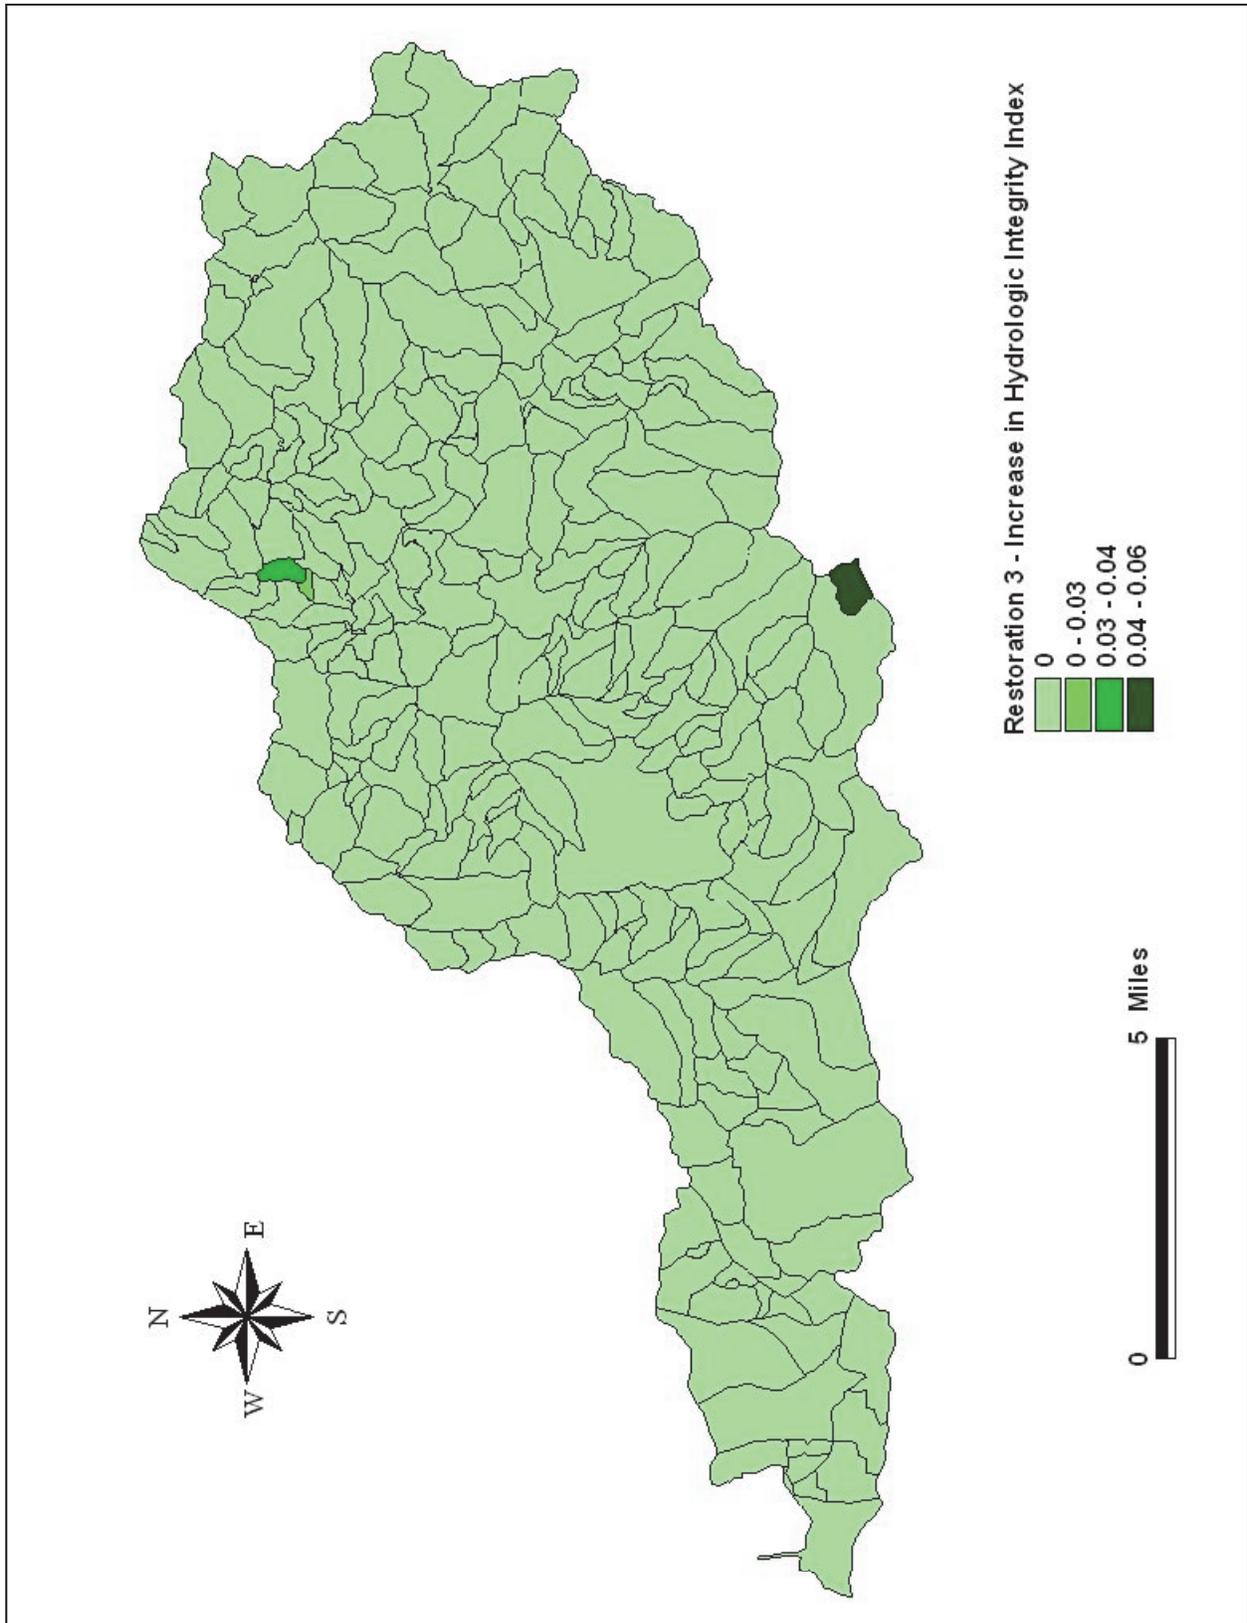
Figure C30. Increase in normalized hydrologic integrity index under Restoration Scenario 3.

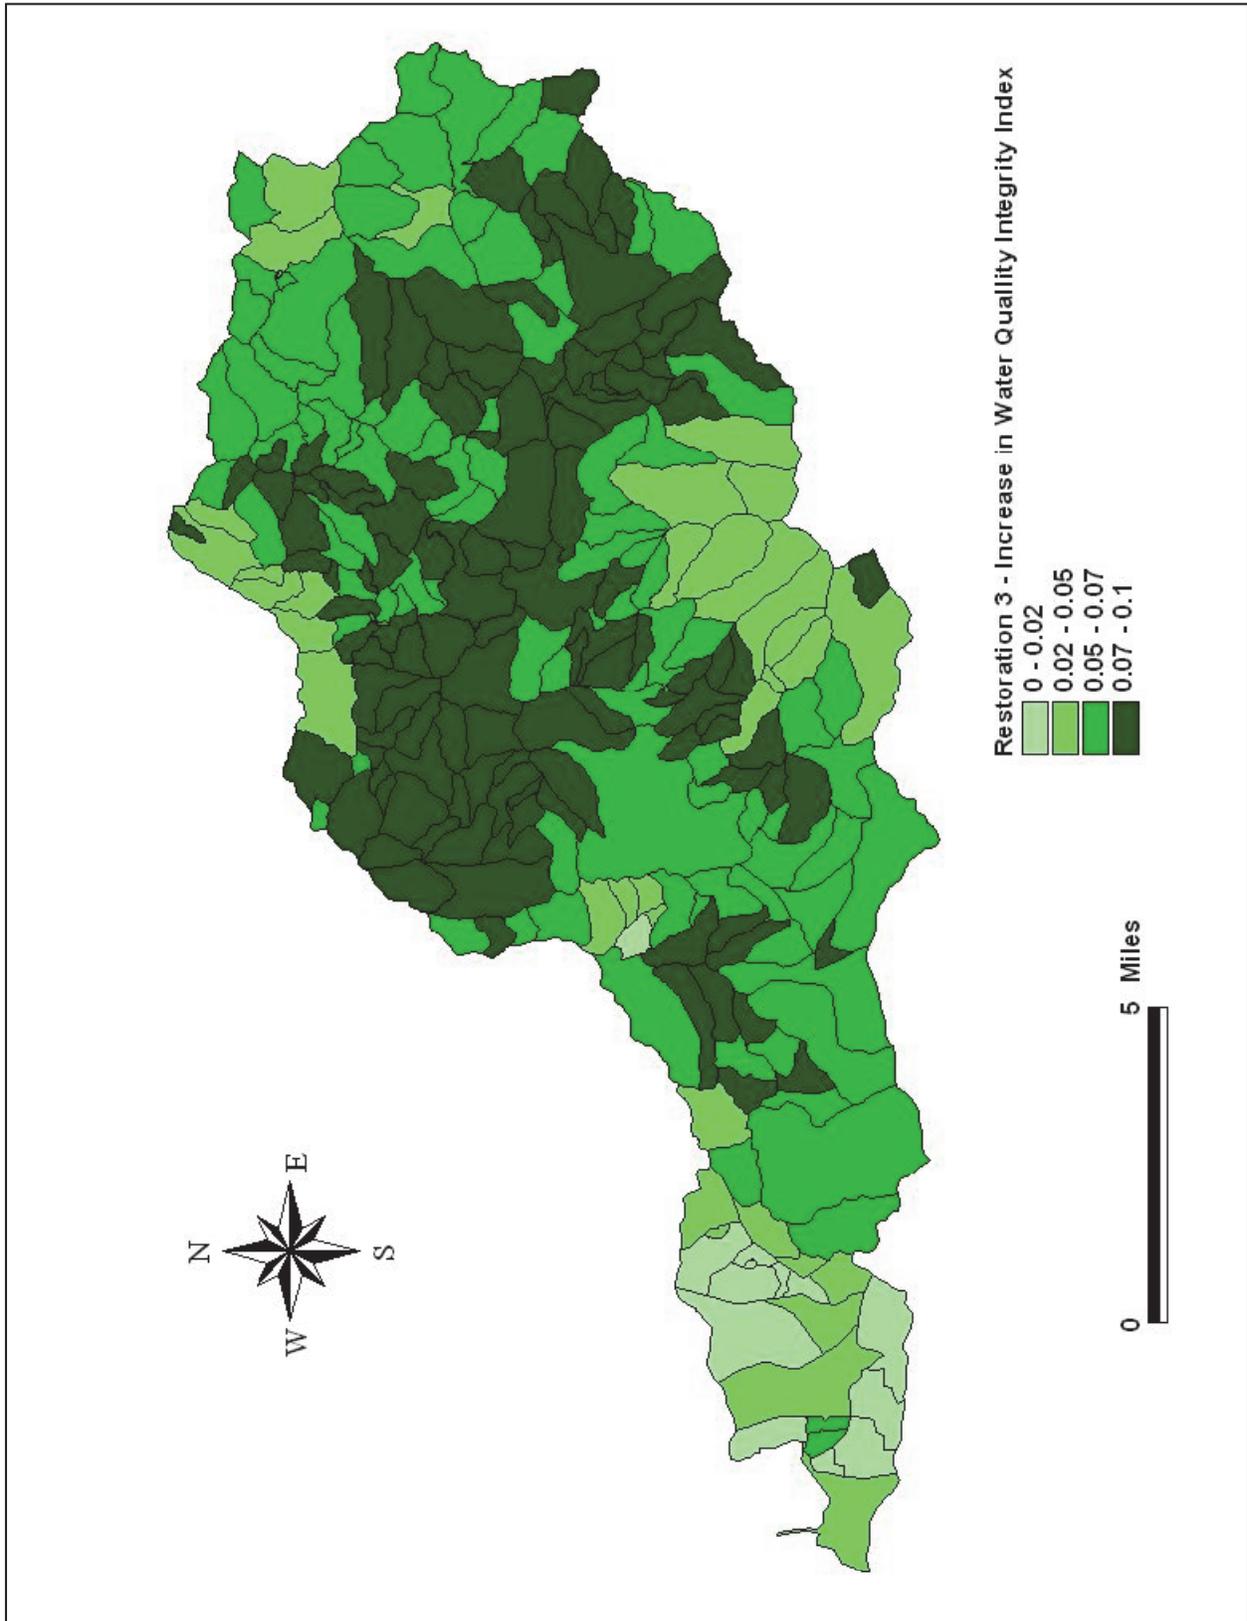
Figure C31. Increase in normalized water quality integrity index under Restoration Scenario 3 simulation.

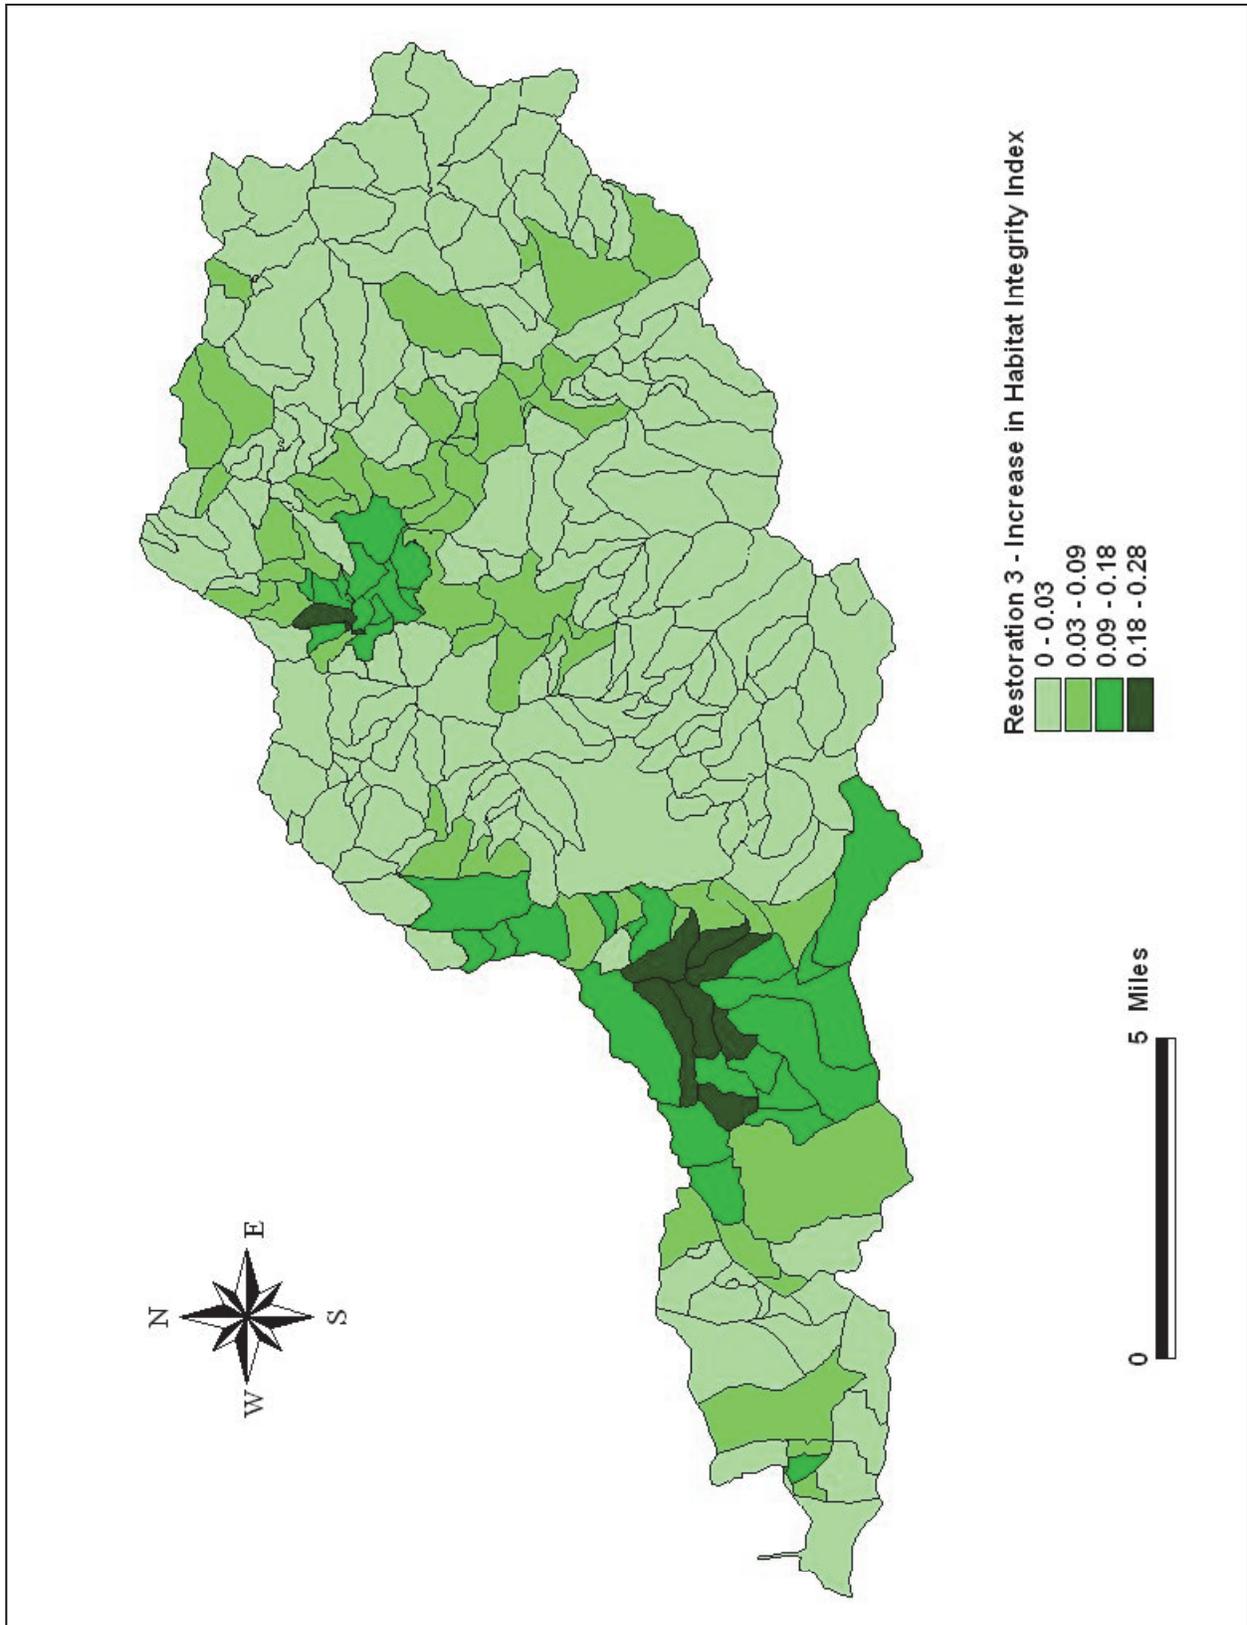
Figure C32. Increase in normalized habitat integrity index under Restoration Scenario 3 simulation.

The three restoration scenarios presented represent only a small sample of the variety of scenarios that are possible. Depending on restoration objectives, numerous variations for prioritizing reaches may be identified. For example, if the objective is to restore large patches (i.e., subbasins) to restore habitat for area-sensitive wildlife species, or to restore riparian corridors for the purpose of connecting existing large patches, it would be possible to identify which of various candidate subbasins or riparian reaches would require the least effort (cost) to restore, and which could be most fully restored, or combinations of both considerations could be developed. This assessment approach also provides the option of considering upland restoration as a component of the overall hydrologic, water quality, and habitat integrity indices of riparian areas.
